October 2017  
FL748A  
NHTSA #17V-629  
Transport Canada #17-489  
REVISED NOTICE

## Subject: Freightliner Cascadia Steering Pinch Bolts

**Models Affected: Specific Freightliner Cascadia vehicles manufactured August 23, 2016, through July 7, 2017, at the Saltillo, Mexico, manufacturing plant.**

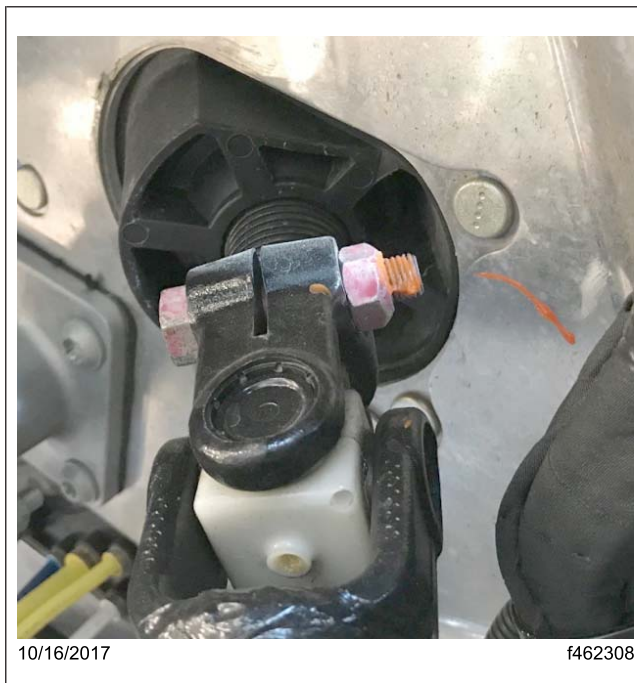
**Fig. 1, Upper Pinch Bolt**

On certain vehicles, the upper steering pinch bolt may have been loosened and not re-tightened. A loose steering pinch bolt may result in a loss of steering and possible vehicle crash. **DTNA urges customers NOT TO DRIVE THEIR VEHICLES until they are inspected. Vehicles should only be driven cautiously to a DTNA dealership for inspection.** Replacement parts are available now.

5. Check the torque on the pinch bolt while holding the pinch bolt with a wrench. If the torque is 27 lbf·f (36 N·m) or higher go to step 8. If the torque is lower continue with step 6.
6. Install a new pinch bolt. Hold the pinch bolt in place with a wrench. Torque the nut to 30-35 lbf·ft (40-47 N·m).
7. Apply torque seal to the nut.
8. Clean a spot on the base label (Form WAR259), write the recall number, FL748, on a red completion sticker (Form WAR260), and attach it to the base label.
