October 2017  
FL748A  
NHTSA #TBD  
Transport Canada #TBD

## Subject: Freightliner Cascadia Steering Pinch Bolts

**Models Affected: Specific Freightliner Cascadia vehicles manufactured August 23, 2016, through July 7, 2017, at the Saltillo, Mexico, manufacturing plant.**

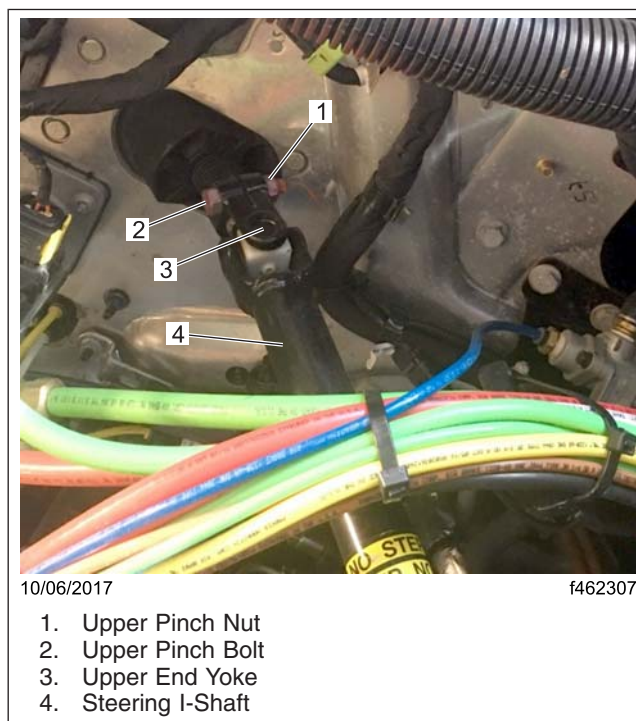
**Fig. 1, Steering Shaft on the Engine-Side Frontwall**

On certain vehicles, the upper steering pinch bolt may have been loosened and not re-tightened. A loose steering pinch bolt may result in a loss of steering and possible vehicle crash. **DTNA urges customers NOT TO DRIVE THEIR VEHICLES until they are inspected. Vehicles should only be driven cautiously to a DTNA dealership for inspection.** Replacement parts are available now.

1. Check the base label (Form WAR259) for a completion sticker for FL748 (Form WAR260) indicating this work has been completed. The base label is usually located on the passenger-side door, about 12 inches (30 cm) below the door latch. If a completion sticker is present, no work is needed. If a completion sticker is not present, proceed to the next step.
2. Park the vehicle, shut down the engine, and apply the parking brakes. Chock the tires.
3. Open the hood.
4. Inspect the pinch bolt to make sure that the torque seal is not broken. See [Fig. 1](#). If the torque seal is **not** broken, go to step 7. If the torque seal is broken, or the bolt or nut is missing, continue with step 6.

5. Check the torque on the pinch bolt. If the pinch bolt torque is 27 lbf-ft (36 N-m), go to step 7. If the torque is lower, continue with step 6.
6. Install a new pinch bolt. Hold the nut in place with a wrench, and torque the nut 30 to 35 lbf-ft (40 to 47 N-m.).
7. Clean a spot on the base label (Form WAR259), write the recall number, FL748, on a red completion sticker (Form WAR260), and attach it to the base label.
