PRODUCT IMPROVEMENT PROGRAM FOR INSPECTING AND POSSIBLY REPLACING TIE RODS AND STEERING KNUCKLES ON CERTAIN CT660 ON HIGHWAY TRUCKS

Media Number -TEBE7016-00

U-693

PI11133

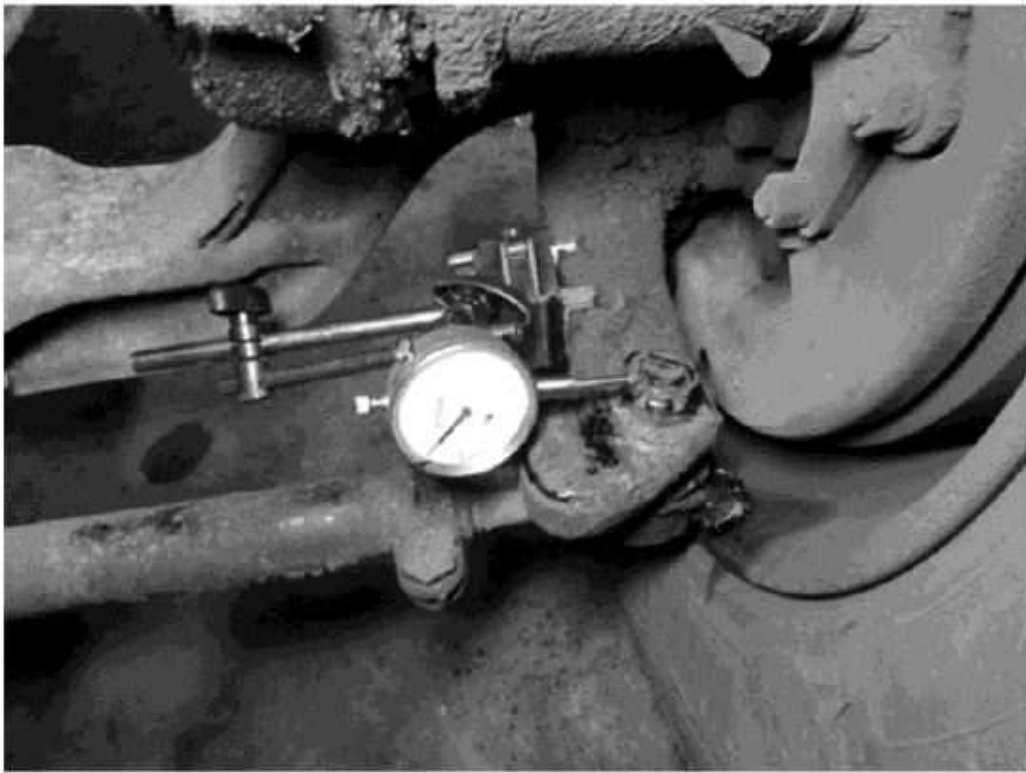
Image1.1.1

Image1.1.1: Dial Indicator Mounting Position

6. Starting with driver-side of vehicle, using a flexible, magnetic base dial indicator (Image1.1.1), mount base of indicator on tie rod arm.

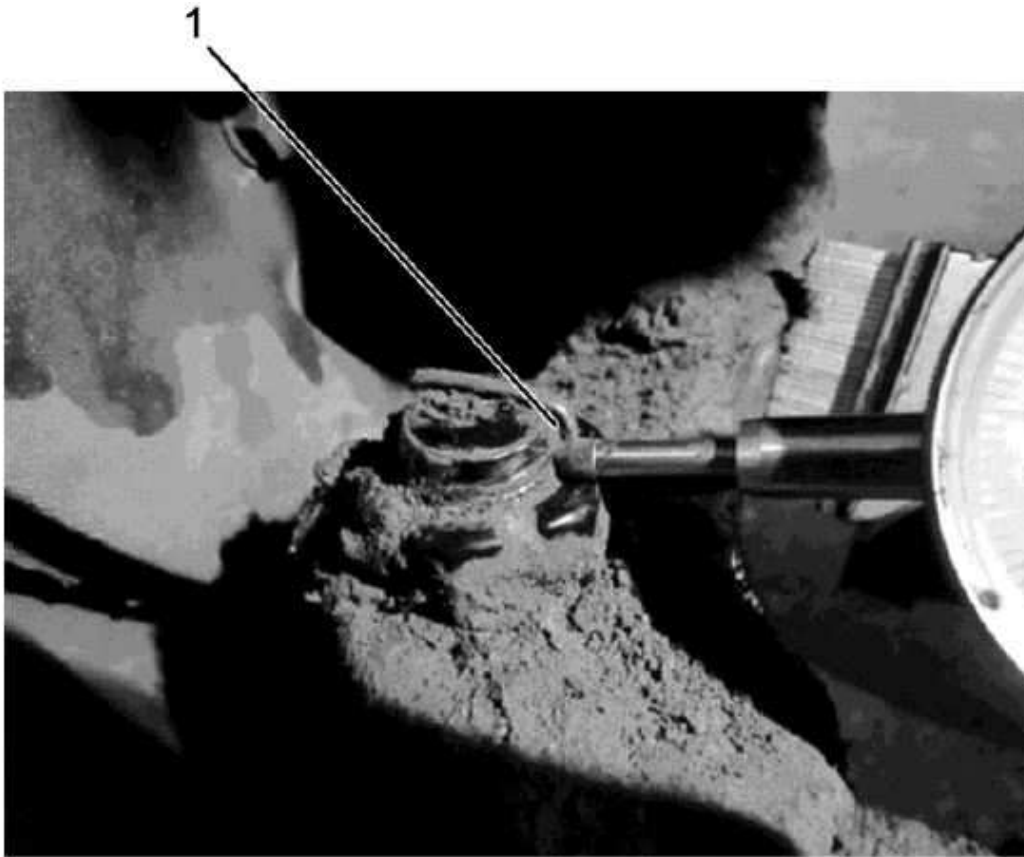
Image1.2.1

Image1.2.1: Dial Indicator Tip Placement (1) Indicator tip

7. Center indicator tip (Image1.2.1, Item 1) on threads of stud just above nut.

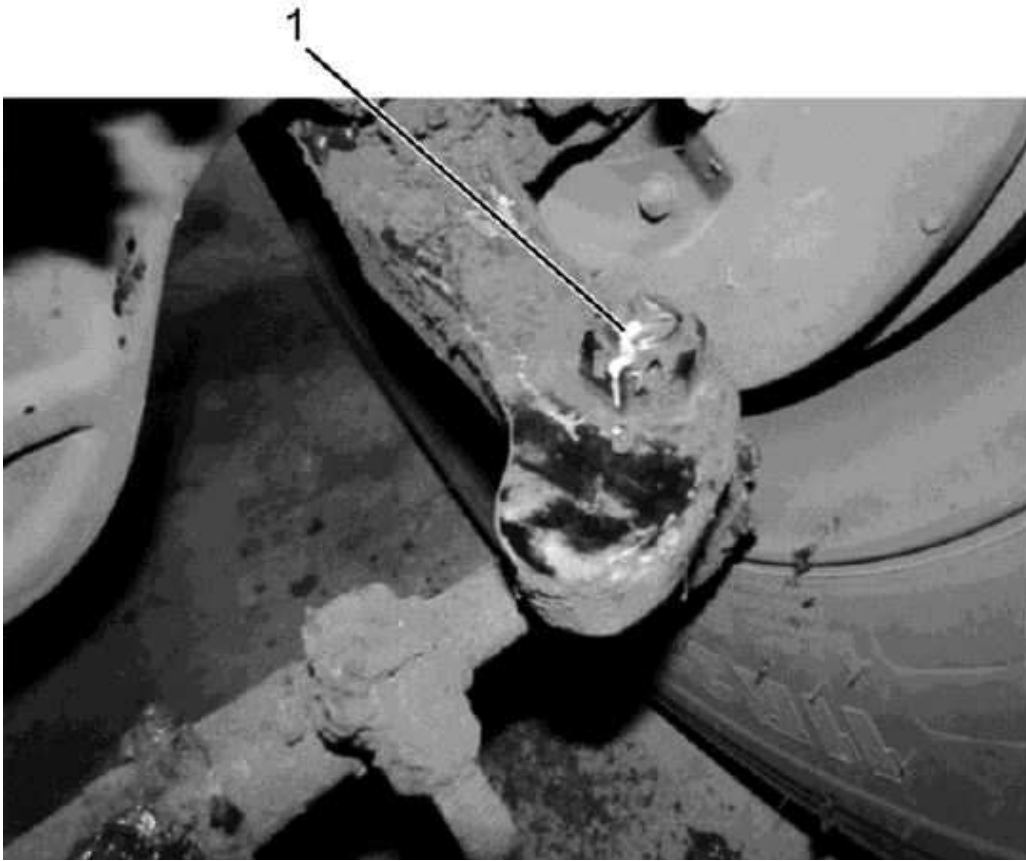
Image1.3.1

Image1.3.1: Paint Mark to Identify Nut Rotation (1) Paint mark

10. Remove cotter pins and using paint marker, make a mark (Image1.3.1, Item 1) across one side of nut and stud.

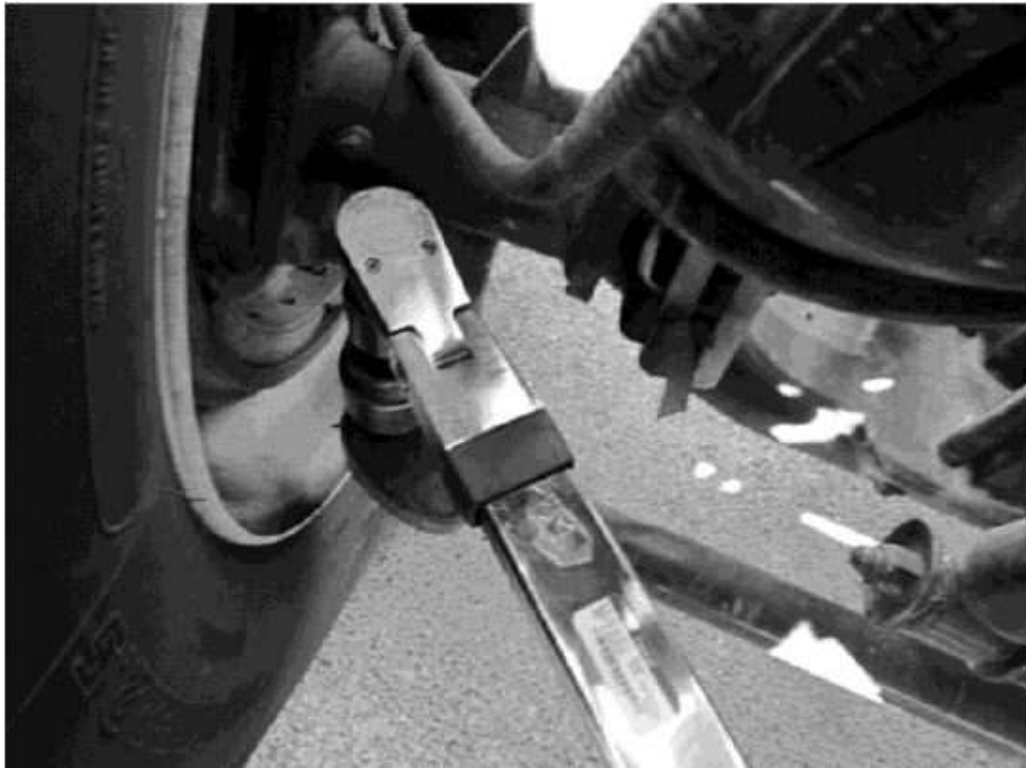
Image1.4.1

Image1.4.1: Verifying Nut Torque

NOTE: Never back the nut off to align the cotter pin hole to the nut slot. Torque may reach 170 lb-ft (230 nm) to obtain proper alignment.

11. Tighten nut to 130 lb-ft (176 nm) (Image1.4.1):

- a. If nut does not turn when 130 lb-ft (176 nm) is reached, go to Step 21.
- b. If nut does turn before 130 lb-ft (176 nm) is reached, go to Step 12.

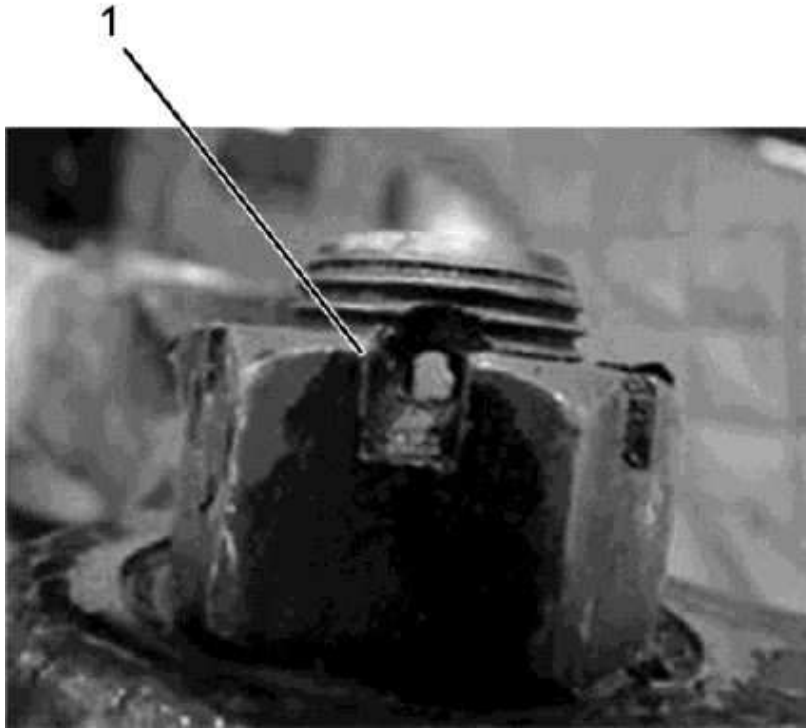
Image1.5.1

Image1.5.1: Unacceptable Cotter Pin Hole Position (1) Top of castellated nut

NOTE: Any tie rod stud with movement after proper nut torque and alignment and / or the cotter pin hole is above the top of the nut surface will require authorization from Caterpillar.

14. After nut has been aligned with cotter pin hole in stud, check to see if cotter pin hole is above top of castellated nut (Image1.5.1, Item 1):

- a. If top of cotter pin hole is even with or less than top of nut, continue to Step 21.
- b. If cotter pin hole is above top of nut surface, continue to Step 15.
