David J. Johnson  
Director  
Service Engineering Operations  
Ford Customer Service Division

April 23, 2019

**SUBJECT: NEW VEHICLE DEMONSTRATION / DELIVERY HOLD - Safety Recall 17S33 - Supplement #3**

Certain 2015-2017 Model Year F-150 and 2017 Model Year F-Super Duty Vehicles  
Doors Will Not Close or Open While Driving

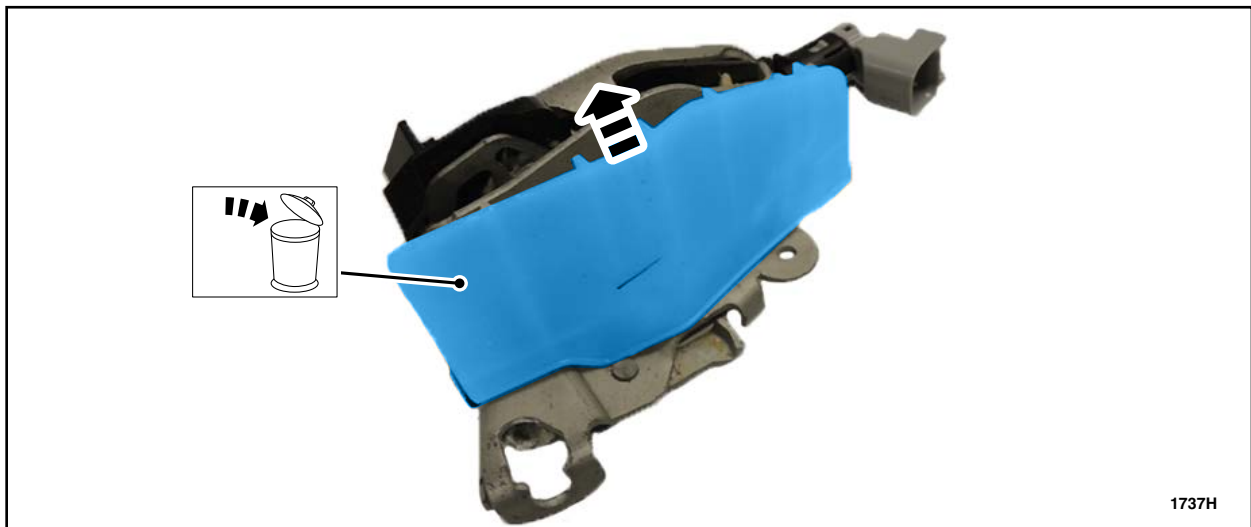
FIGURE 32

**NOTE:** Some F-150 SuperCab vehicles may be equipped with a smaller water shield than what is being installed in this safety recall. The smaller shields must be removed and replaced. See Figure 32.

6. If equipped with small water shields, remove and discard the existing lower door latch water shields. See Figure 32.

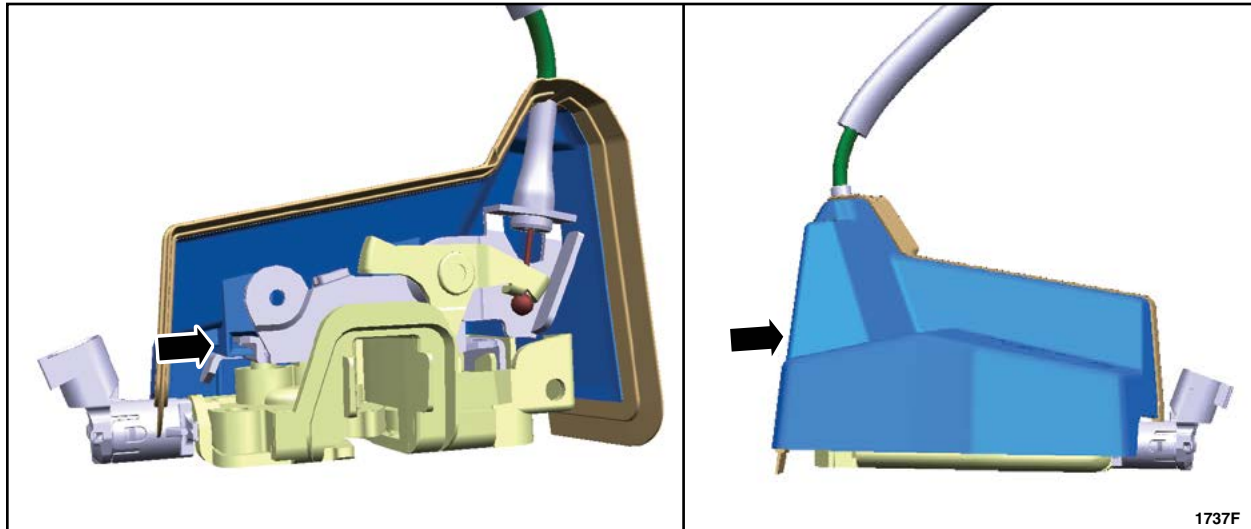
**FIGURE 33**

**NOTE:** If the vehicle has previously had a rear lower door latch replaced, it may already have the latest level door latch water shield installed. If the Super Cab rear lower door latch has a large water shield installed as shown in Figure 33, then installation of a new water shield is not required.

7. Using compressed air, blow out any debris or residual water from the latch assembly area.
8. Install a *new* door latch water shield onto the lower rear door latch. See Figure 33.
