TO: Mercedes-Benz Dealer Principals, General Managers, Sales Managers, Service Managers, Parts Managers	FROM: Gregory Gunther, Department Manager, Vehicle Compliance and Analysis, Engineering Services
RE: <b>Recall Campaign Launch Notification</b> <b>Rework Bulkhead Insulation</b> <b>MY16-17 166 292 (GLE-Class, GLE-Coupe Class)</b>	DATE: February 16, 2018

Campaign No. 2018020002, February 2018

SUBJECT: **Models 166 and 292 Model Years 2016 and 2017**  
**Check Windshield Bonding, Rework if Necessary**

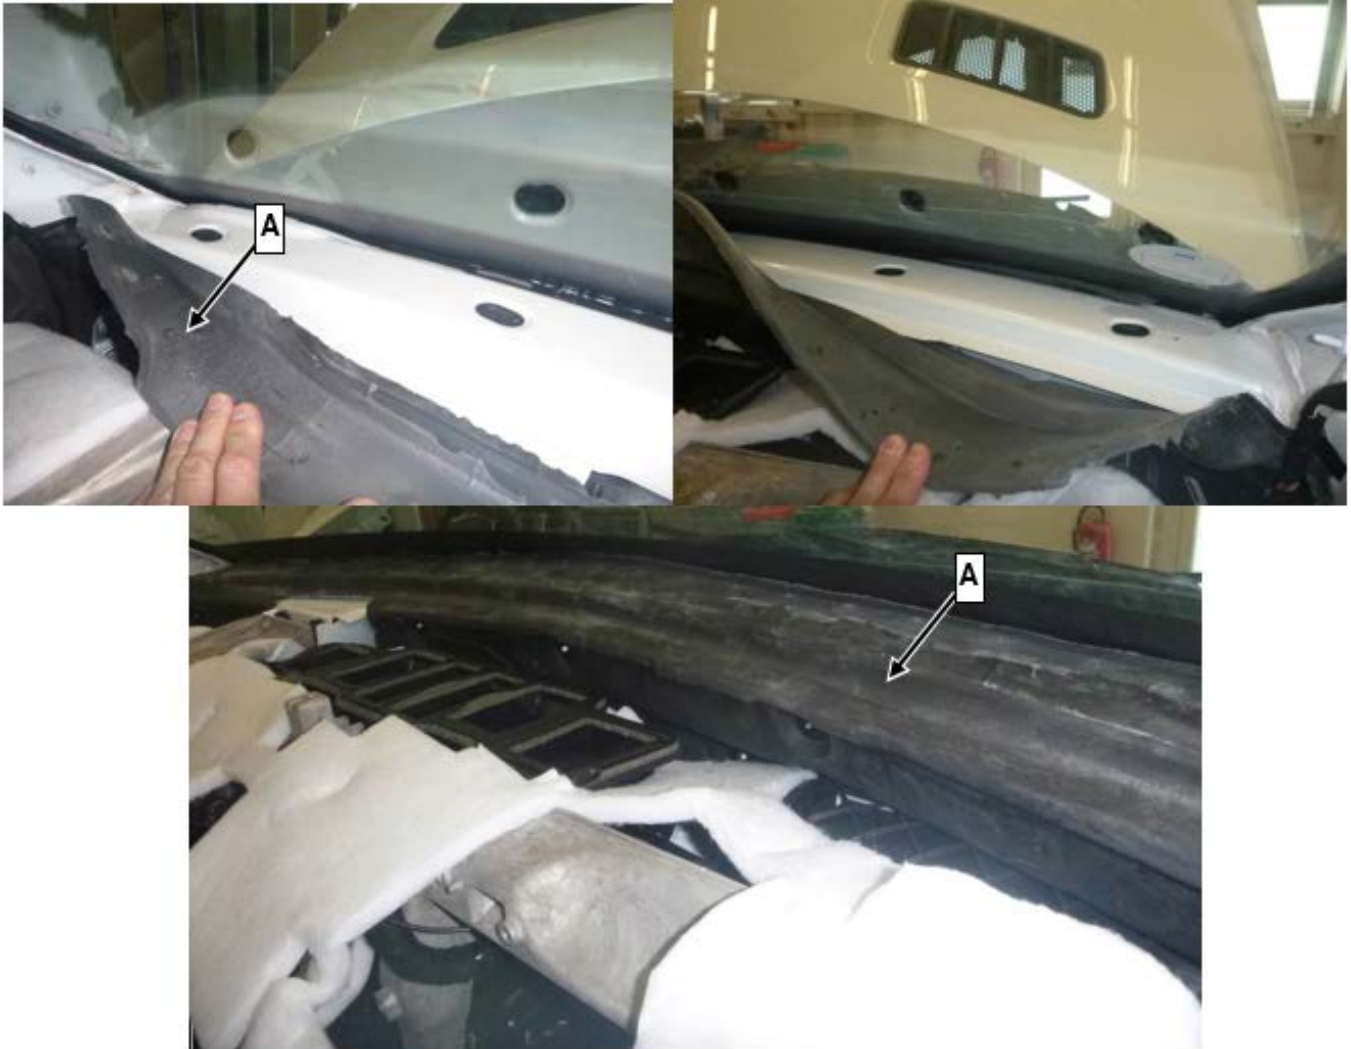
**Figure 1**

1. 1. Remove upper part of instrument panel (AR68.10-P-1020GQ).
2. Fold back damping (A, figure 1) across the entire width of the windshield and check the adhesive bead for the windshield.

**i** There must be no part of the damping (A) that is bonded into the adhesive bead (B) for the windshield. Figures 2 and 3 show a **not** OK condition.

- a. Damping (A) bonded into the adhesive bead (B) for the windshield: Carry out work procedure.
- b. Damping (A) not bonded into the adhesive bead (B) for the windshield: End measure.
