SUBJECT: NEW VEHICLE DEMONSTRATION / DELIVERY HOLD

Safety Recall 17S34 - Supplement #2

Certain 2015-2017 Transit Vehicles Equipped with a Trailer Module

Trailer Module Fuse and Footwell Drainage Hole

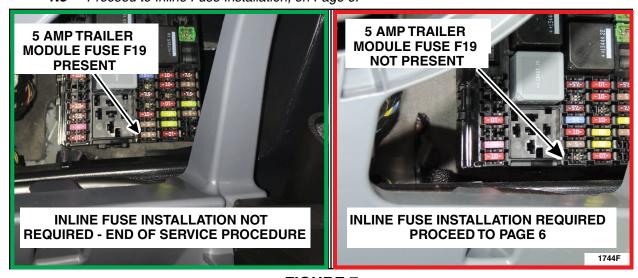
FIGURE 7

NOTE: Some installers may have used fuse position F19 for their aftermarket components. If F19 is anything other than a 5 amp fuse or has aftermarket wiring, then inline fuse installation is required.

2. Inspect for the presence of a 5 amp fuse in the auxiliary junction box at the specified location. Is a **5 amp** fuse present in position F19? See Figure 7.

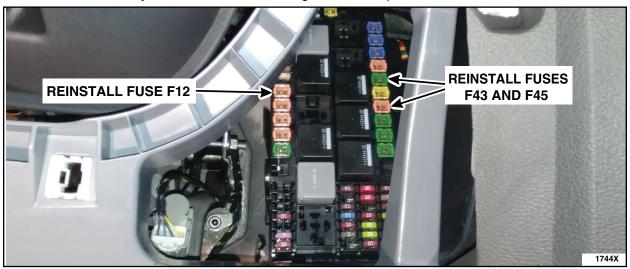
FIGURE 30

NOTE: These fuses may have been removed during an interim repair.

8. Inspect for fuses F12, F43 (pink 30 amp) and F45 (green 40 amp), and reinstall as required. See Figure 30.
