**SUBJECT: NEW VEHICLE DEMONSTRATION / DELIVERY HOLD - Safety Recall 17S36**  
Certain 2017 Model Year F-150 Vehicles with a 10R80 Transmission  
Transmission Roll Pin Replacement

**NEW VEHICLE DEMONSTRATION / DELIVERY HOLD - Safety Recall 17S36**

## CERTAIN 2017 MODEL YEAR F-150 VEHICLES EQUIPPED WITH A 10R80 TRANSMISSION — ROLL PIN REPLACEMENT

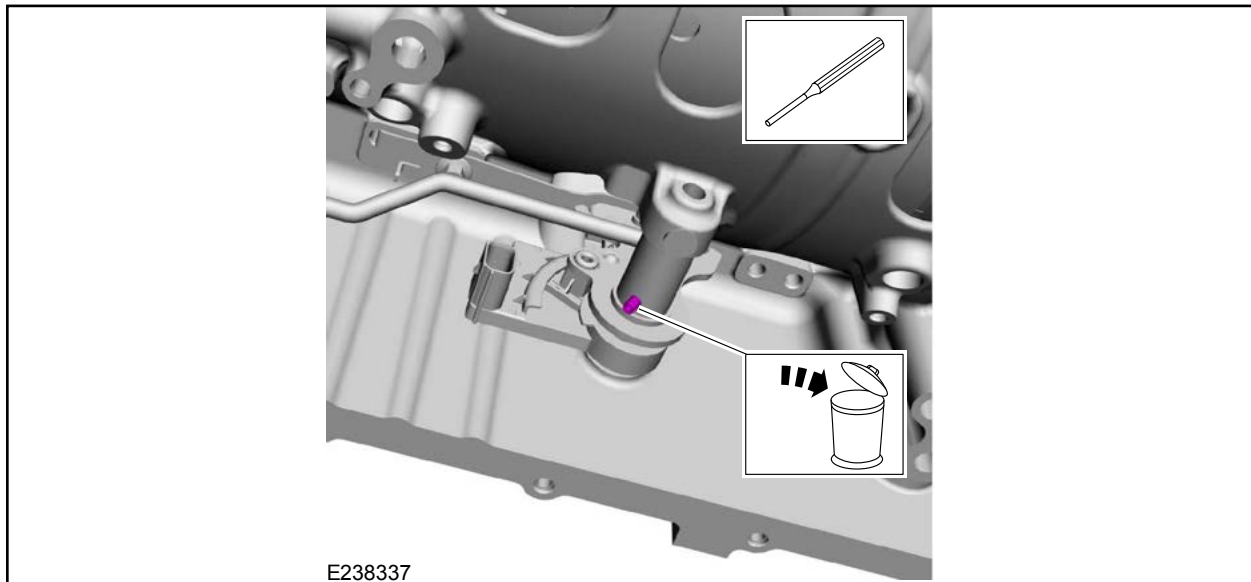
**FIGURE 1**

In some of the affected vehicles, the roll pin attaching the transmission shift linkage to the transmission may come out. If this happens, movement of the shift lever by the driver will not change the transmission gear state. The transmission will remain in the gear it was in when the pin came out regardless of the position of the shift lever.

**NOTE:** Mark the new roll pin at 3 mm (0.11 in) up from the bottom (opposite the tapered end) to aid installation.

2. Replace the transmission manual control shaft-to-transmission range sensor roll pin. See Figure 1.

- When installing the new (revised) roll pin, insert tapered end first. Then drive the roll pin into the manual control lever shaft until 3 mm (0.11 in) of the roll pin remains out of the bottom of the shaft.
