David J. Johnson
 Director
 Service Engineering Operations
 Ford Customer Service Division

March 1, 2018

**SUBJECT: NEW VEHICLE DEMONSTRATION / DELIVERY HOLD -
 Safety Recall 17S40 – Supplement #1**
 Certain 2016 Model Year F-150 and Explorer Vehicles Equipped with Power Seats
 Seat Track Pivot Link Bolt Inspection and Repair

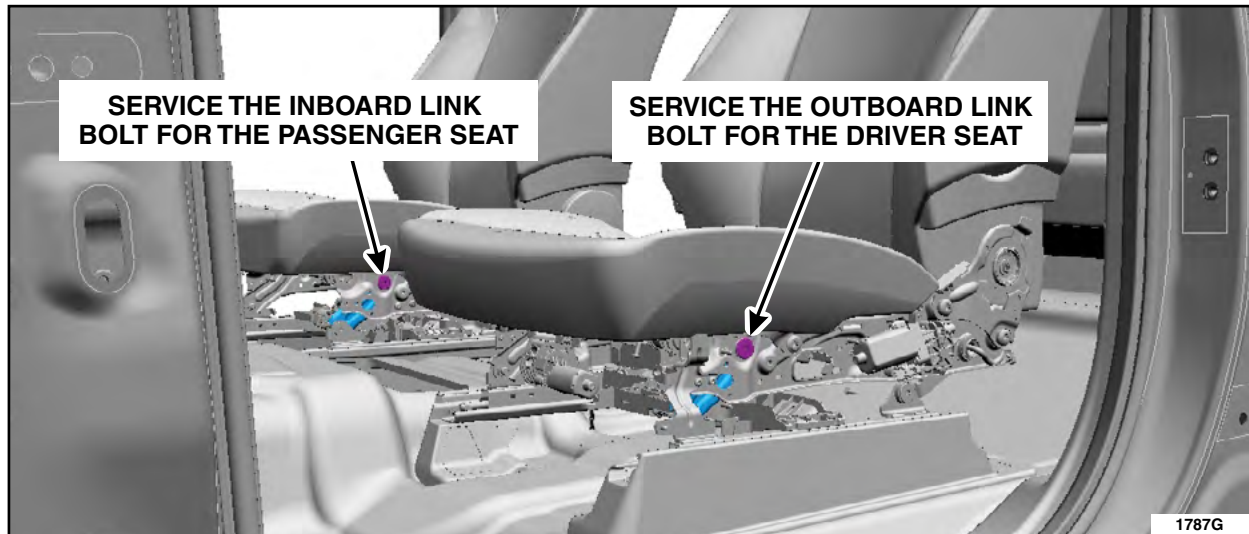
FIGURE 1

NOTE: The affected seat track pivot link will be located on the outboard side of the drivers seat, and the inboard side for the passenger seat. See Figure 1.

5. Check the upper pivot link bolt break-away torque. Using a torque wrench set to 10 Nm (7 ft-lb), attempt to loosen the seat track upper pivot link bolt. See Figure 1.

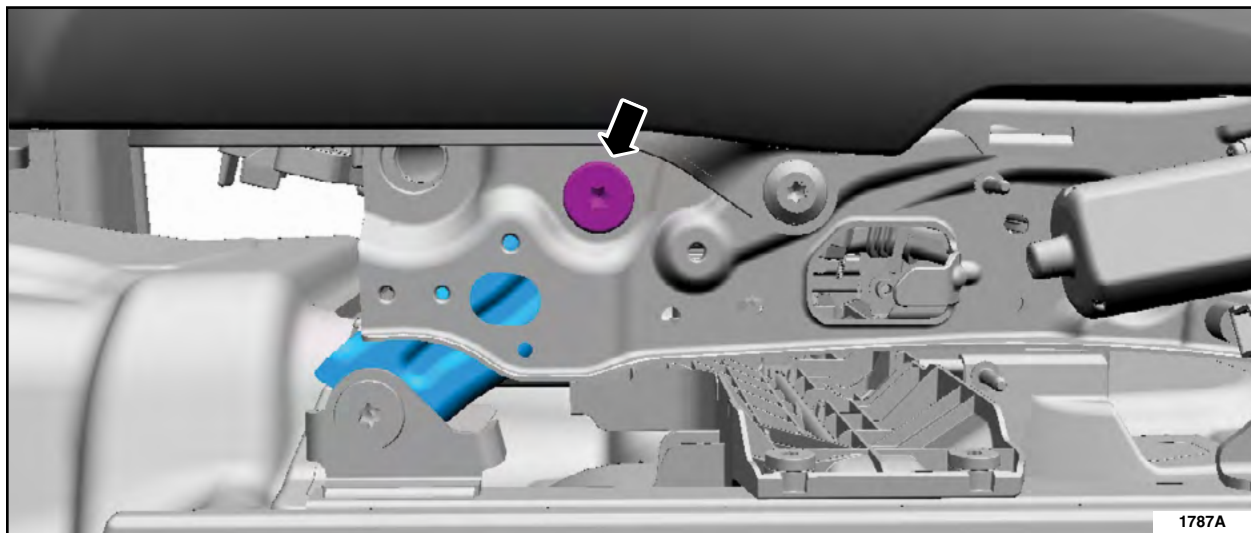
FIGURE 2

6. Remove the seat track upper pivot link bolt. See Figures 1 and 2.

8. Using a wire brush, remove any remaining threadlocker from the pivot link bolt threads.
9. Apply Motorcraft® TA-26 Threadlocker or equivalent to the pivot link bolt threads.
10. Align the pivot link to seat track holes, reinstall the seat track pivot link bolt and torque to 22 Nm (16 ft-lb). To assist in starting the bolt, wiggle the seat cushion frame by hand until the bolt can be started.

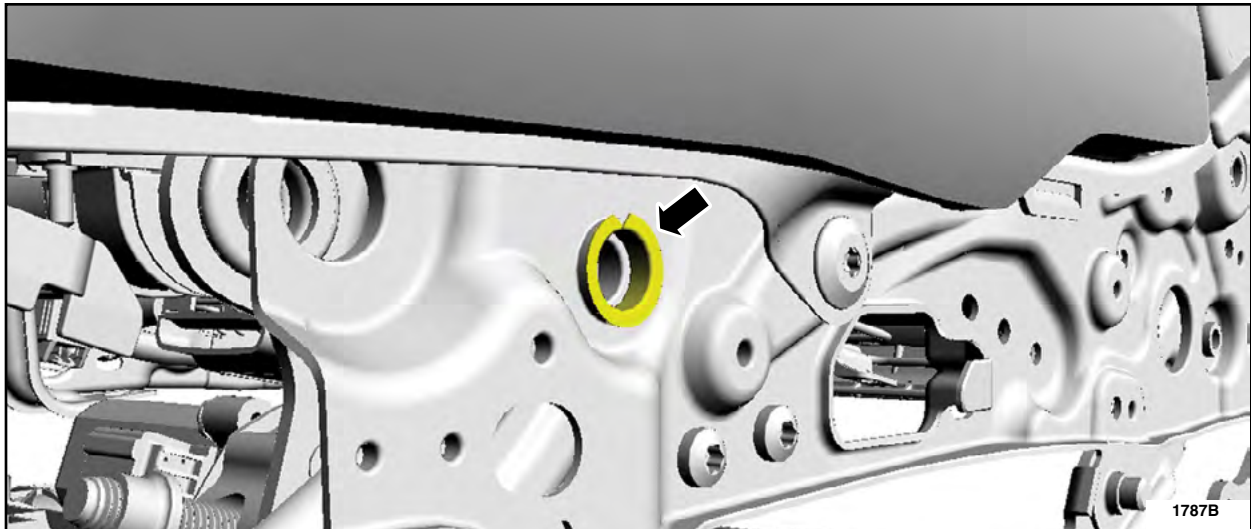
FIGURE 3

7. Inspect the seat track upper pivot link bolt bushing for signs of wear or damage. See Figure 3.

Yes - Proceed to the Pivot Link Replacement Procedure on Page 5.

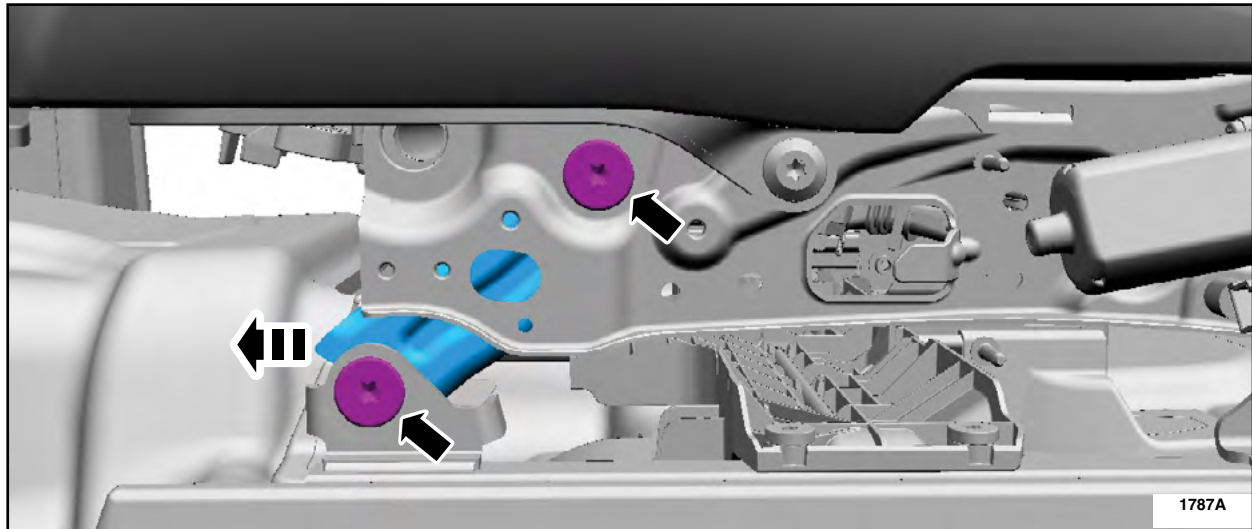
FIGURE 4

1. Remove the seat track pivot link bolts and pivot link. See Figure 4.

4. *Install the new pivot link. See Figure 4.*

6. *Install the new pivot link bolts.*

- *Torque the upper bolt to 22 Nm (16 ft-lb).*
- *Torque the lower bolt to 28 Nm (21 ft-lb).*

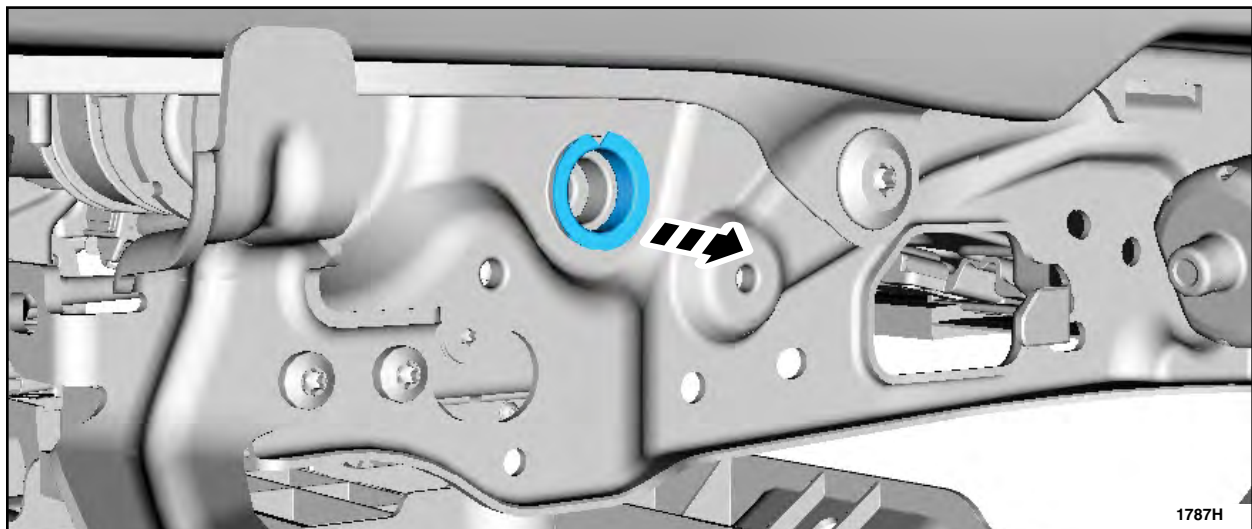
FIGURE 5

2. Remove the upper pivot link bushing. See Figure 5.

3. *Install the new upper pivot link bushing. See Figure 5.*
