December 1, 2017

**SUBJECT: NEW VEHICLE DEMONSTRATION / DELIVERY HOLD –
Compliance Recall 17C20**
Certain 2018 Model Year Expedition Vehicles
Comfort Lock Inspection and Marriage Bolt Torque

CERTAIN 2018 MODEL YEAR EXPEDITION VEHICLES — COMFORT LOCK INSPECTION AND MARRIAGE BOLT TORQUE

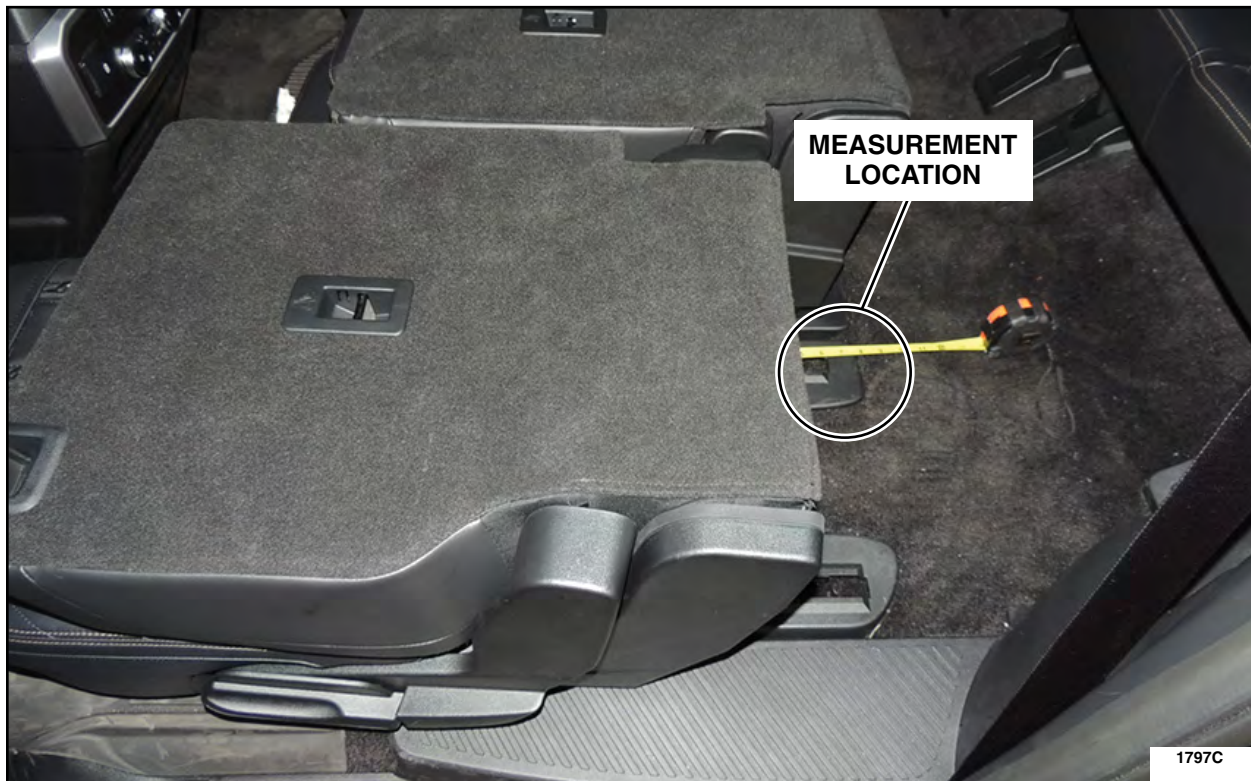
FIGURE 1

1. With the seats in their most forward position (Comfort Lock Forward Position), measure the position of both the RH and LH 2nd row 40% seats. See Figures 1 and 2.

NOTE: Seatback folded down in Figure 1 for photographic purposes only.

- a. With the seatback upright and the seat in the full rearward position, lift up on the "towel bar" under the seat and slide the seat to the full forward position.
- b. Measure the distance from the "arrow point" of the seat frame cover to the end of the seat track trim cover on the inboard side.
- c. Repeat steps "a" and "b" five (5) times on both the RH and LH seat.

2. Was the measurement equal to or less than 8.0 in (203 mm)?

No – Replace the affected 2nd row 40% seat frame assembly. Transfer components from the original seat frame to the *new* assembly as required. Please follow the Workshop Manual (WSM) procedures in Section 501-10B. Repair is complete for that seat assembly.

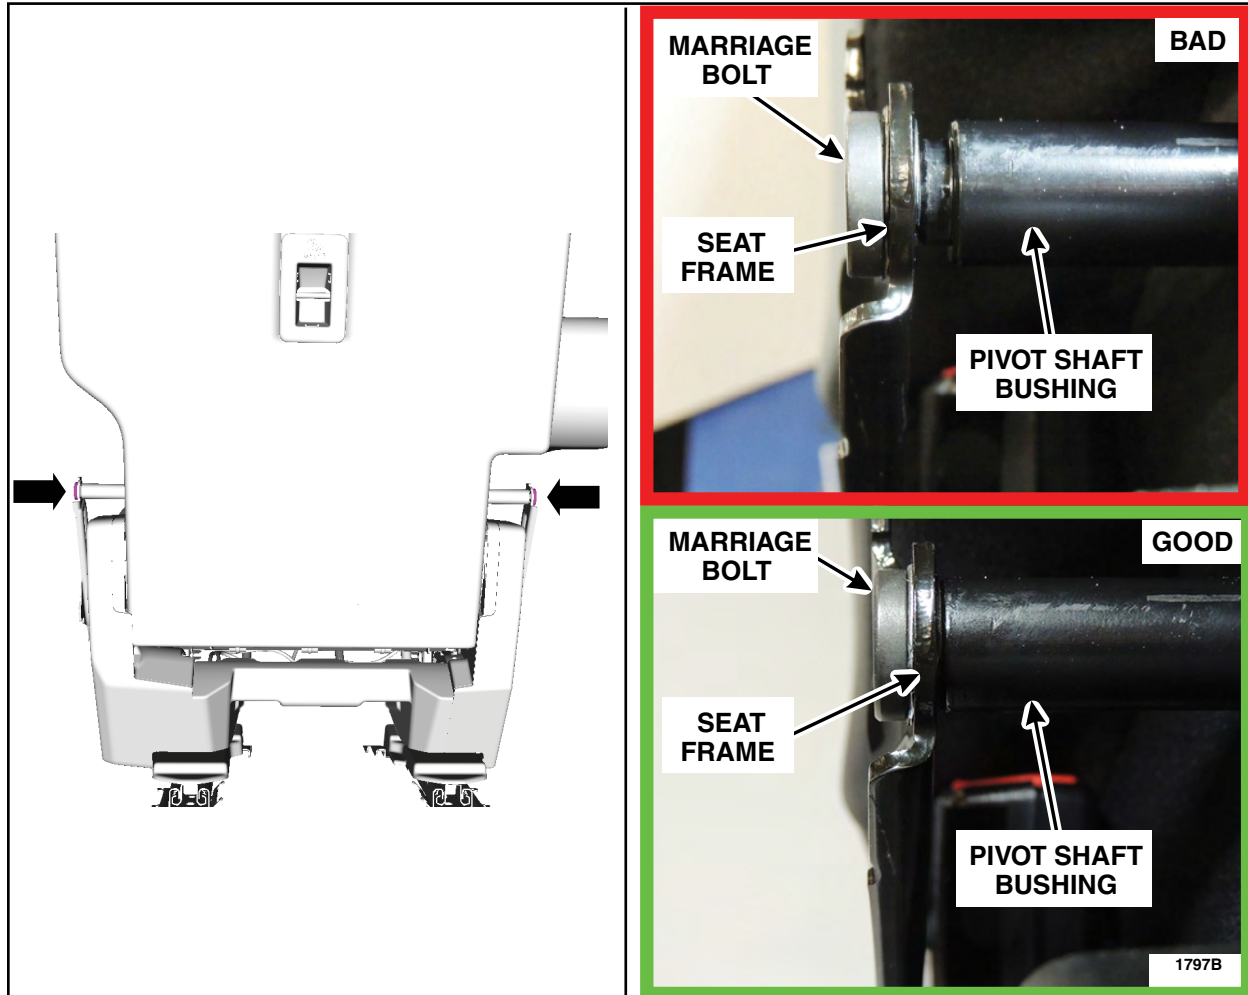
FIGURE 7

6. Verify the marriage bolts (2 per seat, four total), pivot shaft bushings and seat frames are properly aligned. See Figure 7.

- Tighten bolts to 15 Nm (11 lb-ft).
