IMPORTANT SAFETY RECALL RECALL NO. 17E061

December 2017

This campaign involves mounting brackets (Part Nos. AB037A-100, AB037A-100P, AB037A-100B) in ProCharger supercharger kits, intended for installation on Model Year 2012 – 2017 Jeep Grand Cherokee SRT8/SRT vehicles in the US and Canada. These mounting brackets were included with the following kits:

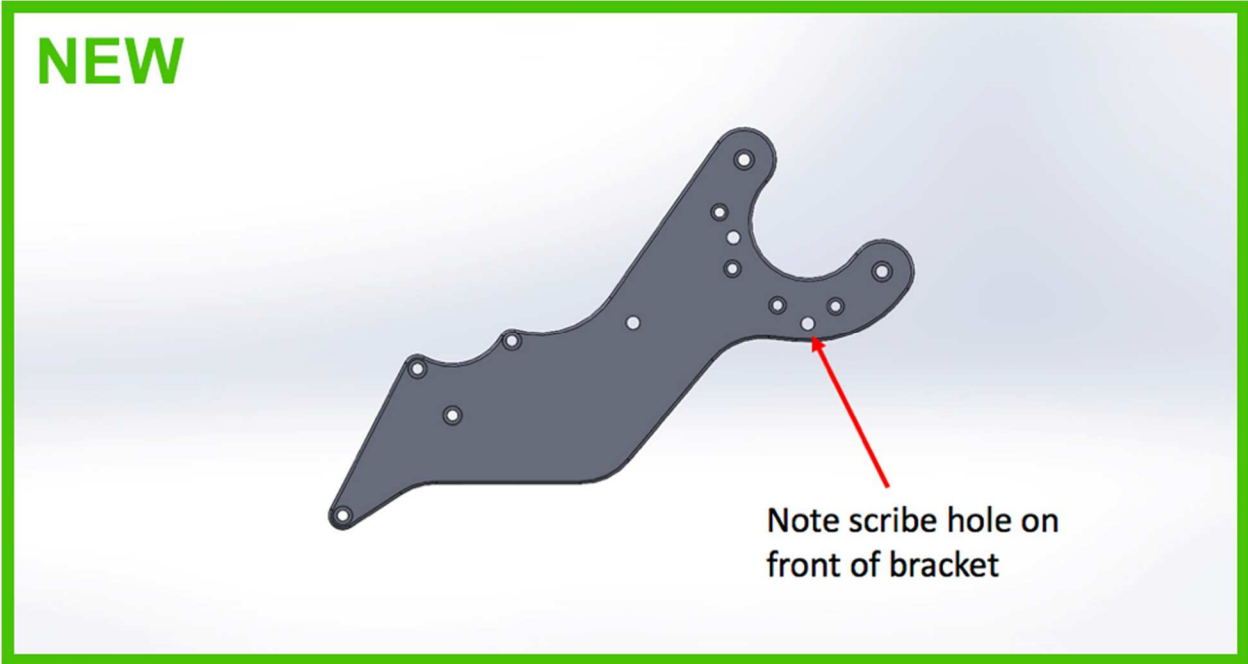
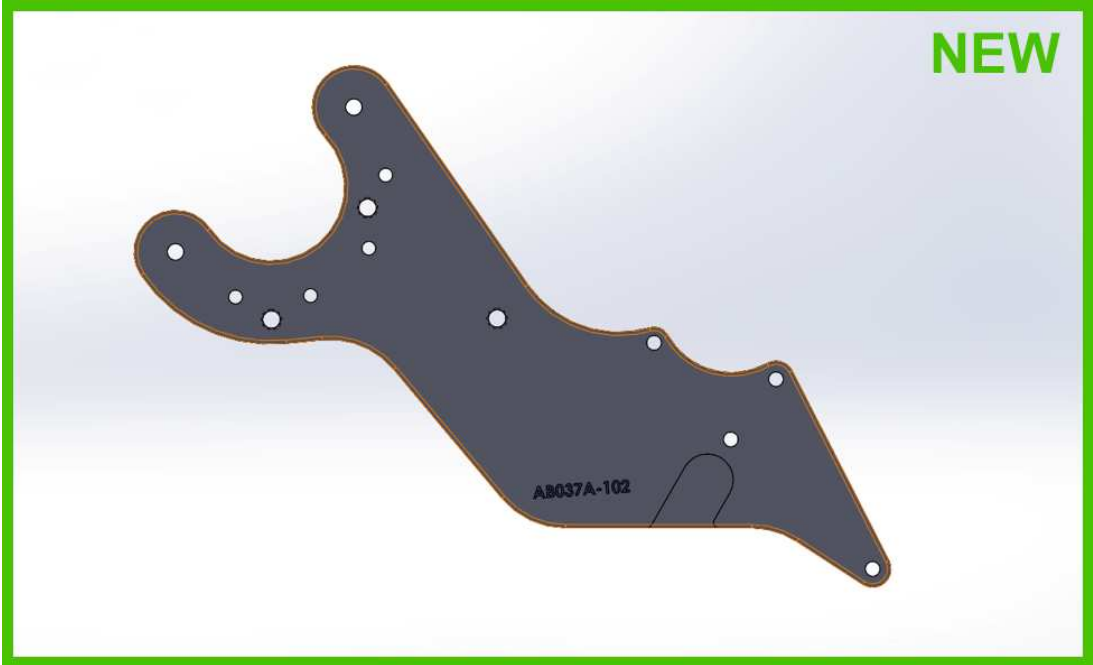
New Bracket

Satin Finish: AB037A-102
Black Finish: AB037A-102B

Polished Finish: AB037A-102P

If you have one of the vehicles listed above, a visual inspection will easily identify whether you have a kit or system covered by this recall. The replacement part can be visually identified by the addition of an unused scribe hole on the front (forward) facing side of the new replacement bracket (See top two illustrations above, outlined in green).

Please schedule an appointment at your earliest opportunity with the dealer that sold and/or installed the kit/system. If you self-installed, ATI ProCharger can support you directly. If you own one of the kits containing the recalled mounting brackets, ATI will send you an improved bracket for remounting the supercharger either directly to you, if your ProCharger was self-installed, or to your local dealer, and reimburse you for the cost of remounting the supercharger.

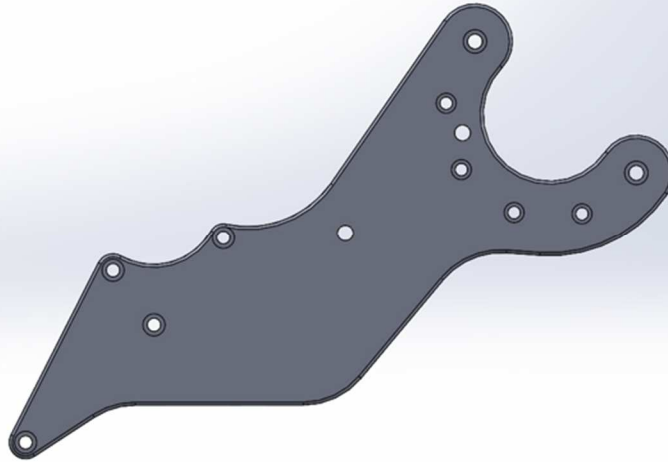
RECALLED BRACKET

ProCharger has discovered that the compressor housing for the above listed applications may, over time, contact the ABS brake lines due to insufficient clearance afforded by the mounting. Contact with the brake lines could compromise the integrity of the line. This contact between the bracket and brake line can occur under a variety of circumstances including improper bracket installation, variation in the engine mount positions within the vehicle manufacturer’s specifications (which potentially results in the bracket being placed close to the ABS line), and/or possible degradation of the motor mount over time that may increase movement of the engine. If this condition remains undetected, the compromised integrity of the ABS brake line could eventually result in loss of brake fluid and degraded braking performance, increasing the risk of a vehicle crash.
