IMPORTANT SAFETY RECALL

NHTSA Safety Recall No. 17V-236

Customer Service Notice

Upper Boom Fiberglass Inspection

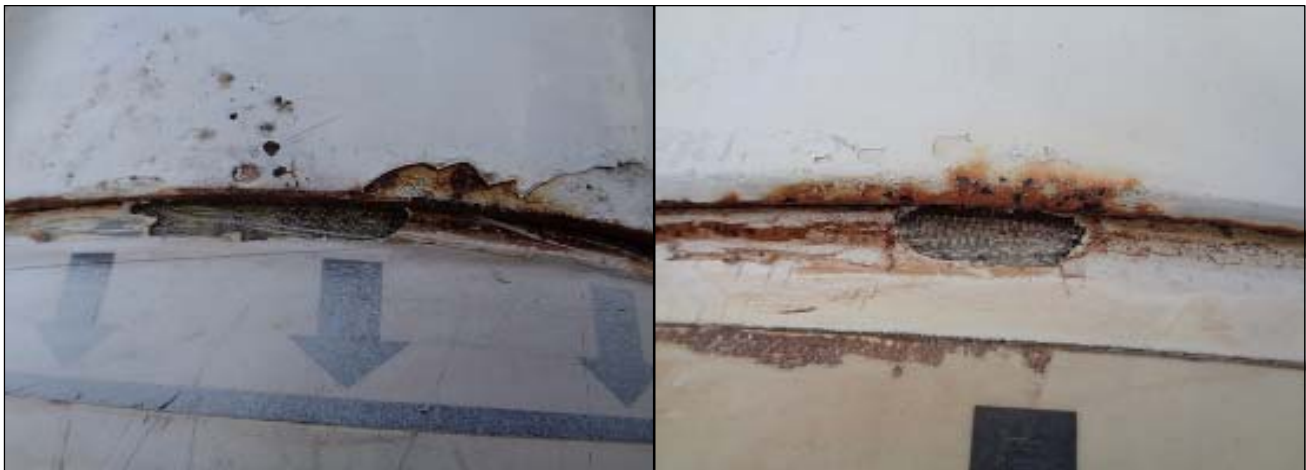
6. Remove any dirt or debris from the inspection area.
7. Inspect the area where the fiberglass joins to the steel boom for any cracks or damage including broken, bubbled, or flaking gelcoat (refer to Figure 2).

Figure 2 — Examples Of Gelcoat Damage

8. If the fiberglass gelcoat is scratched, but not damaged, continue to Step 9. If any fiberglass gelcoat is damaged, remove the unit from service immediately and go to Step 19.
9. Look into the leveling system access hole and clean the inside of the boom, if needed, so the interior surface can be adequately inspected.
10. Use a scope, camera, or similar method to closely examine the inside of the boom near the fiberglass to steel joint. While doing the inspection look for any of the following (refer to Figure 3).
 - cracks
 - spots of resin discoloration
 - any other abnormalities which could represent fiberglass damage

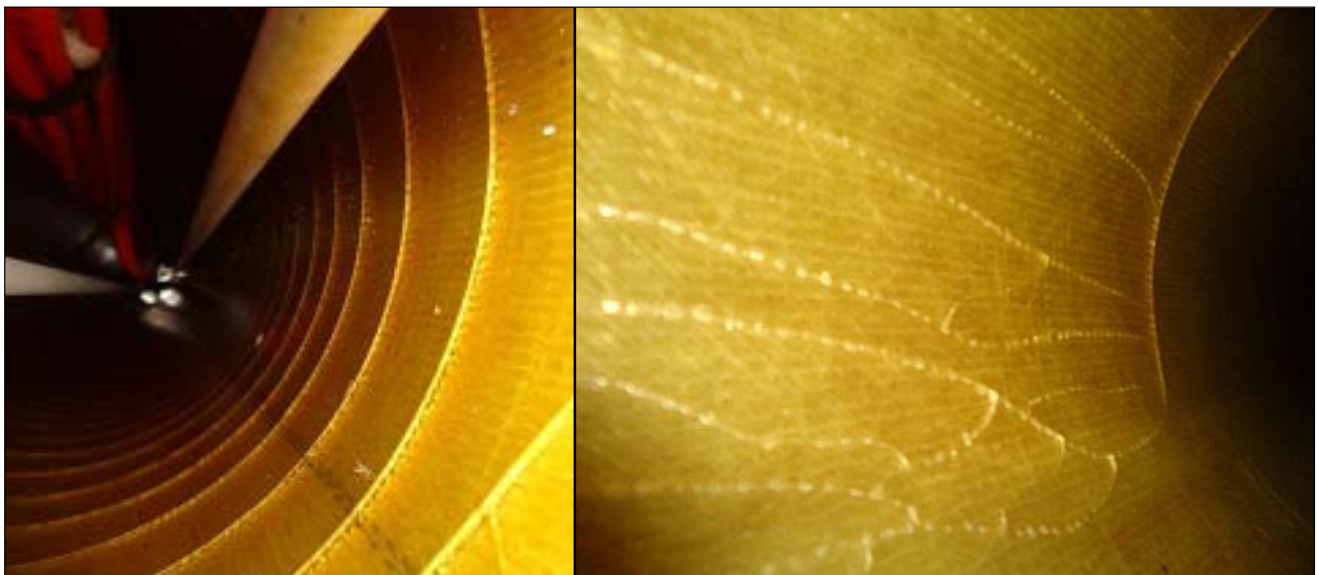
Figure 3 — Inside Boom (representative cracks shown)

11. If there are any cracks, internal or external, chipping, or other signs of fiberglass damage near the fiberglass to steel joint, remove the unit from service immediately and go to Step 19.
12. With the unit still in the overcenter position and the platform no more than one foot from the ground, have a second person standing on the ground at the platform quickly push up and down on the platform (maximum force of 150 lbs) in order to “bounce the boom” slightly. As the second person bounces the boom up and down, inspect the fiberglass to steel joint area around the entire boom for any signs of cracking in the gelcoat or fiberglass. The cracks may be small (refer to Figure 4). Also look for any signs of excessive motion at the fiberglass to steel joint.

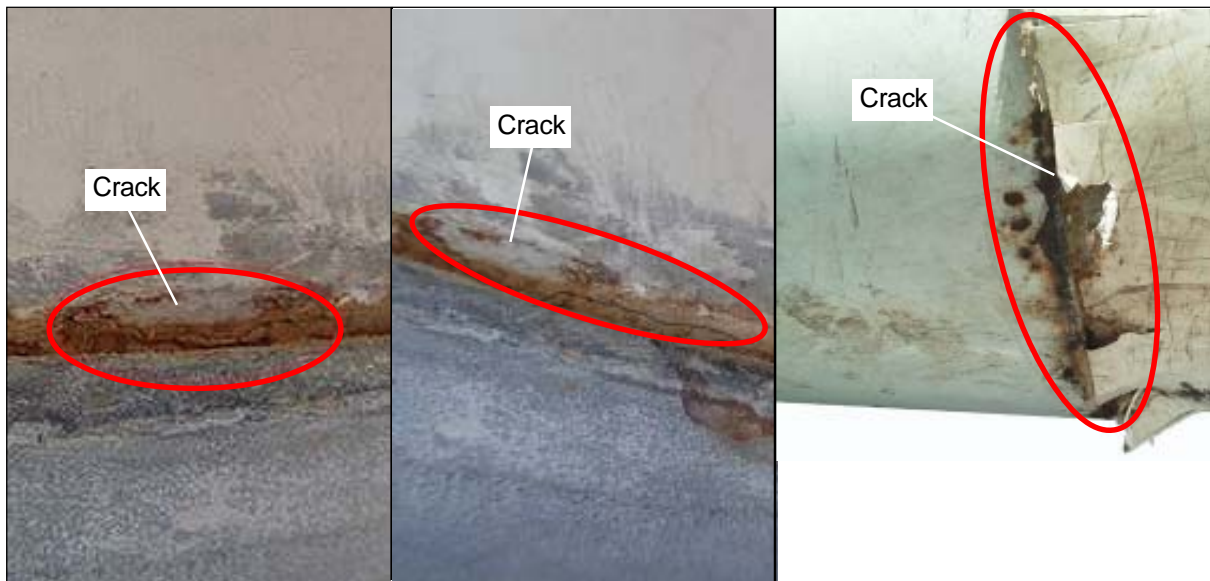
Figure 4 — Fiberglass Cracks

13. If there is any evidence of cracking or noise (which could represent fiberglass movement or degradation) or other signs of fiberglass damage, remove the unit from service immediately and go to Step 19. If no damage is seen, go to Step 14.
