# Safety Recall

## Code: 69P1

<b>Subject</b>	<b>Head Curtain Airbag Canister</b>
<b>Release Date</b>	February 02, 2017
<b>Affected Vehicles</b>	<p><b>U.S.A. &amp; CANADA: Certain 2011-2017 MY Audi Q5 with Panoramic Sunroof</b></p> <p><i>Check Campaigns/Actions screen in Elsa on the day of repair to verify that a VIN qualifies for repair under this action. Elsa is the <u>only</u> valid campaign inquiry &amp; verification source.</i></p> <ul style="list-style-type: none"><li>✓ Campaign status must show "open."</li><li>✓ If Elsa shows other open action(s), inform your customer so that the work can also be completed at the same time the vehicle is in the workshop for this campaign.</li></ul>
<b>Problem Description</b>	If the water drainage system of the sunroof becomes damaged or impaired (such as during a repair), water could saturate the foam around a side head curtain airbag canister. This could cause corrosion to form on the canister over time. If this happens, the canister could fracture without airbag deployment, propelling fragments into the passenger compartment, striking and causing serious injury to vehicle occupants.

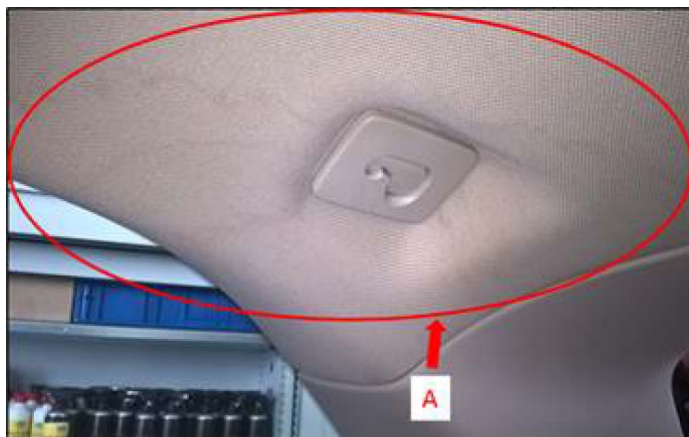
- Open the rear doors of the vehicle and inspect the headliner on both sides of the vehicle for water ingress on the rear area of the headliner <A> near the D-pillar trim.
- If no water ingress is noted on either side, proceed to the next step.
  - If, at **ANY** time during the water ingress inspection, evidence of prior water ingress is noted, **STOP** the procedure and create a Technical Assistance WEB ticket and follow the direction of the Technical Assistance Consultant.

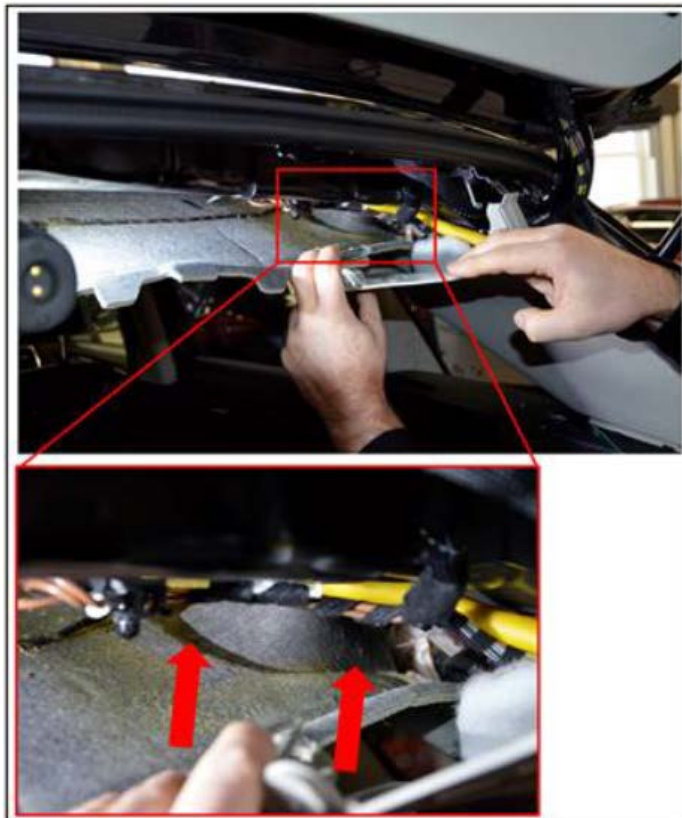
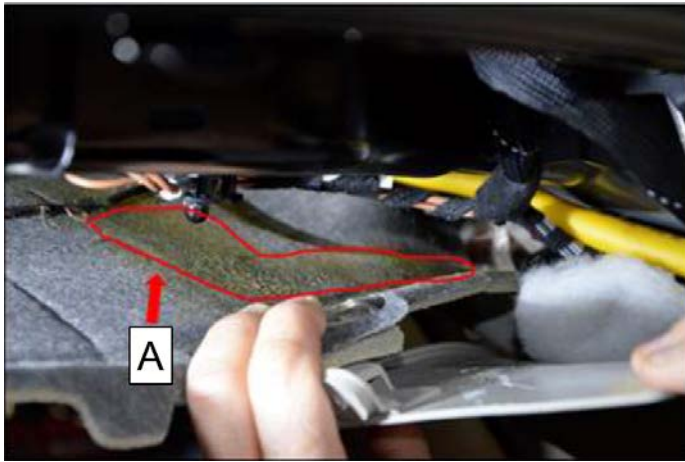
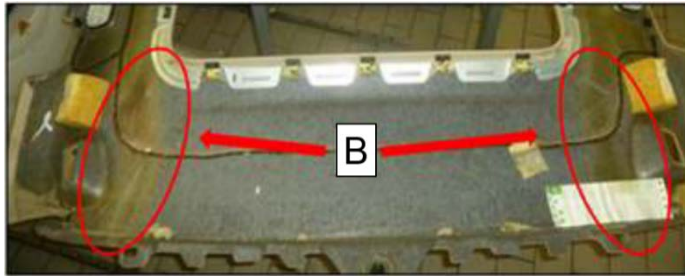
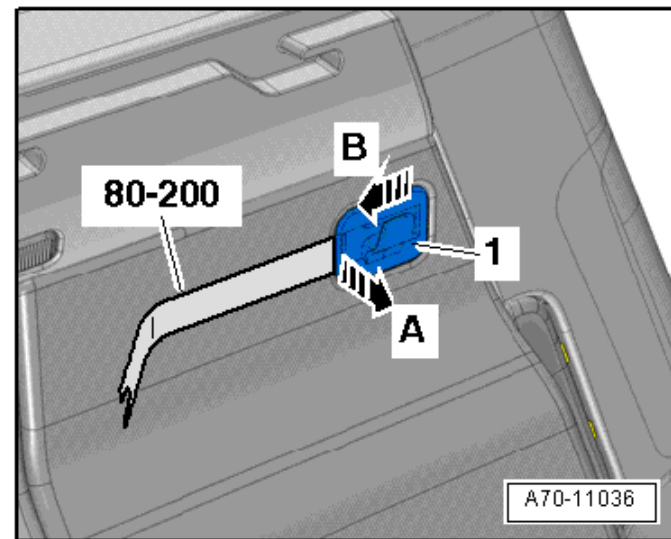
- Inspect the underside of the headliner on the left and right sides for evidence of water ingress, as shown, in the location indicated by the <arrows>.

The underside of the headliner will have adhesive spray in the areas shown <A>. Do not confuse the adhesive spray with water ingress.

- If **ANY** water ingress is noted on the headliner area around the panoramic sunroof or the areas highlighted on the headliner <B>, **STOP** the procedure and create a Technical Assistance WEB ticket and follow the direction of the Technical Assistance Consultant. The headliner in photograph <B> shows the headliner removed for visual clarity of water ingress. **It is not necessary or required to remove the headliner for this procedure.**
- If **NO** evidence of water ingress has been noted during any of the above inspection procedures, continue to the next step.
- Lift the rear coat hook <1> slightly off the side trim panel using the Pry Lever -80 - 200- <arrow A> and then pull it off toward the rear <arrow B>.
- Remove the screw behind the rear coat hook from the luggage compartment trim panel.
- Repeat to remove both sides.

- If no water ingress is noted, proceed to the next step.
    - If, at **ANY** time during the water ingress inspection, evidence of prior water ingress is noted, **STOP** the procedure and create a Technical Assistance WEB ticket and follow the direction of the Technical Assistance Consultant.

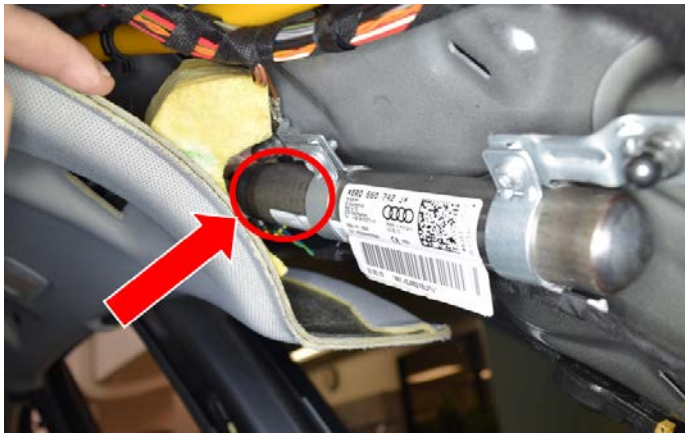
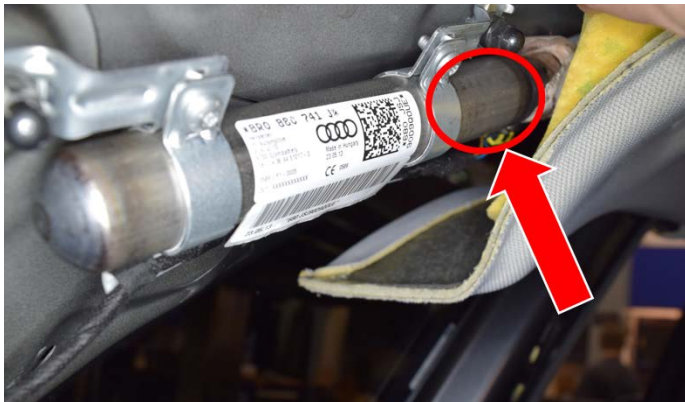
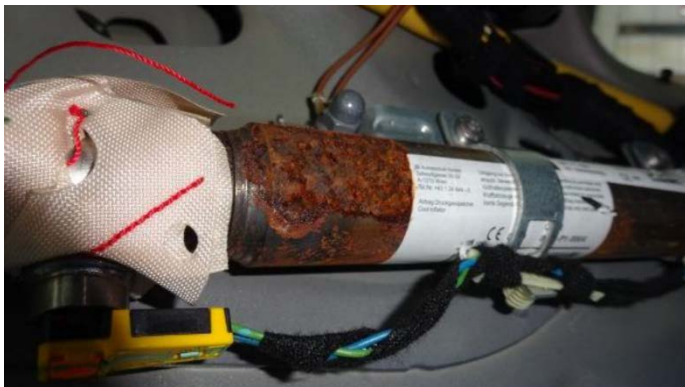
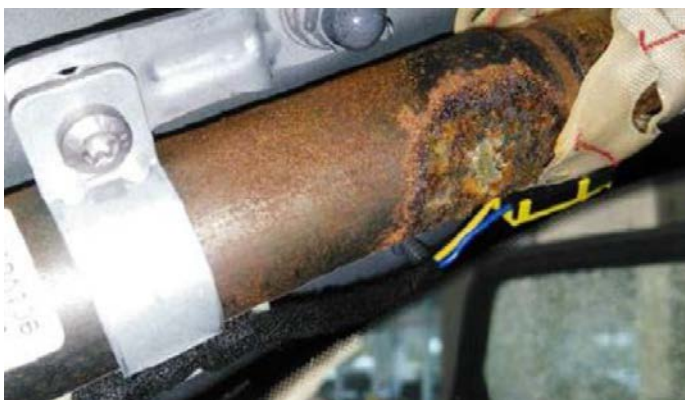
- Gently lower the headliner on the right and left sides to inspect the head curtain inflators <arrows> for corrosion. **Pay particular attention to the areas that were covered by the foam block.**

**If corrosion is found: DO NOT** attempt any further repair, diagnosis, inspection, or disruption of the airbag inflator canister or headliner if corrosion and/or pitting is found. Risk of rupture of the airbag inflator is possible. Rupture of the airbag inflator can cause serious injury or death.

- If heavy corrosion and/or pitting is found as shown, **STOP ALL FURTHER REPAIR OR INSPECTION.** Create a Technical Assistance WEB ticket and follow the direction of the Technical Assistance Consultant. Do not continue with any further repair, diagnosis, inspection, or disruption of the airbag inflator canister or headliner.
- If no corrosion was found, continue to the next step.
