Safety Recall

Code: 69P1

Subject	Head Curtain Airbag Canister
Release Date	February 07, 2017
Revision Summary	Work procedure updated.
Affected Vehicles	U.S.A. & CANADA: Certain 2011-2017 MY Audi Q5 with Panoramic Sunroof <i>Check Campaigns/Actions screen in Elsa on the day of repair to verify that a VIN qualifies for repair under this action. Elsa is the <u>only</u> valid campaign inquiry & verification source.</i> <ul style="list-style-type: none">✓ Campaign status must show "open."✓ If Elsa shows other open action(s), inform your customer so that the work can also be completed at the same time the vehicle is in the workshop for this campaign.
Problem Description	If the water drainage system of the sunroof becomes damaged or impaired (such as during a repair), water could saturate the foam around a side head curtain airbag canister. This could cause corrosion to form on the canister over time. If this happens, the canister could fracture without airbag deployment, propelling fragments into the passenger compartment, striking and causing serious injury to vehicle occupants.

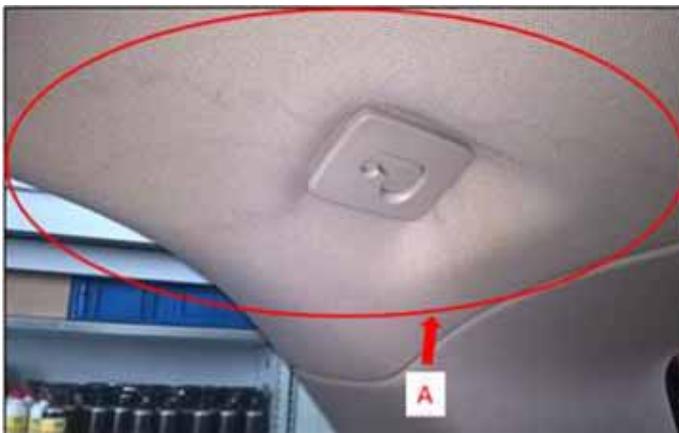
- Open the rear doors of the vehicle and inspect the headliner on both sides of the vehicle for water ingress on the rear area of the headliner <A> near the D-pillar trim.

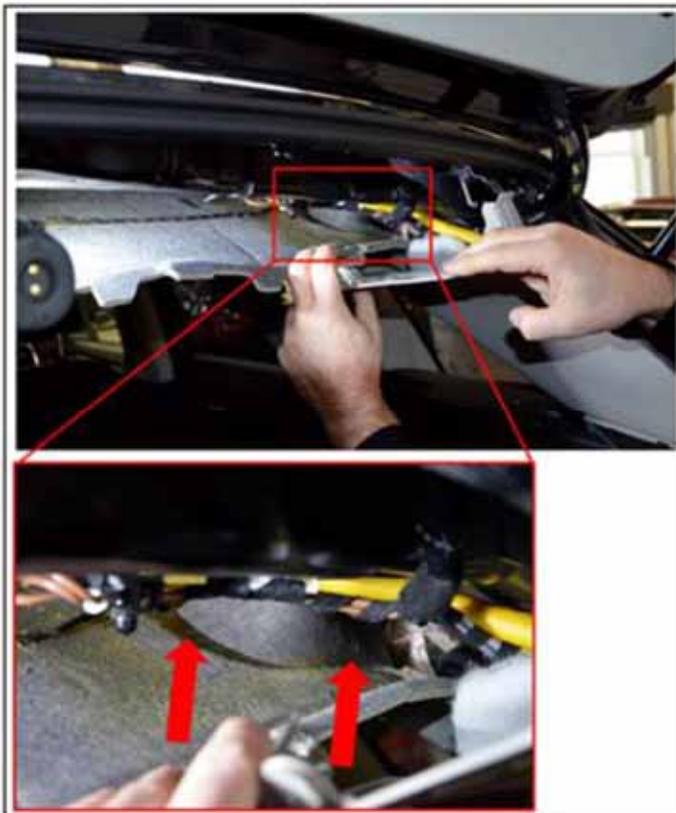
- Inspect the underside of the headliner on the left and right sides for evidence of water ingress, as shown, in the location indicated by the <arrows>.

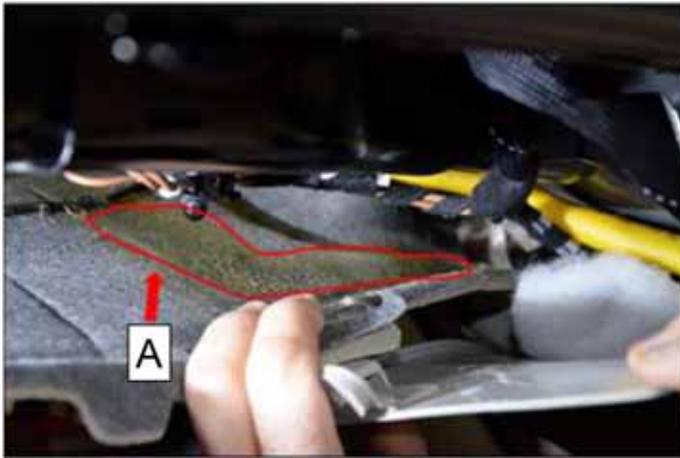
The underside of the headliner will have adhesive spray in the areas shown <A>. Do not confuse the adhesive spray with water ingress.

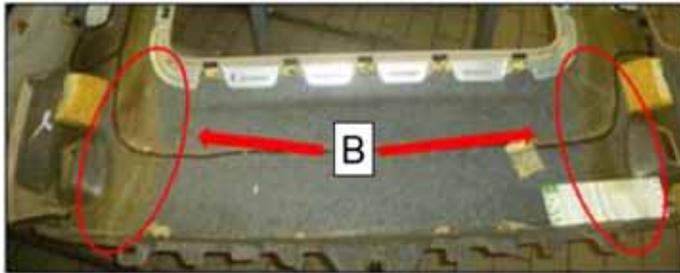
If ANY water ingress is noted on the headliner area around the panoramic sunroof or the areas highlighted on the headliner , proceed to inflator canister inspection with extreme caution.

The headliner in photograph shows the headliner removed for visual clarity of water ingress. It is not necessary or required to remove the headliner for this procedure.

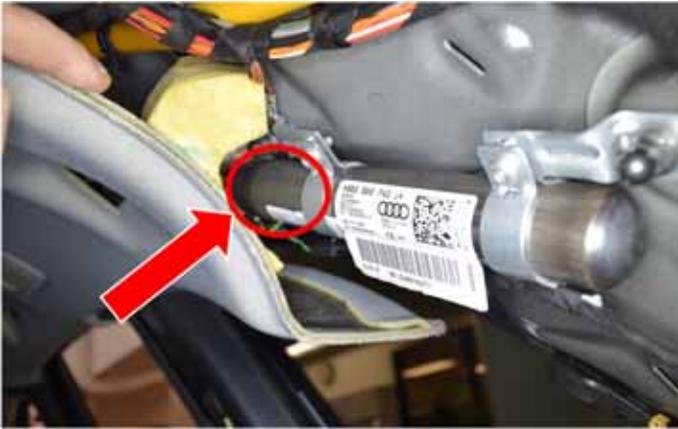
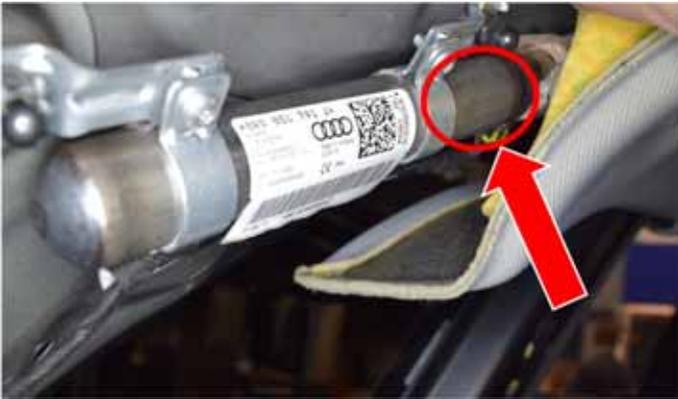
- Gently lower the headliner on the right and left sides to inspect the head curtain inflators <arrows> for corrosion. **Pay particular attention to the areas that were covered by the foam block.**

If corrosion is found: **DO NOT** attempt any further repair, diagnosis, inspection, or disruption of the airbag inflator canister or headliner if corrosion and/or pitting is found. Risk of rupture of the airbag inflator is possible. Rupture of the airbag inflator can cause serious injury or death.

- If heavy corrosion and/or pitting is found as shown, **STOP ALL FURTHER REPAIR OR INSPECTION.** Create a Technical Assistance WEB ticket and follow the direction of the Technical Assistance Consultant. Do not continue with any further repair, diagnosis, inspection, or disruption of the airbag inflator canister or headliner.
