## PRODUCT CAMPAIGN BULLETIN

**APPLICABILITY:** 2005-2006 model year Baja  
 2009-2012 model year Legacy  
 2009-2012 model year Outback  
 2009-2012 model year Forester  
 2006-2012 model year Tribeca  
 2006-2011 model year Impreza (including WRX and STI)  
 2012 model year WRX and STI

**NUMBERS:** TKA-17R  
 TKB-17R  
 TKC-17R

**SUBJECT:** Takata Front Passenger Airbag Inflator Replacement

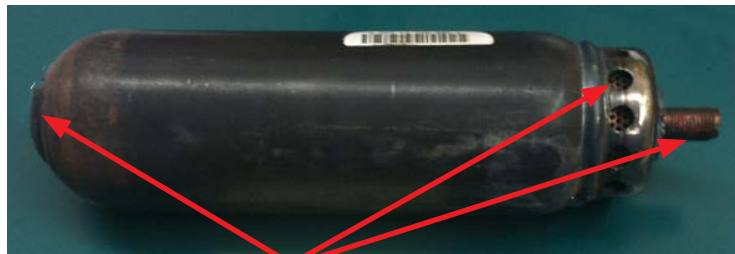
**The shape, holes, and copper-colored stud indicate this not a Genuine Subaru inflator.**

- **Do not proceed with this repair if your inspection reveals a non-Genuine Subaru airbag module has been installed in the vehicle.** Follow the instructions described in the “Counterfeit Airbag Information” Dealer Advisory Bulletin.

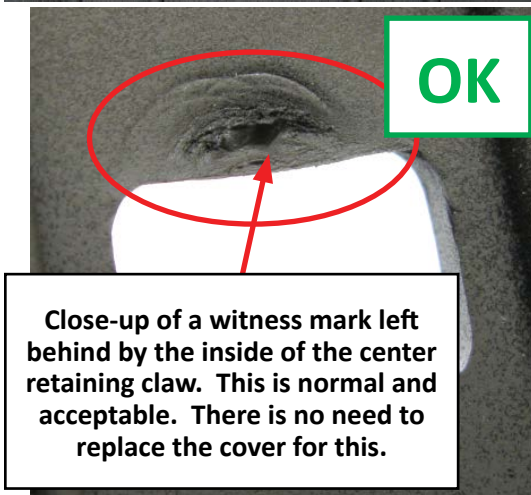
Close-up of a witness mark left  
behind by the inside of the center  
retaining claw. This is normal and  
acceptable. There is no need to  
replace the cover for this.

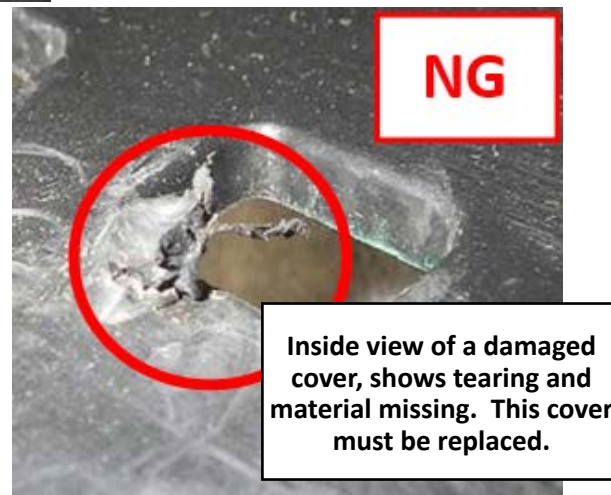
Inside view of a damaged  
cover, shows tearing and  
material missing. This cover  
must be replaced.
