## PRODUCT CAMPAIGN BULLETIN

**APPLICABILITY:** 2005-2006 model year Baja  
 2009-2012 model year Legacy  
 2009-2012 model year Outback  
 2009-2012 model year Forester  
 2006-2012 model year Tribeca  
 2006-2011 model year Impreza (including WRX and STI)  
 2012 model year WRX and STI

**NUMBERS:** TKA-17R  
 TKB-17R  
 TKC-17R

**SUBJECT:** Takata Front Passenger Airbag Inflator Replacement

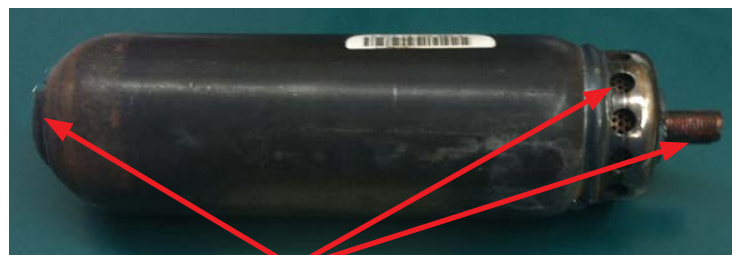
**The shape, holes, and copper-colored stud indicate this not a Genuine Subaru inflator.**

- **Do not proceed with this repair if your inspection reveals a non-Genuine Subaru airbag module has been installed in the vehicle.** Follow the instructions described in the “Counterfeit Airbag Information” Dealer Advisory Bulletin.

- Document the presence of the aftermarket or counterfeit device on the repair order and with photos. Report this information immediately on a Quality Monitoring Report (QMR). **IMPORTANT:** When entering a related QMR, use failure code **ULF** and **NOT** the campaign fail code.

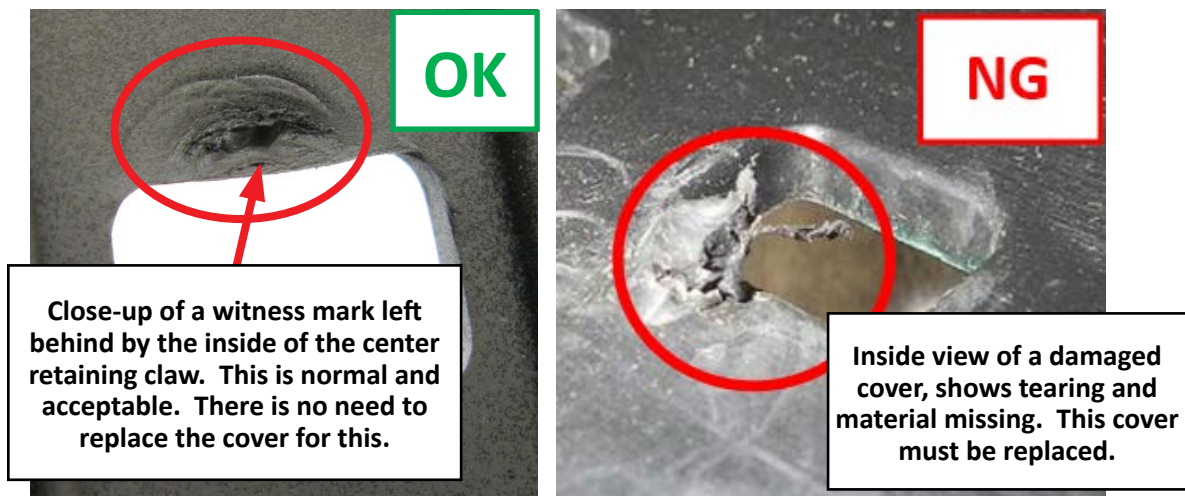
- Inspect the claw openings on the outside and inside of the cover for damage. If any found to look like the NG example photo below, the cover must be replaced.
