P082NAS3

# TECHNICAL BULLETIN

501-20B: Supplemental Restraint System

SAFETY RECALL: Takata Passenger Airbag

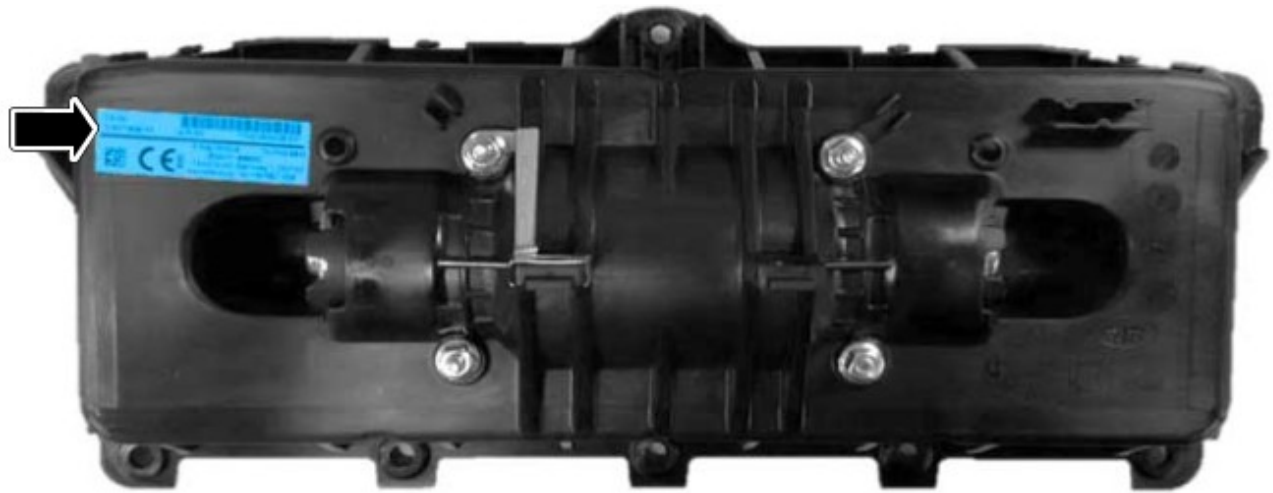
E207032

Locate the label on the NEW passenger airbag module.

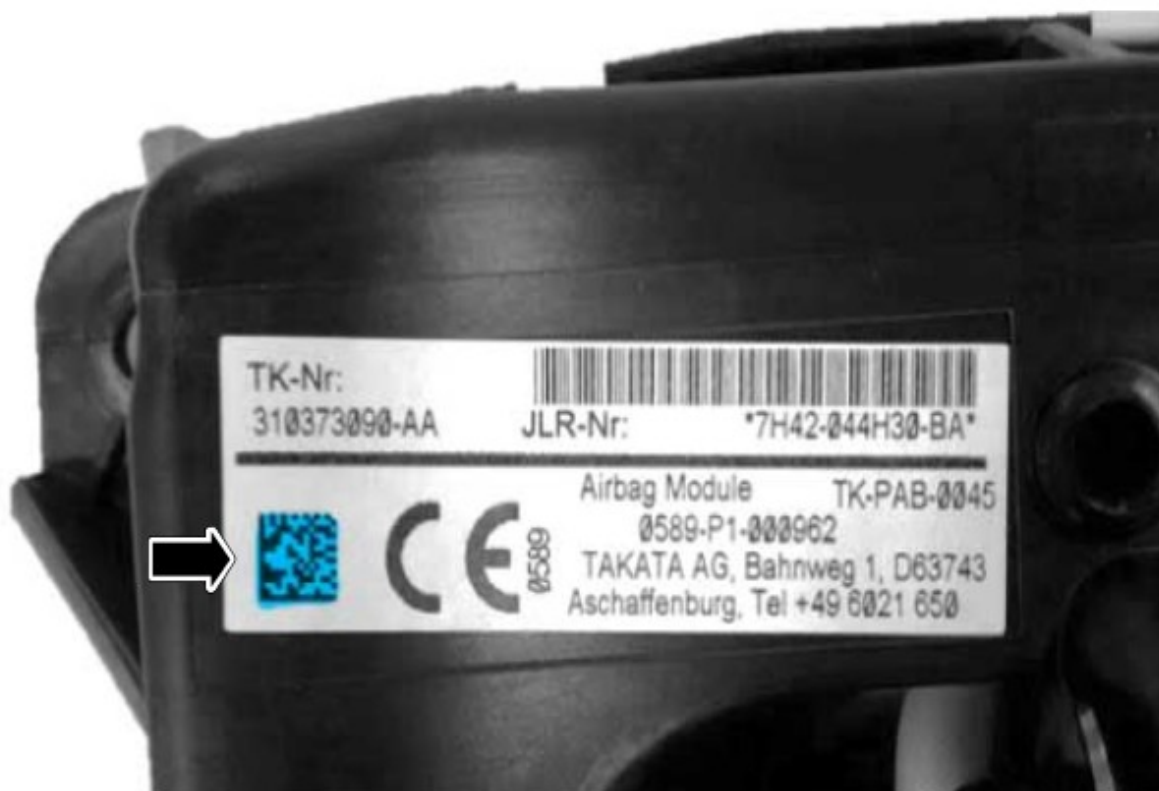
E207031

Locate the QR code on the NEW passenger airbag module label.

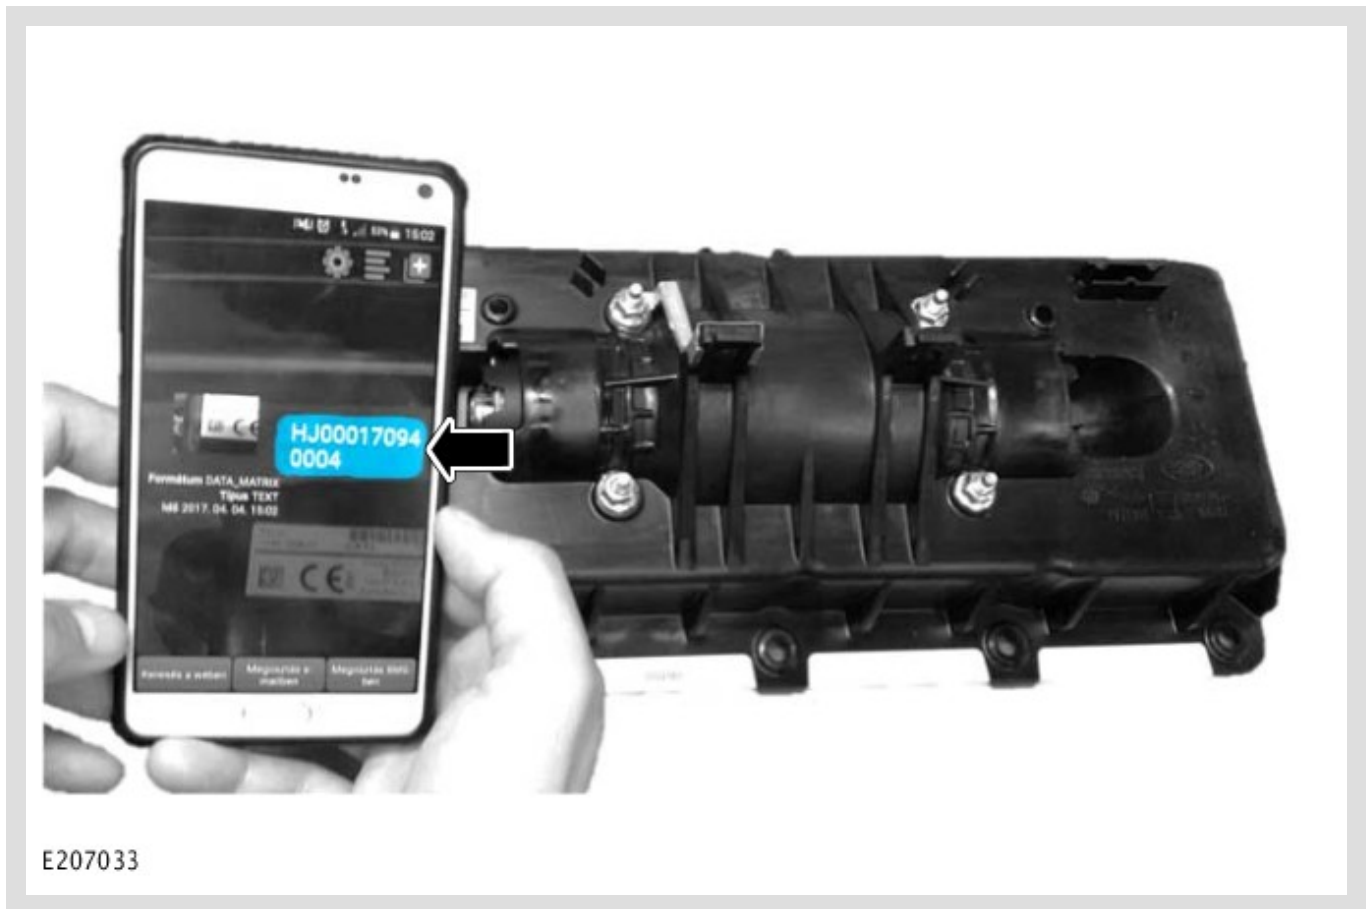
Use a smartphone with a QR code scanner to scan the QR code of the NEW front passenger airbag module.

- 1 Record the NEW passenger airbag module serial number, displayed on the screen, on the claim verbatim.
