SUBARU

PRODUCT CAMPAIGN BULLETIN

NUMBERS: TKA-17R
 TKB-17R
 TKC-17R

SUBJECT: Takata Front Passenger Airbag Inflator Replacement

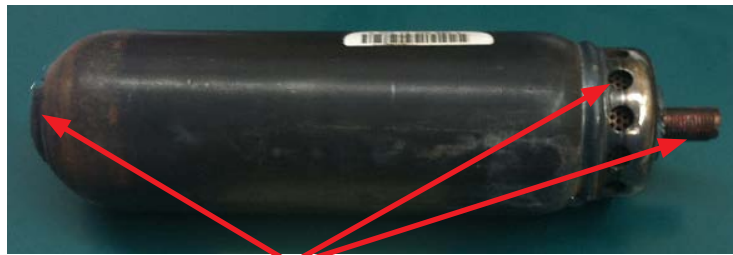
The shape, holes, and copper-colored stud indicate this not a Genuine Subaru inflator.

- **Do not proceed with this repair if your inspection reveals a non-Genuine Subaru air bag module has been installed in the vehicle.** Follow the instructions described in the “Counterfeit Air Bag Information” Dealer Advisory Bulletin.
