PRODUCT CAMPAIGN BULLETIN

APPLICABILITY: 2005-2006 model year Baja
 2009-2012 model year Legacy
 2009-2012 model year Outback
 2009-2012 model year Forester
 2006-2012 model year Tribeca
 2006-2011 model year Impreza (including WRX and STI)
 2012 model year WRX and STI

NUMBERS: TKA-17R
 TKB-17R
 TKC-17R

SUBJECT: Takata Front Passenger Airbag Inflator Replacement

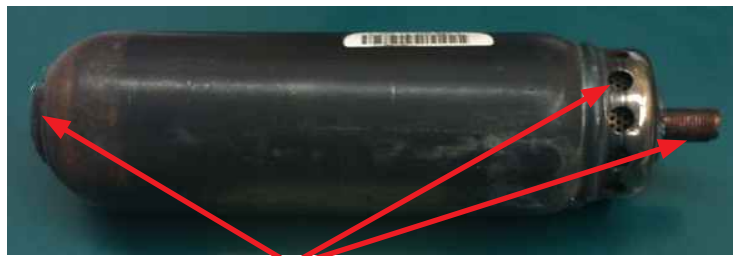
The shape, holes, and copper-colored stud indicate this not a Genuine Subaru inflator.

- **Do not proceed with this repair if your inspection reveals a non-Genuine Subaru airbag module has been installed in the vehicle.** Follow the instructions described in the “Counterfeit Airbag Information” Dealer Advisory Bulletin.

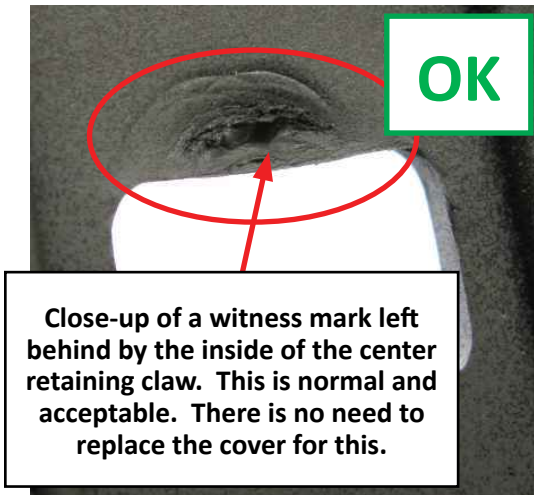
Close-up of a witness mark left behind by the inside of the center retaining claw. This is normal and acceptable. There is no need to replace the cover for this.

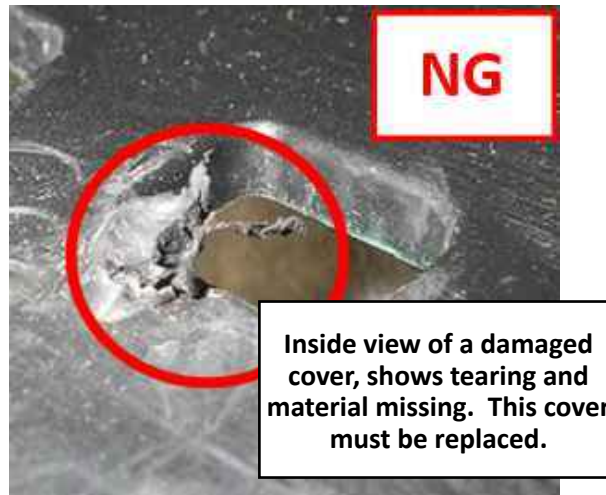
Inside view of a damaged cover, shows tearing and material missing. This cover must be replaced.

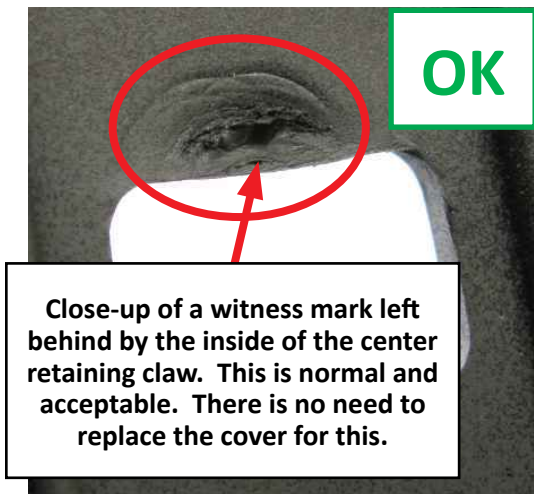
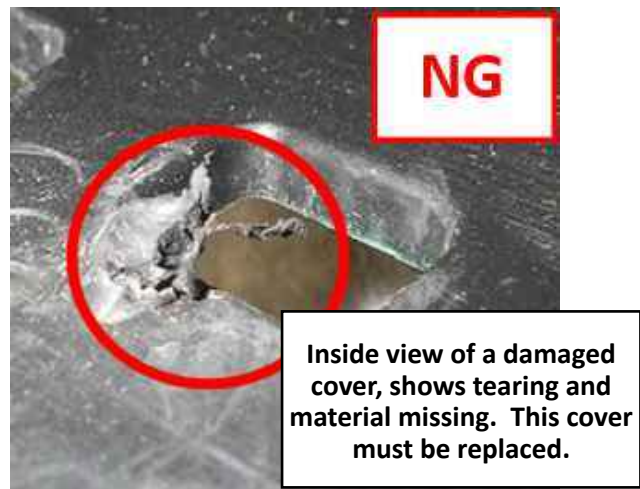
- Inspect the claw openings on the outside and inside of the cover for damage. If any found to look like the NG example photo below, the cover must be replaced.
