PRODUCT CAMPAIGN BULLETIN

<p>APPLICABILITY: 2005-2006 model year Baja 2009-2012 model year Legacy 2009-2012 model year Outback 2009-2012 model year Forester 2006-2012 model year Tribeca 2006-2011 model year Impreza (including WRX and STI) 2012 model year WRX and STI</p>	<p>NUMBERS: TKA-17R TKB-17R TKC-17R</p> <p>DATE: 01/13/17</p> <p>REVISED: 03/06/18</p> <p>NHTSA ID: 17V-014 17V-026 17V-016</p>
<p>SUBJECT: Takata Front Passenger Airbag Inflator Replacement</p>

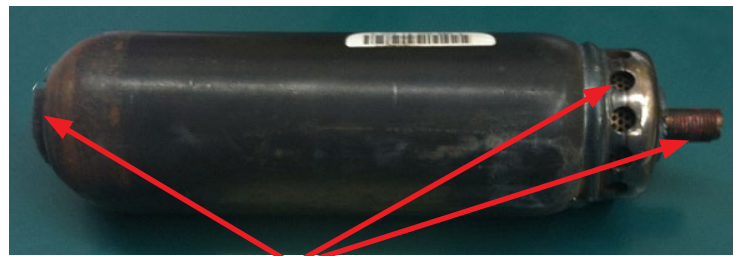
The shape, holes, and copper-colored stud indicate this not a Genuine Subaru inflator.

- **Do not proceed with this repair if your inspection reveals a non-Genuine Subaru airbag module has been installed in the vehicle.** Follow the instructions described in the “Counterfeit Airbag Information” Dealer Advisory Bulletin.

- Document the presence of the aftermarket or counterfeit device on the repair order and with photos. Report this information immediately on a Quality Monitoring Report (QMR). **IMPORTANT:** When entering a related QMR, use failure code **ULF** and **NOT** the campaign fail code.

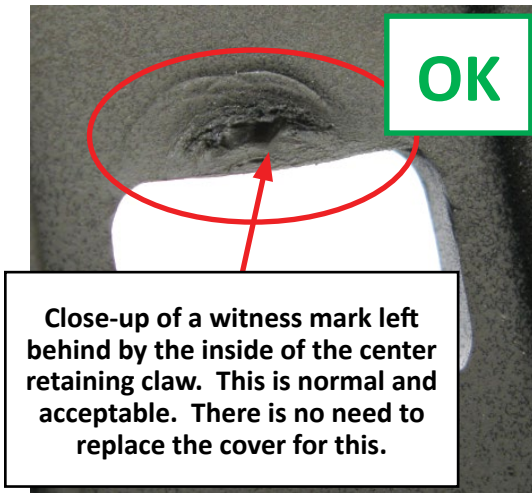
Close-up of a witness mark left behind by the inside of the center retaining claw. This is normal and acceptable. There is no need to replace the cover for this.

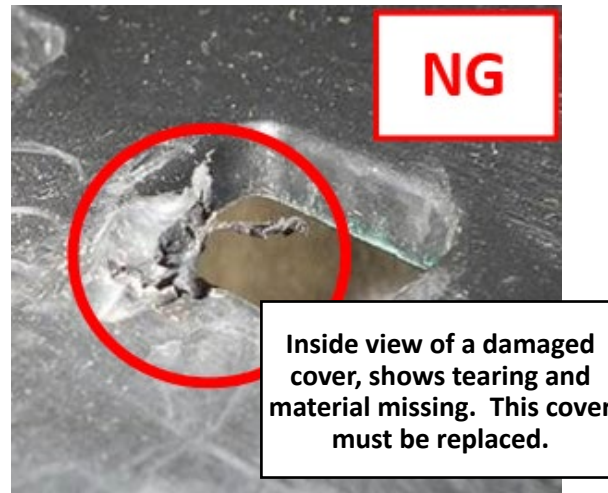
Inside view of a damaged cover, shows tearing and material missing. This cover must be replaced.
