SIB 65 08 17

**RECALL 17V-020: PASSENGERS FRONT AIR BAG  
MODULE(EXPANSION TO 16V-364)**

This Service Information bulletin (Revision 5) replaces SI B65 08 17 dated October 2019.

BMW AG is expanding the previously announced (16V-364 / SI B65 19 16) passenger front air bag recall.. The vehicles affected by the expansion (Recall 17V-020) will be identified by **defect code 0072810100**.

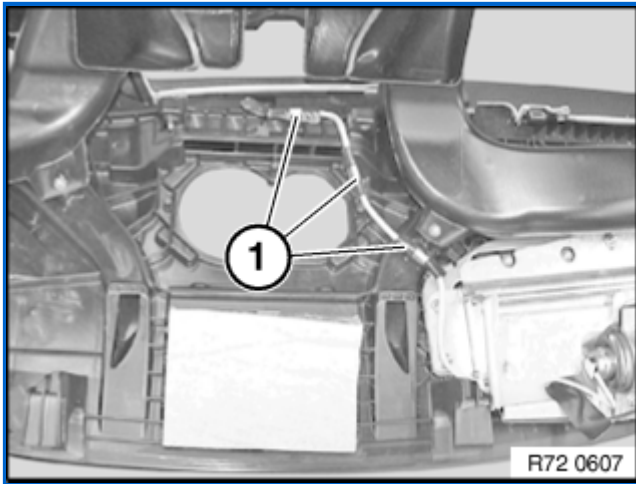
Unclip airbag lead with holders (1) from instrument panel.

Unscrew nuts (1).

*Installation:*  
Replace nuts.

Tightening torque [72 12 01AZ](#).
