PRODUCT CAMPAIGN BULLETIN

APPLICABILITY: 2005-2006 model year Baja
 2009-2012 model year Legacy
 2009-2012 model year Outback
 2009-2012 model year Forester
 2006-2012 model year Tribeca
 2006-2011 model year Impreza (including WRX and STI)
 2012 model year WRX and STI

NUMBERS: TKA-17R
 TKB-17R
 TKC-17R

SUBJECT: Takata Front Passenger Airbag Inflator Replacement

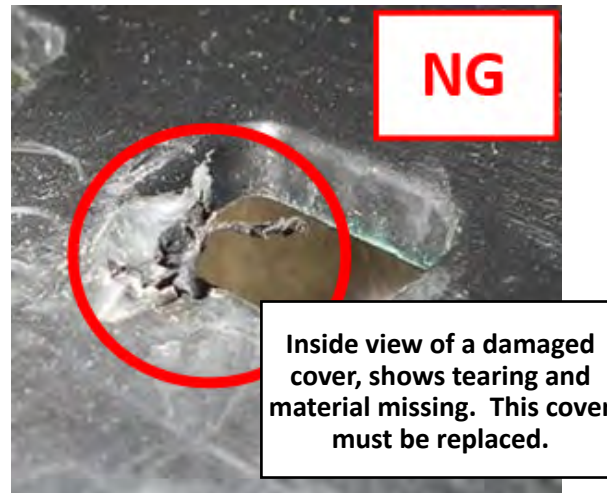
Inside view of a damaged cover, shows tearing and material missing. This cover must be replaced.

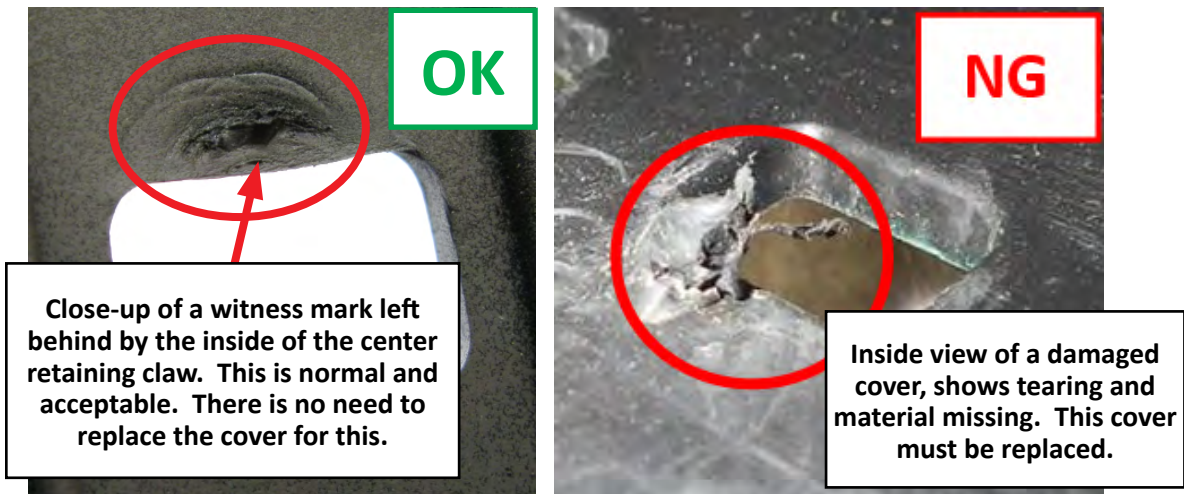
Close-up of a witness mark left behind by the inside of the center retaining claw. This is normal and acceptable. There is no need to replace the cover for this.

- Inspect the claw openings on the outside and inside of the cover for damage. If any found to look like the NG example photo below, the cover must be replaced.
