PRODUCT CAMPAIGN BULLETIN

<p>APPLICABILITY: 2005-2006 model year Baja 2009-2012 model year Legacy 2009-2012 model year Outback 2009-2012 model year Forester 2006-2012 model year Tribeca 2006-2011 model year Impreza (including WRX and STI) 2012 model year WRX and STI</p>	<p>NUMBERS: TKA-17R TKB-17R TKC-17R</p> <p>DATE: 01/13/17</p> <p>REVISED: 07/20/18</p> <p>NHTSA ID: 17V-014 17V-026 17V-016</p>
<p>SUBJECT: Takata Front Passenger Airbag Inflator Replacement</p>

SUBARU OF AMERICA, INC. has determined that a defect, which relates to motor vehicle safety, exists in certain Subaru vehicles listed above, equipped with a non-desiccated Takata-sourced passenger side frontal airbag containing the propellant Phase Stabilized Ammonium Nitrate (certain specific vehicles only).

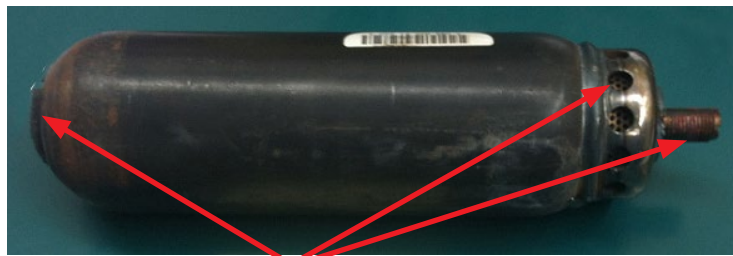
The shape, holes, and copper-colored stud indicate this not a Genuine Subaru inflator.

- **Do not proceed with this repair if your inspection reveals a non-Genuine Subaru airbag module has been installed in the vehicle.** Follow the instructions described in the “Counterfeit Airbag Information” Dealer Advisory Bulletin.

- Document the presence of the aftermarket or counterfeit device on the repair order and with photos. Report this information immediately on a Quality Monitoring Report (QMR). **IMPORTANT:** When entering a related QMR, use failure code **ULF** and **NOT** the campaign fail code.

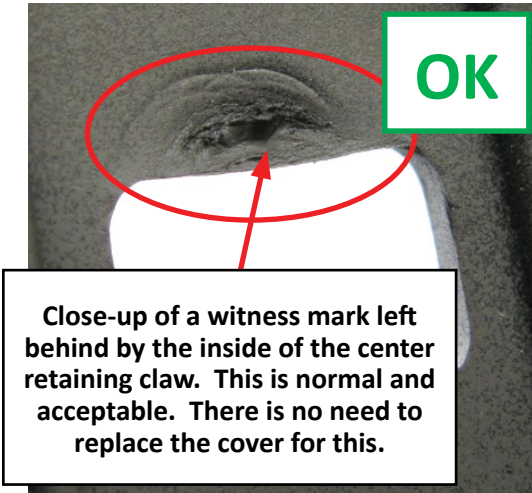
Close-up of a witness mark left behind by the inside of the center retaining claw. This is normal and acceptable. There is no need to replace the cover for this.

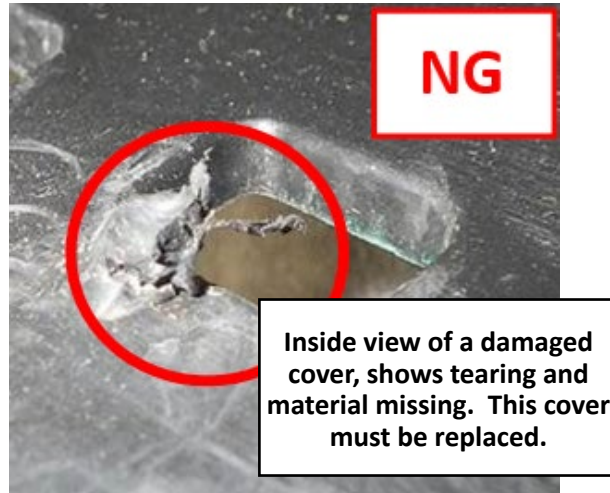
Inside view of a damaged cover, shows tearing and material missing. This cover must be replaced.
