J070NAS1

TECHNICAL BULLETIN

501-20B: Supplemental Restraint System

SAFETY RECALL: Takata Passenger Airbag

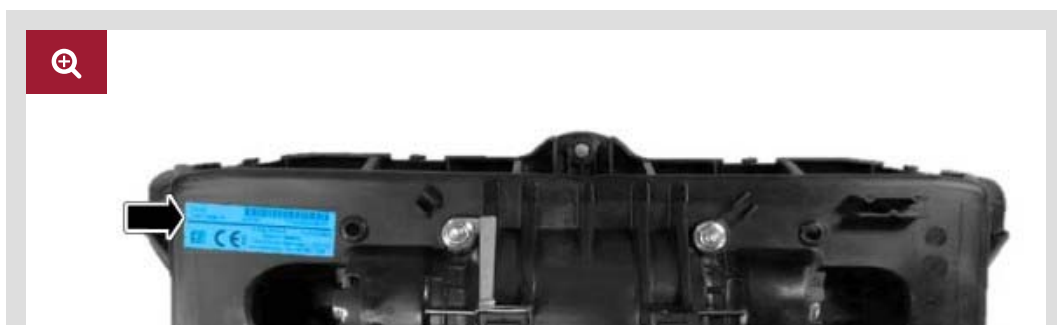
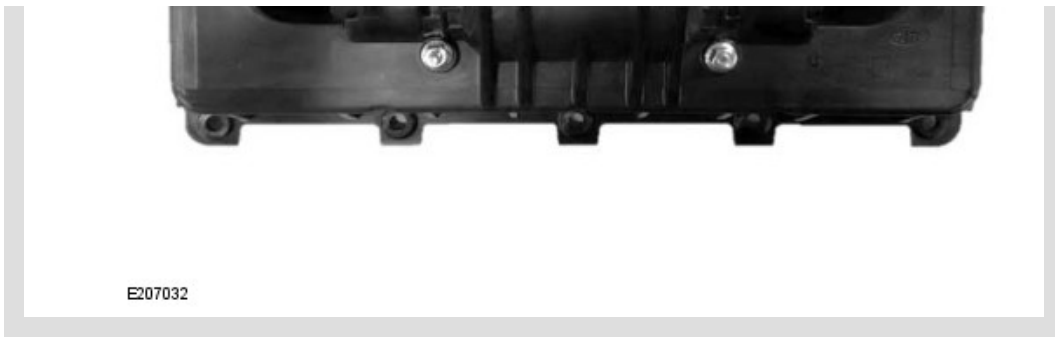
Locate the label on the NEW passenger airbag module.

The serial number of the NEW airbag module MUST be recorded on the claim verbatim.

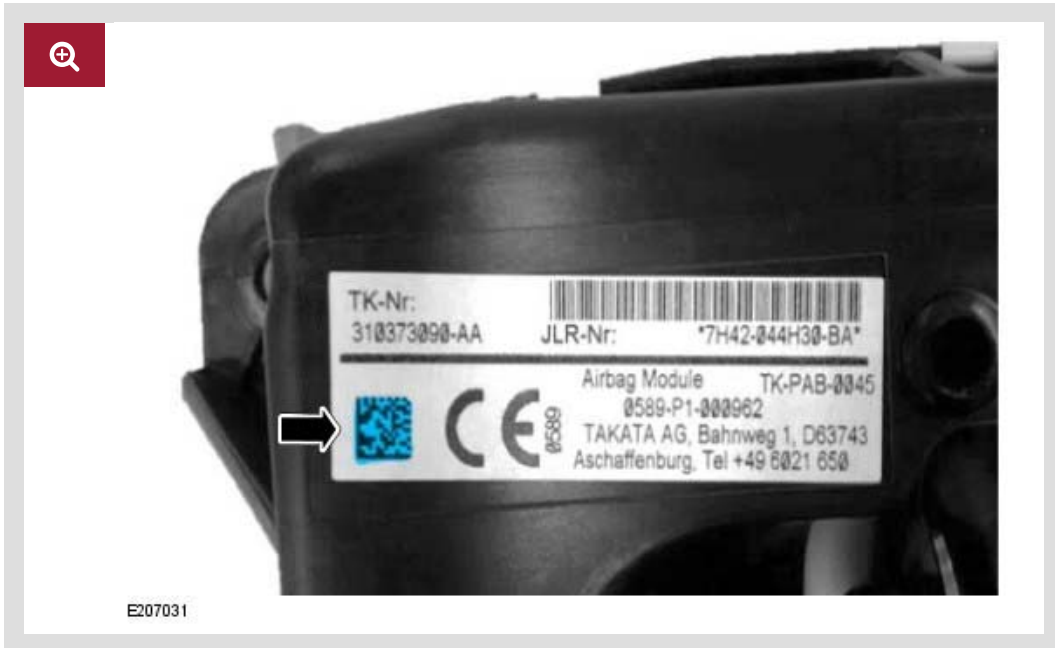
Locate the QR code on the NEW passenger airbag module label.

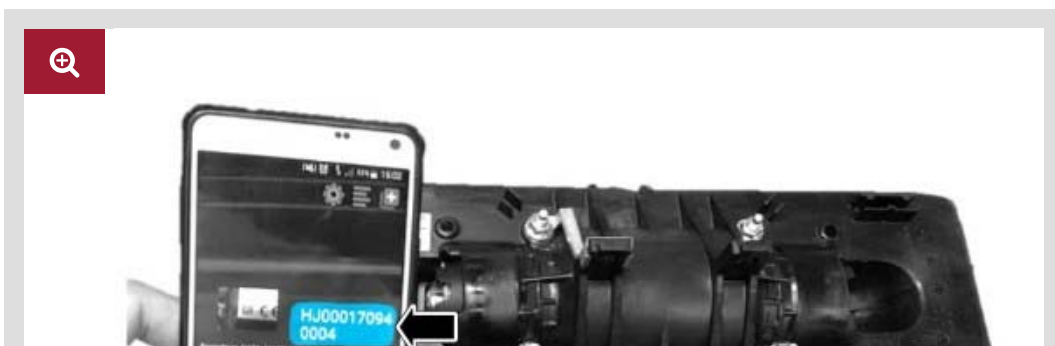
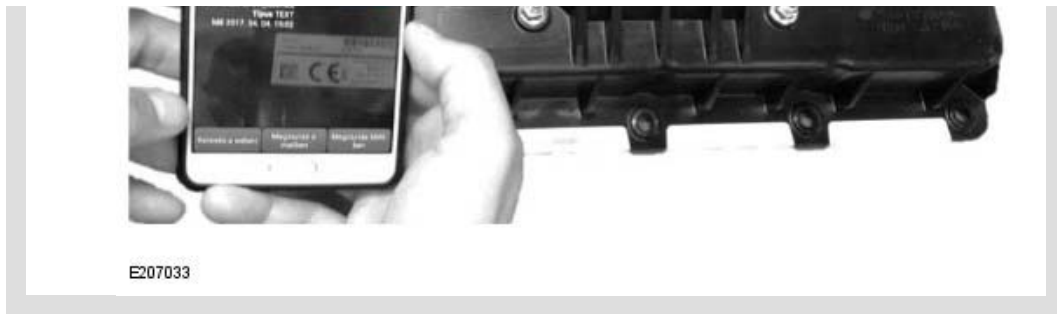
Use a smartphone with a QR code scanner to scan the QR code of the NEW front passenger airbag module.

1. Record the NEW passenger airbag module serial number, displayed on the screen, on the claim verbatim.
