RECALL CAMPAIGN BULLETIN

NTB17-012

VOLUNTARY SAFETY RECALL CAMPAIGN 2015-2017 ALTIMA; REAR DOOR SEALING SCREEN/VAPOR BARRIER

CAMPAIGN ID #: PC540

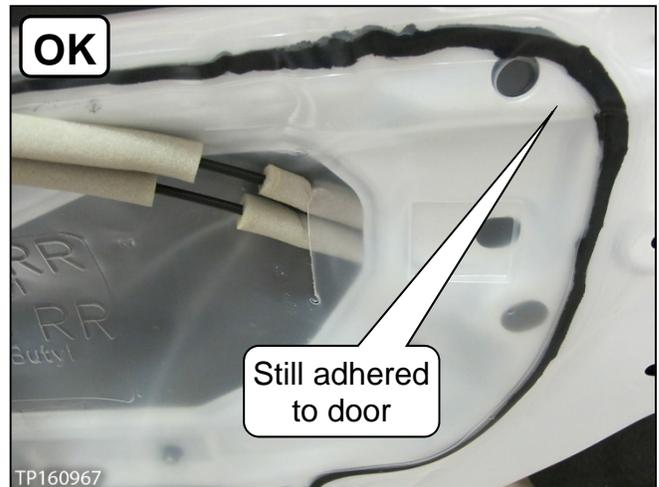
Figure 8

- 8. Inspect the upper right portion of the vapor barrier.
 - a. If the vapor barrier's condition is similar to the one in Figure 8, go to page 6, **Vapor Barrier - Adjustment**.

Vapor Barrier – Adjustment

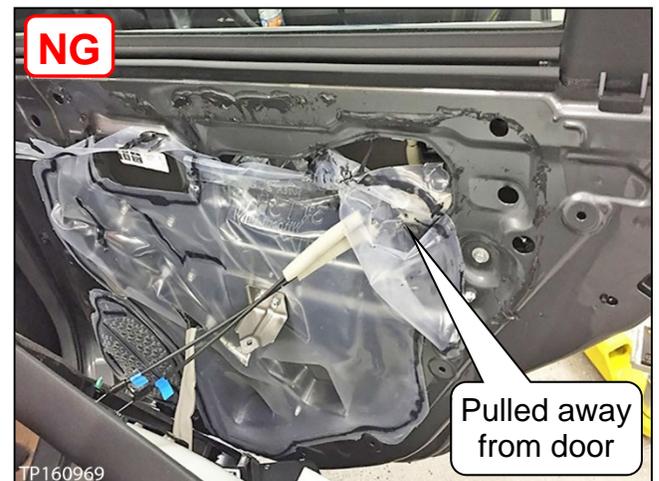
Figure 9

- b. If the vapor barrier's condition is similar to the one in Figure 9, go to page 8, **Inspect Cables and Inside Handle, and Replace Vapor Barrier**.

7. Replace the damaged vapor barrier.

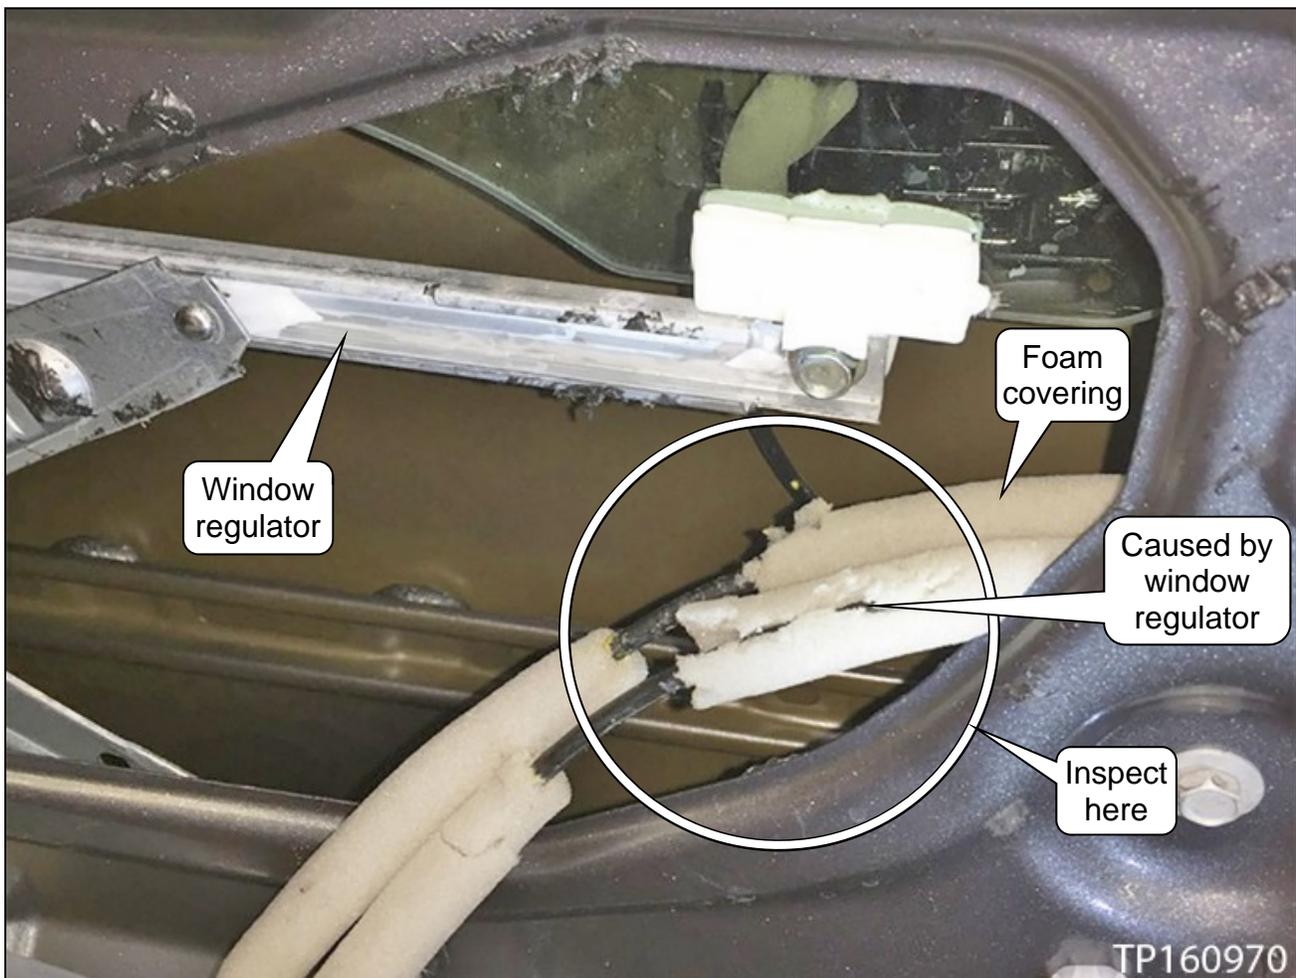
Figure 15

1. Inspect the foam covering on the cables for damage (see example in Figure 15).
2. Damage found: Replace the door lock assembly with cables.
 - Refer to the ESM, section **DLK-Door & Lock**, door lock assembly with cables replacement.
 - Skip to page 9, step 4.
3. No damage found: Do not replace the door lock assembly with cables.
 - Skip to page 9, step 7.

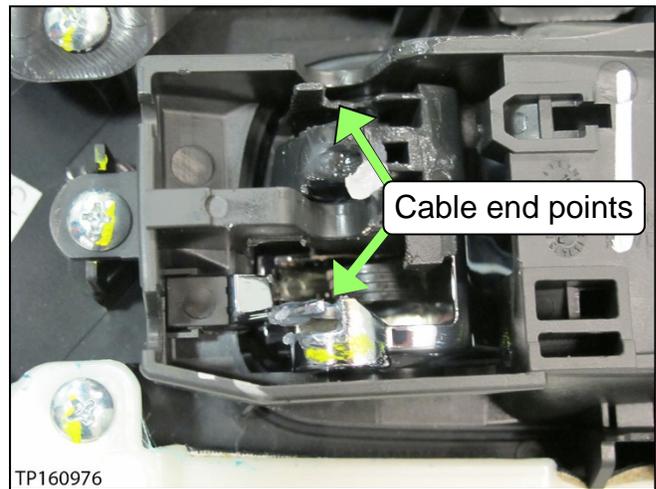
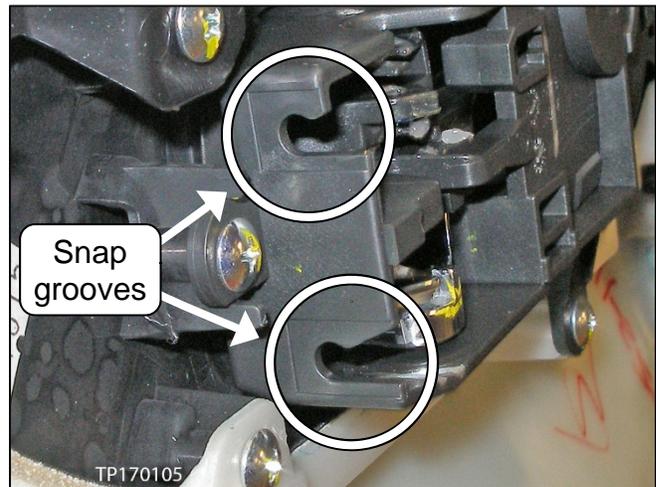
4. Inspect the inside door handle snap grooves and cable end points for damage (see Figure 16 and 17).

5. Damage found: Replace the inside door handle.

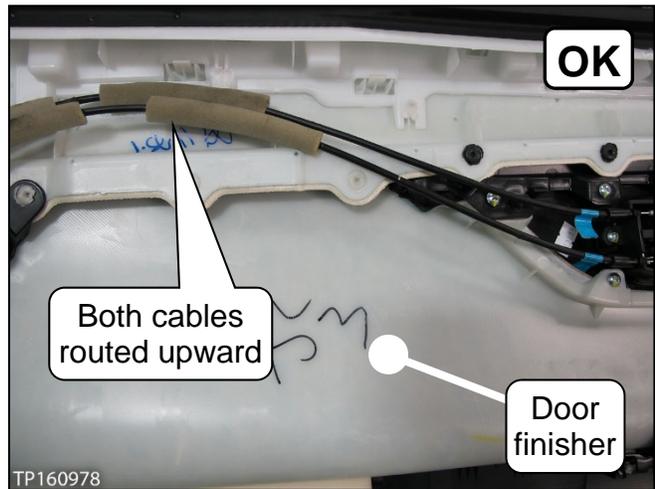
Figure 18 shows proper routing of the cables.

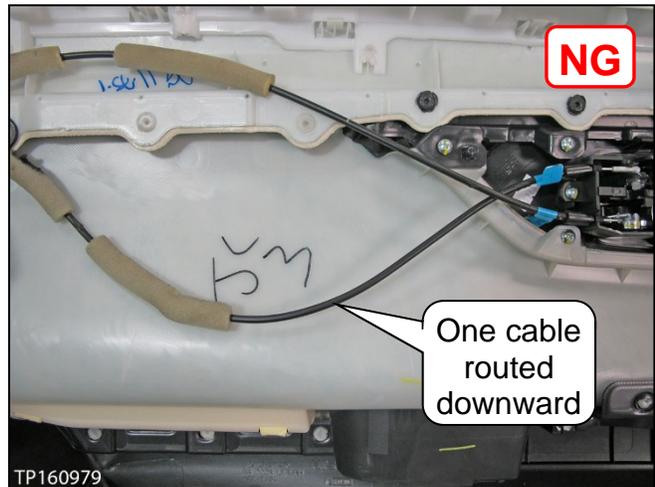
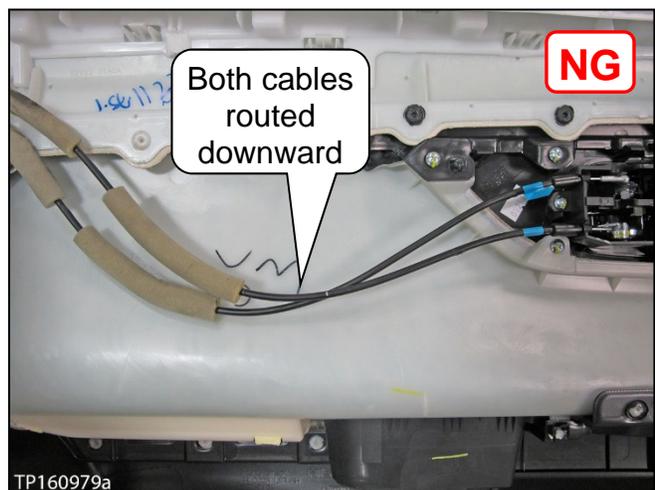
Figure 19 and 20 show incorrect routing of the cables.
