April 2017
FL731A-G
NHTSA #17V-043
Transport Canada #17-031

Subject: ICU3S Dual Cluster Displays

Models Affected: Specific Freightliner 108SD, 114SD, and Business Class M2 vehicles manufactured March 5, 2015, through August 15, 2016.

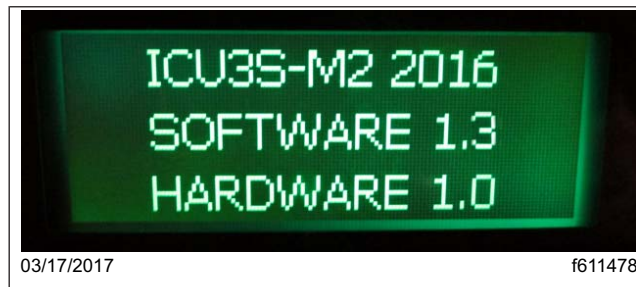
Fig. 1, ICU3S Screen Showing Software Version 1.3 (correct)

1. Check the base label (Form WAR259) for a completion sticker for FL731 (Form WAR260) indicating this work has been completed. The base label is usually located on the passenger-side door, about 12 inches (30 cm) below the door latch. If a completion sticker is present, no work is needed. If a completion sticker is not present, proceed to the next step.
2. Park the vehicle, shut down the engine, and apply the parking brakes. Chock tires.
3. Press the ICU3S mode button until the software/hardware versions display on screen. Verify the software level of the ICU3S. See [Fig. 1](#).

If the software level of the ICU3S is 1.3, or higher, no further action is necessary. Continue with step 19.

If the software level is below 1.3, continue with the next step.
