SIB 65 02 17

RECALL 17V-047: DRIVER'S FRONT AIR BAG MODULE - PRIOR PARTS REPLACEMENT

RE: Recall 17V-047: Driver's Front Air Bag Module B65 02 17

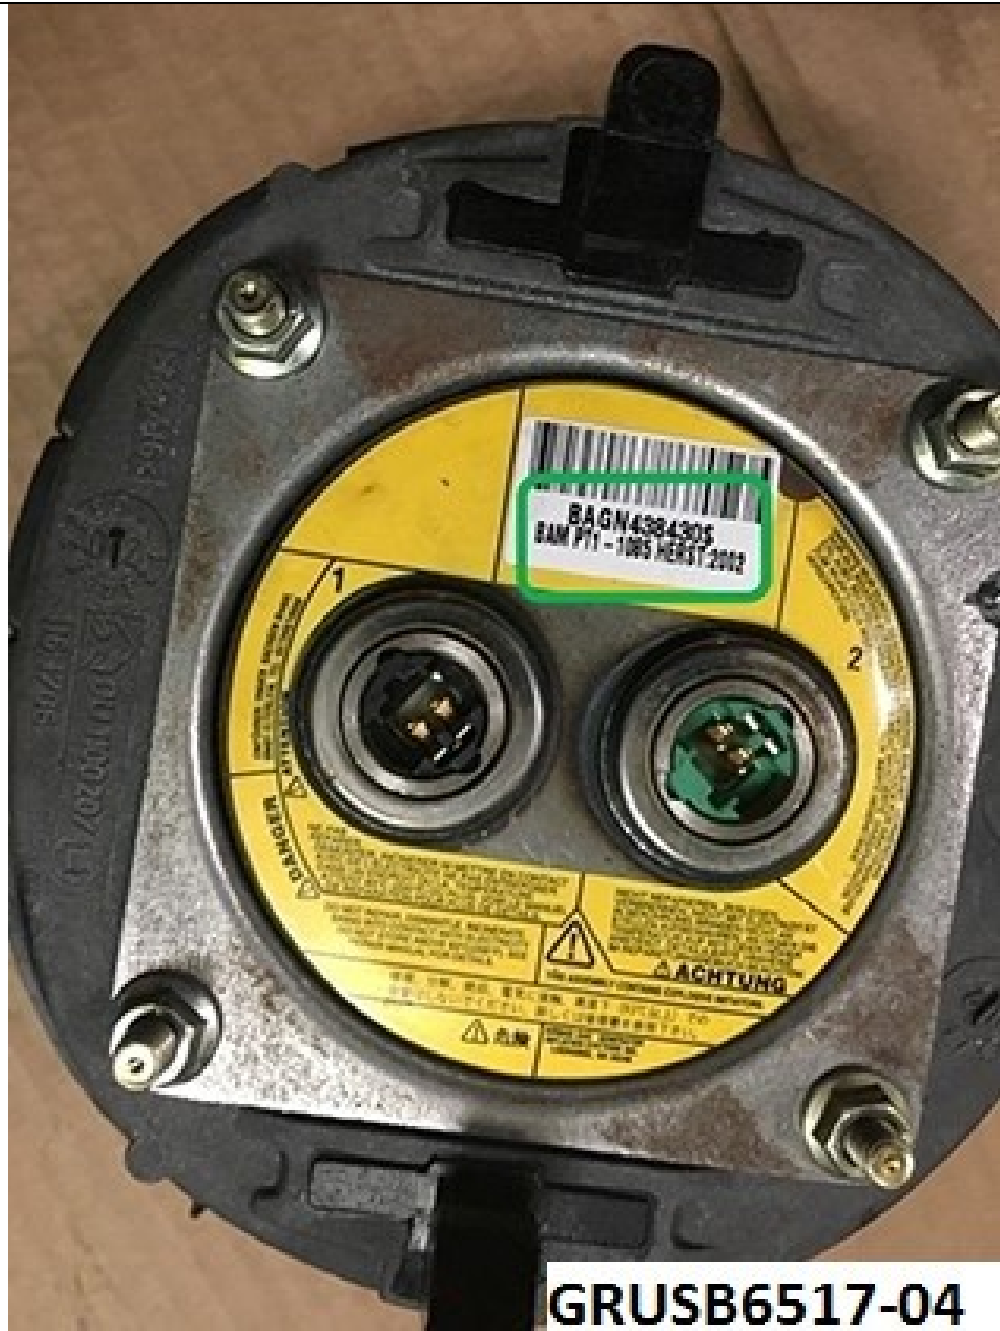
GRUSB6517-04

Is the label yellow with a white number sticker with printed serial number BAM XXX - 1085 (as shown below) printed below the bar code?

YES- replace air bag per the attached procedure.

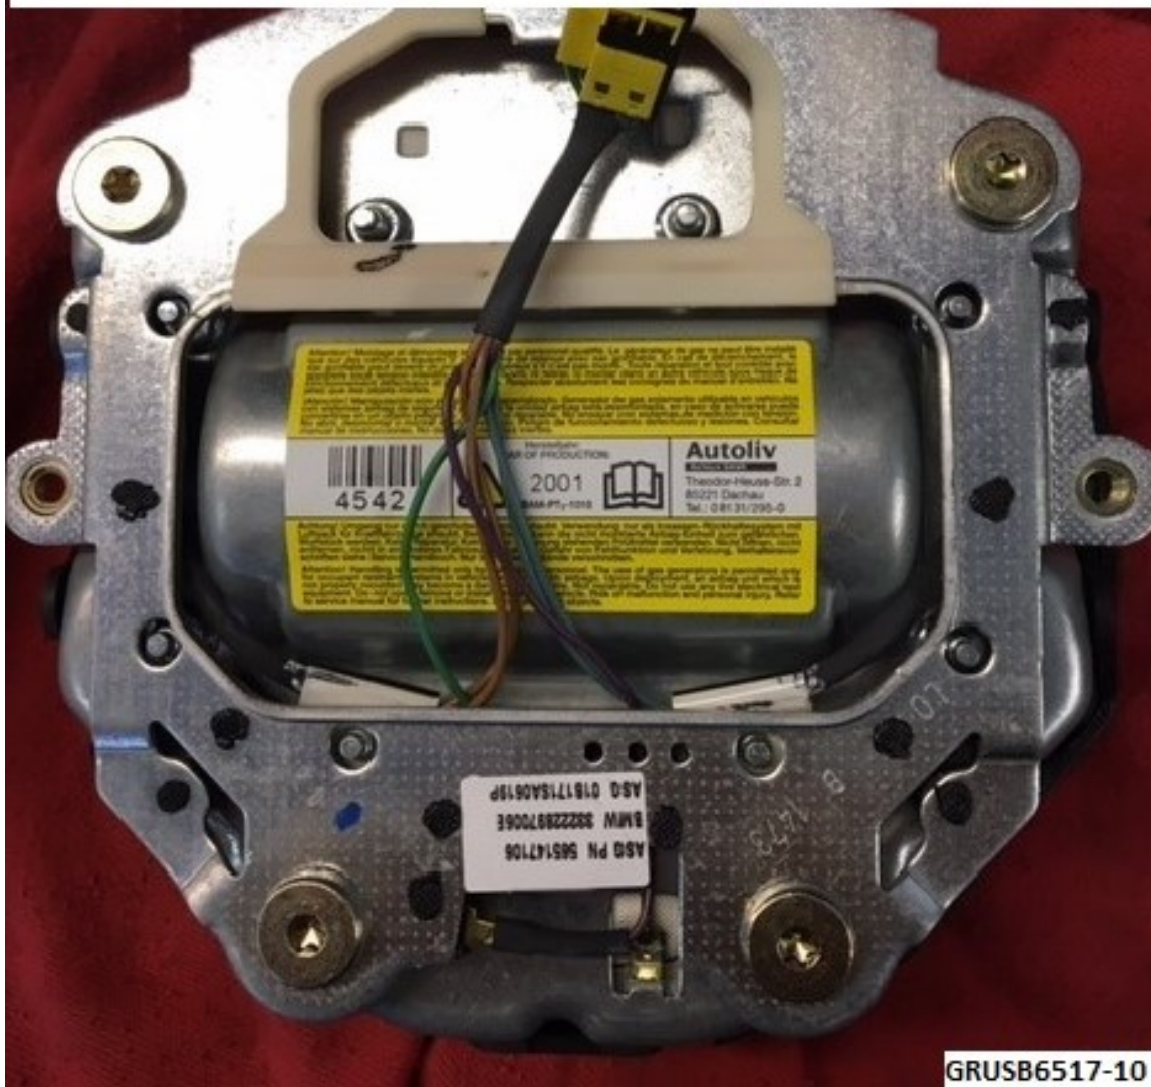
DO NOT REPLACE

NO - the driver's air bag is not affected.

Air bags from other manufacturers (non-Takata), or Takata air bags with different chemical compositions (white label) are not affected by this recall and **DO NOT** need to be replaced.
