SIB 65 02 17

## RECALL 17V-047: DRIVER'S FRONT AIR BAG MODULE - PRIOR PARTS REPLACEMENT

This Service Information Bulletin (Revision 5) replaces SI B65 02 17 **dated July 2020**.

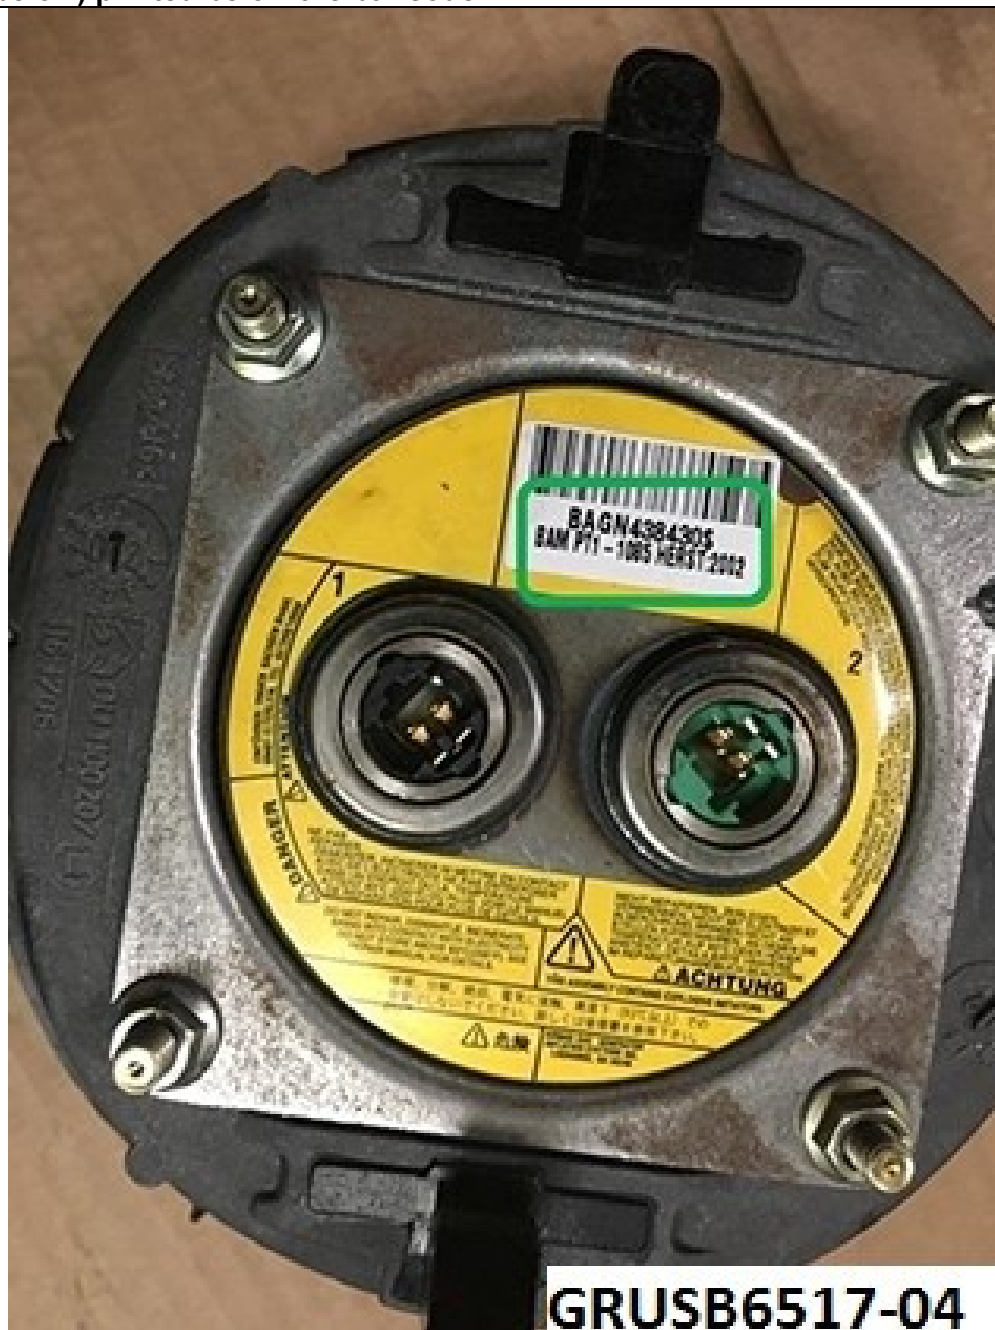
Is the label yellow with a white number sticker with printed serial number **BAM XXX - 1085** (as shown below) printed below the bar code?

**YES-** replace air bag per the attached procedure.
