SIB 65 02 17

2020-07-02

**RECALL 17V-047: DRIVER'S FRONT AIR BAG MODULE - PRIOR PARTS REPLACEMENT**

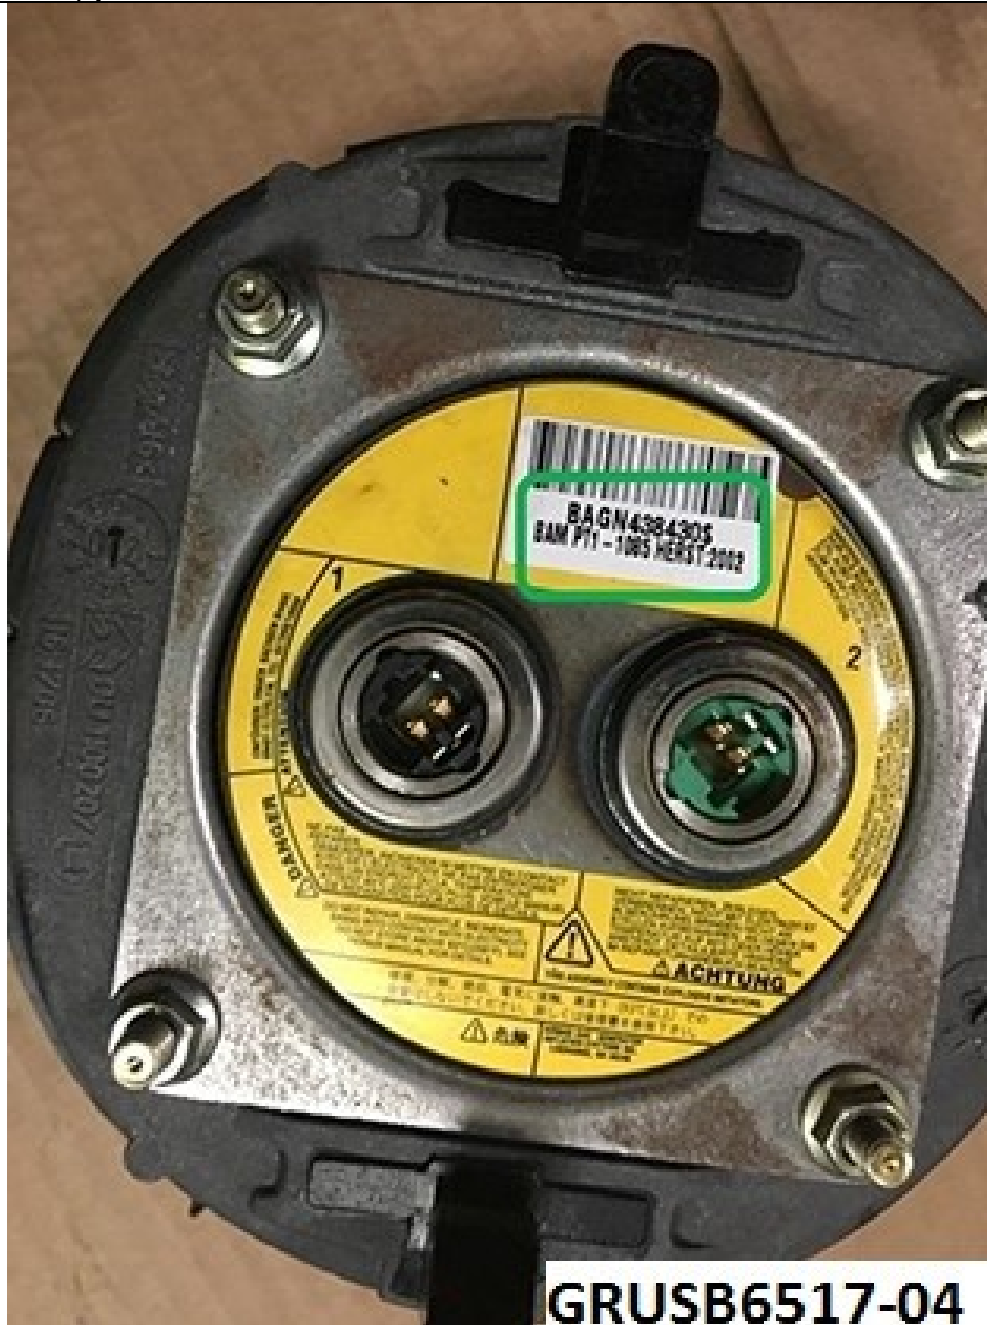
Is the label yellow with a white number sticker with printed serial number **BAM XXX - 1085** (as shown below) printed below the bar code?

**YES-** replace air bag per the attached procedure.

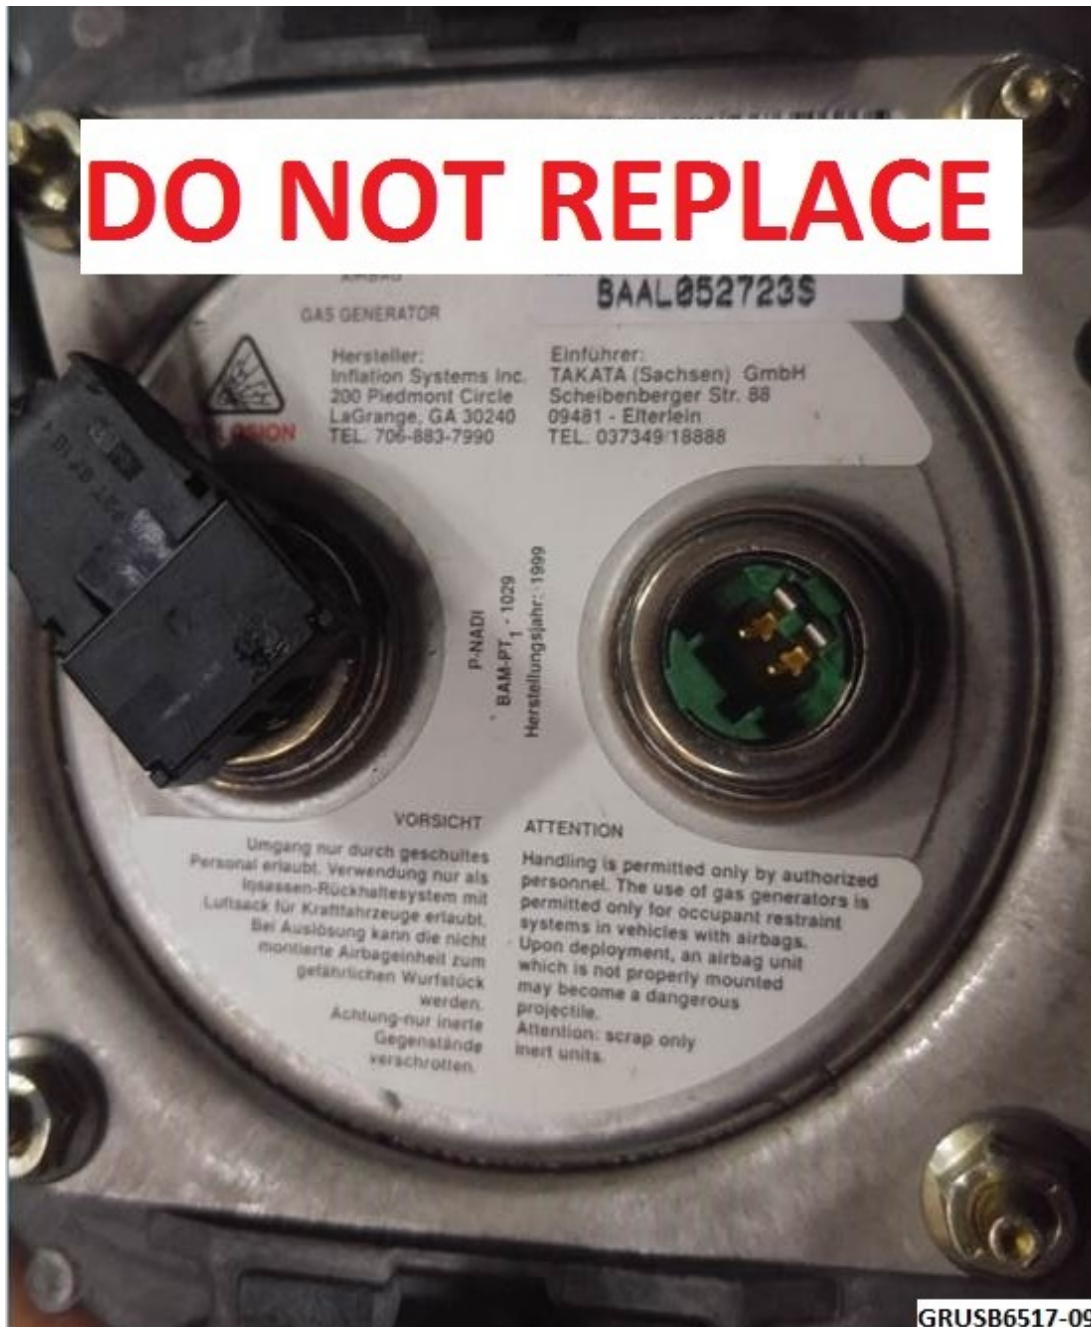
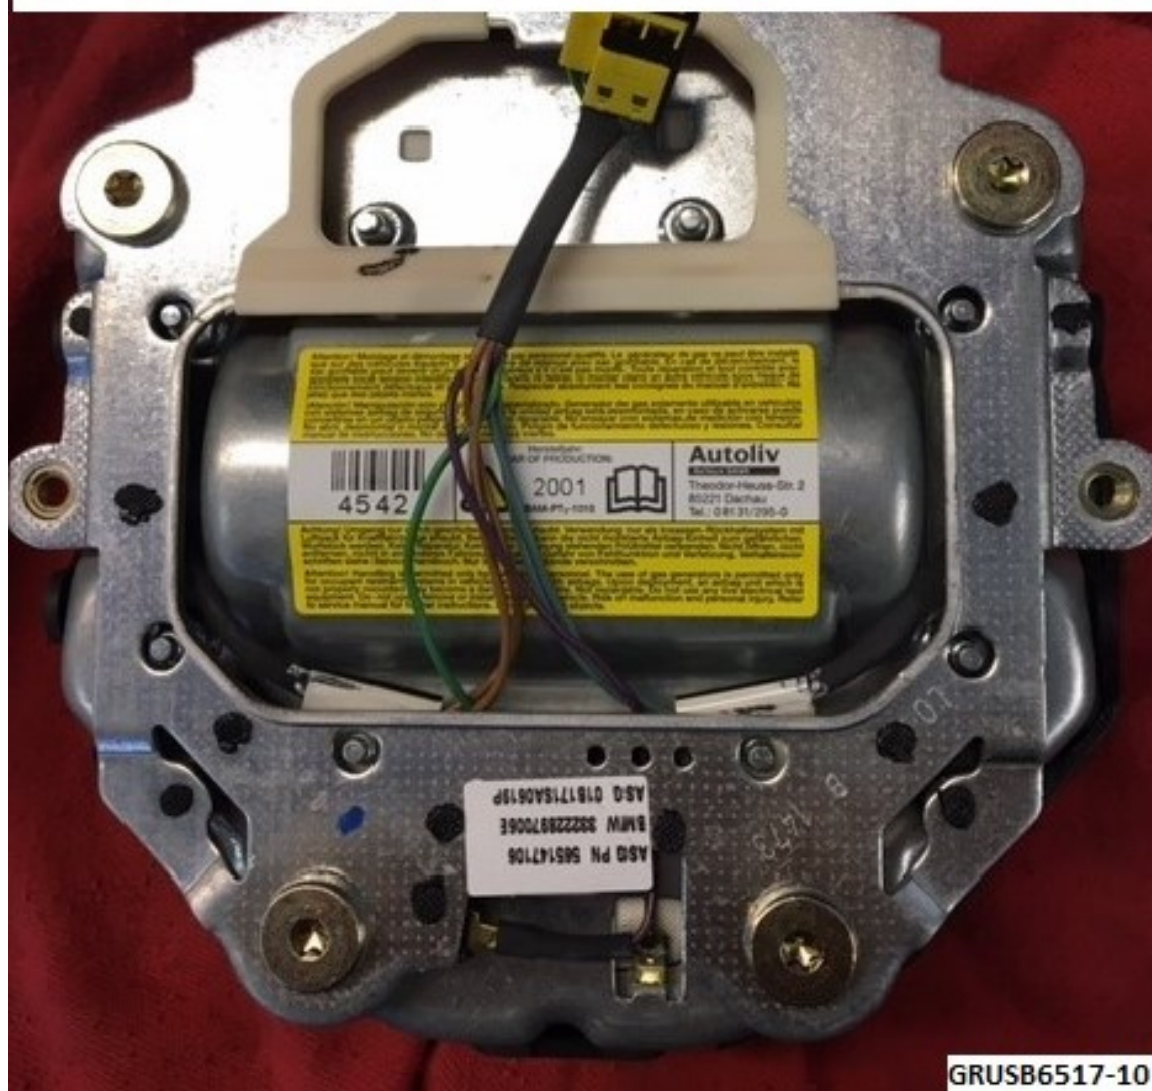
# DO NOT REPLACE

**NO** - the driver's air bag is not affected.

Air bags from other manufacturers (non-Takata), or Takata air bags with different chemical compositions (white label) are not affected by this recall and **DO NOT** need to be replaced.

**Reinstall the driver's air bag.**
