SIB 65 02 17

## RECALL 17V-047: DRIVER'S FRONT AIR BAG MODULE - PRIOR PARTS REPLACEMENT

This Service Information Bulletin (Revision 6) replaces SI B65 02 17 **dated February 2022**.

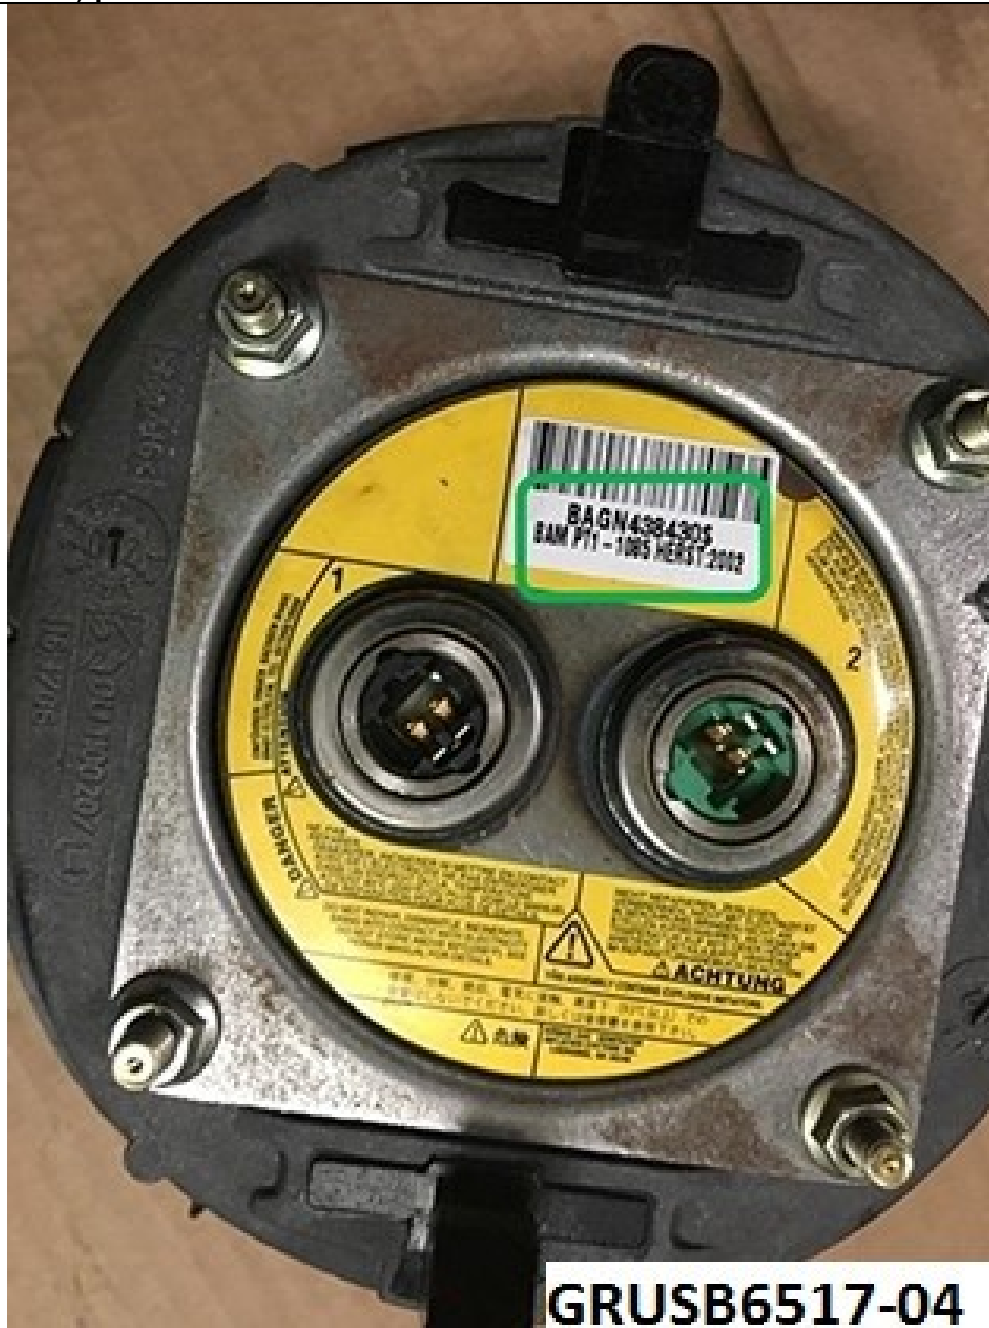
Due to a supplier production error, certain air bags from supplier Takata may not have been produced to specifications.

Is the label yellow with a white number sticker with printed serial number **BAM XXX - 1085** (as shown below) printed below the bar code?

**YES-** replace air bag per the attached procedure.
