RECALL CAMPAIGN 17V-062: FRONT PASSENGER AIR BAG

This Service Information bulletin replaces SI B51 17 17 dated April 2017

F48 (X1)

Vehicles produced June 2016 to February 2017

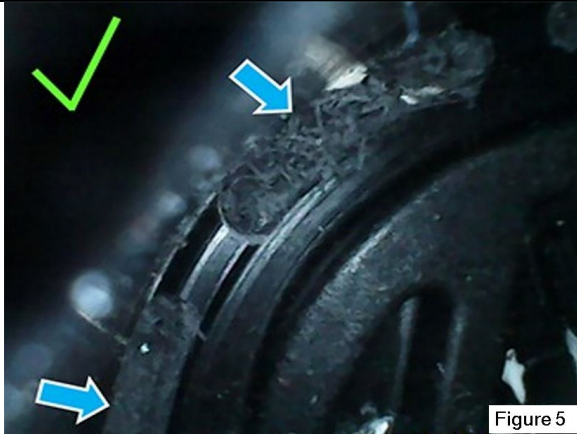
<p>Figure 5</p>	<p>8. In figure 5, the image shows the view via the borescope. The milling area shown (indicated by the blue arrows) is correctly done. If the milling is correct on both side, the vehicle can be reassembled and no further actions is needed. Refer to repair instructions 51 16 366 "Installing the glove box on the right with the housing".</p>
x

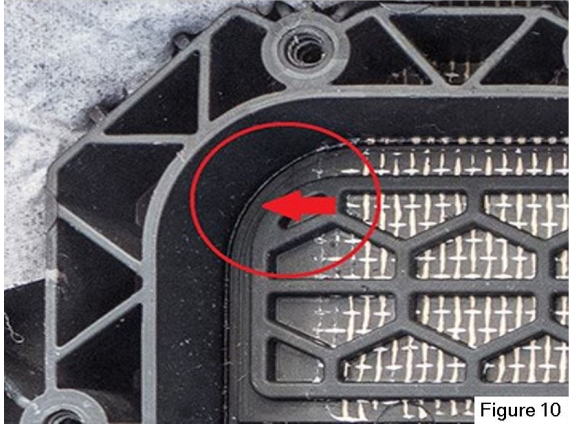
<p>Figure 10</p>

<p>Figure 6</p>	<p>9. Figure 10 shows the incorrect milling of the dashboard. If there is no groove on the image of the borescope and no milling traces as in Fig. 6, then the dashboard must be replaced.</p> <p>Refer to repair instructions “51 45 031 Replace cover for instrument panel”.</p> <p>Note: Only in emergencies when no borescope is available, the dashboard needs to be removed to inspect the milling area. Refer to repair instructions “72 12 000 Removing and installing the airbag module on the passenger side”.</p>

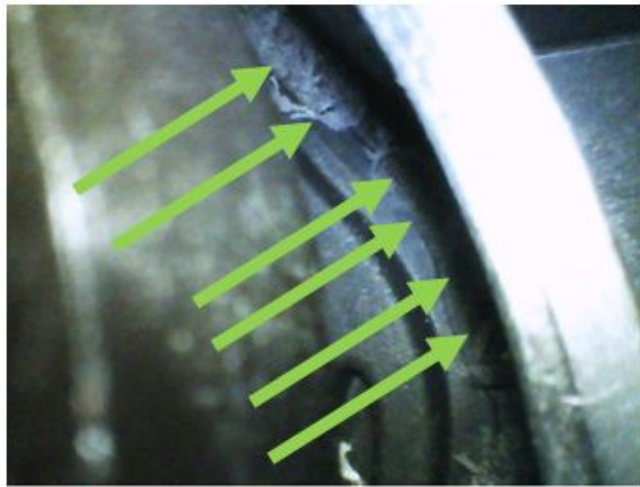
Evidence of correct milling – Green arrow

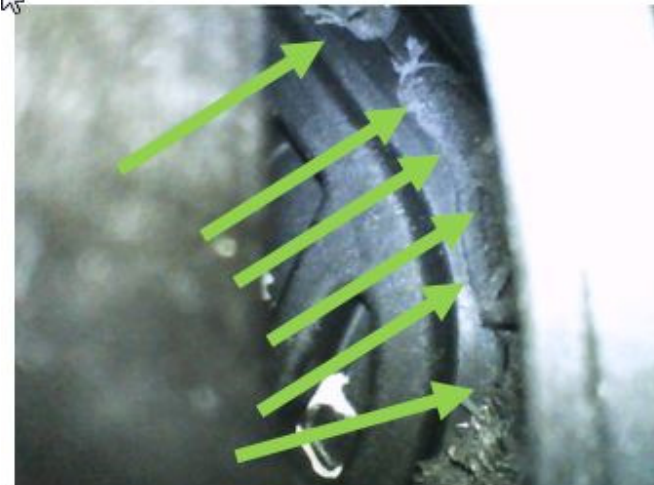
Evidence of correct milling – Green arrow

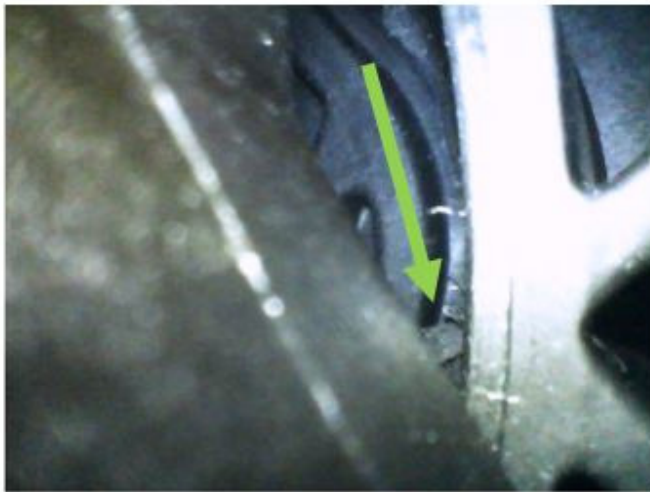
Evidence of correct milling – Green arrow

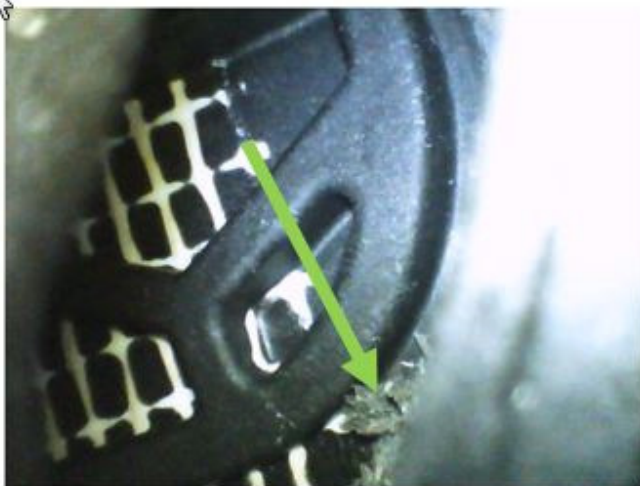
Evidence of correct milling – Green arrow

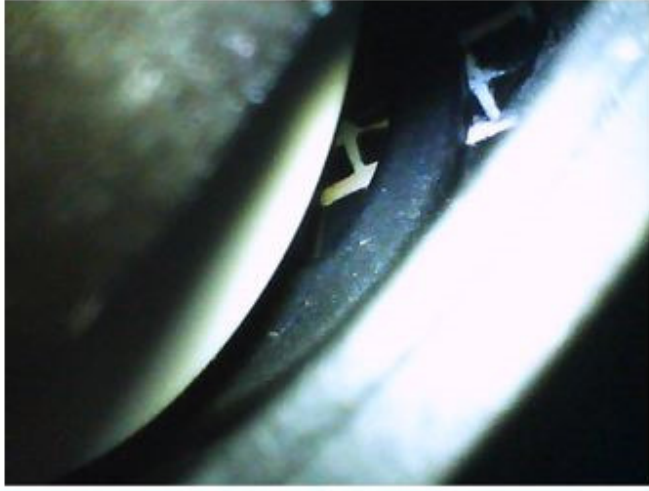
<p data-bbox="215 790 866 842">Unable to determine (wrong angle view)</p>	<p>The image at the left is showing the wrong angle view. The evidence of milling cannot be determined. The borescope must be put at a less extreme angle to obtain correct image.</p>
