RECALL CAMPAIGN 17V-XXX: FRONT PASSENGER AIR BAG

This Service Information bulletin replaces SI B51 01 17 **dated April 2017**

F48 (X1 SAV)

RE: Delivery Stop & Recall 17V-XXX: Check and Replace Instrument Panel B51 17 17

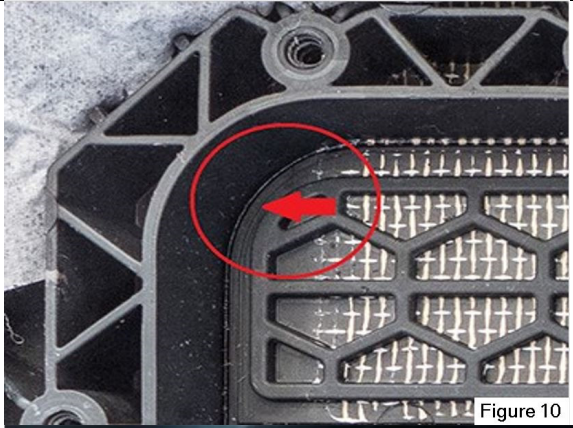
<p>Figure 10</p>

<p>Figure 6</p>	<p>7. Figure 10 shows the incorrect milling of the instrument panel. If there is no groove on the image of the borescope and no milling traces as in Fig. 6, then the instrument panel must be replaced. Refer to repair instructions "51 45 031 Replace cover for instrument panel". Note: Only in emergencies when no borescope is available, the instrument panel needs to be removed to inspect the milling area. Refer to repair instructions "72 12 000 Removing and installing the airbag module on the passenger side". .</p>

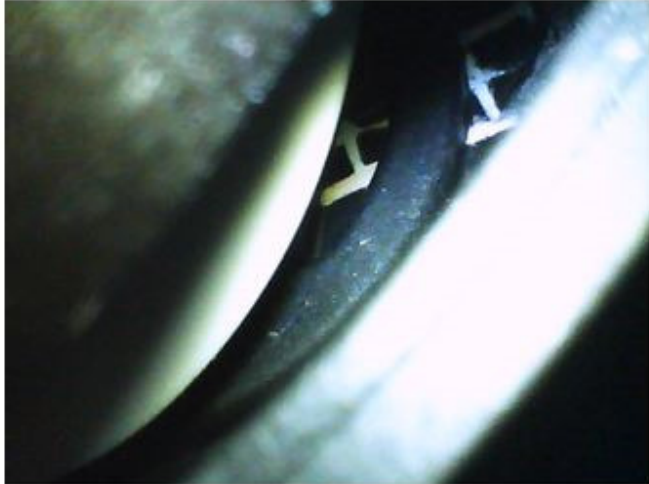
<p data-bbox="215 784 866 840">Unable to determine (wrong angle view)</p>	<p data-bbox="997 286 1390 526">9. The image at the left if showing the wrong angle view. The evidence of milling cannot be determined. The borescope must be put at a less extreme angle to obtain correct image.</p>
