ADDRESSEES	: ABC Customer Care and Parts Source Owners and users of vehicles mentioned under "Application"
VEHICLE TYPE	: T2100, C2045, CX..., TX..., TD925US
CONFIGURATION GROUP	: 7.06 Steering – front-axle steering
BULLETIN TYPE	: Safety Recall NHTSA 17V-064/TC 2017-064
DATE	: February 15 th , 2017
SUBJECT	: Replacement of front axle steering system bevel gear
TERMS & CONDITIONS	: Refer to the warranty section further in this Bulletin.

SERVICE BULLETIN SB1366

SUBJECT OF BULLETIN : To change bevel gear of front axle steering system

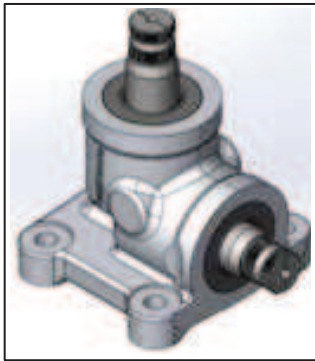
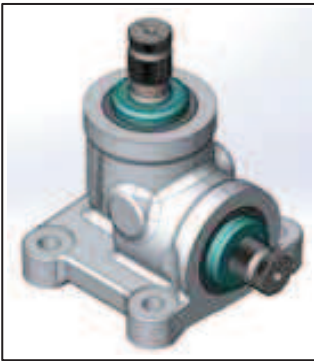
First generation Pailton bevel gear	Second generation Pailton bevel gear (additional dust cover at input and output shafts) (*)

(*) The additional dust covers are colored in green in order to clarify, in reality they are black.

- Owners and operators of coaches equipped with a Pailton bevel gear should first identify their bevel gear. If the vehicle is equipped with a first generation Pailton bevel gear, it must be replaced by a corresponding ZF bevel gear. **The Pailton bevel gears of the second generation are not affected!**
