**RECALL BULLETIN:**  
**170131REV**

Fleetwood Brand:  
Model Year 2017  
Storm

Model Year 2016-  
2017 Vacationer  
manufactured  
9/23/15 - 11/3/16;

**SUBJECT:**  
Inspection/  
Correction of Fuel  
Fill Components

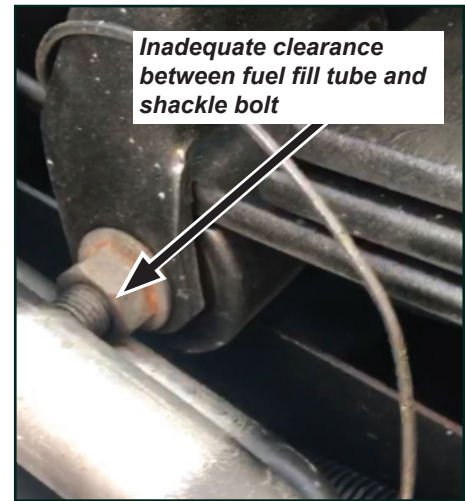
Figure 1

On motorhomes affected by this recall, the fuel fill tubing, fuel fill mounting hardware, or fuel vent tubing may come into contact with the spring shackle bolt.

If the fuel fill tubing is damaged by contact with the spring shackle bolt, a gasoline leak may result, presenting the risk of a fire in the presence of an ignition source, which may result in death, personal injury or property damage.

5. If any part of the fuel fill or vent tubing has 1/2" or less clearance from the spring shackle bolt (as shown in Figure 1), loosen the screws for the four clamps securing the EPDM rubber connectors located near the fuel fill. Remove any additional clamps or nylon ties securing the tubing between the fuel fill and the fuel tank.
6. a. Reposition the steel fuel fill and/or vent tubing further into the EPDM rubber connectors as needed to gain the proper (1/2" min.) clearance. (See Figures 2 and 3.) This may require some tugging or slight rotation of the tubing.

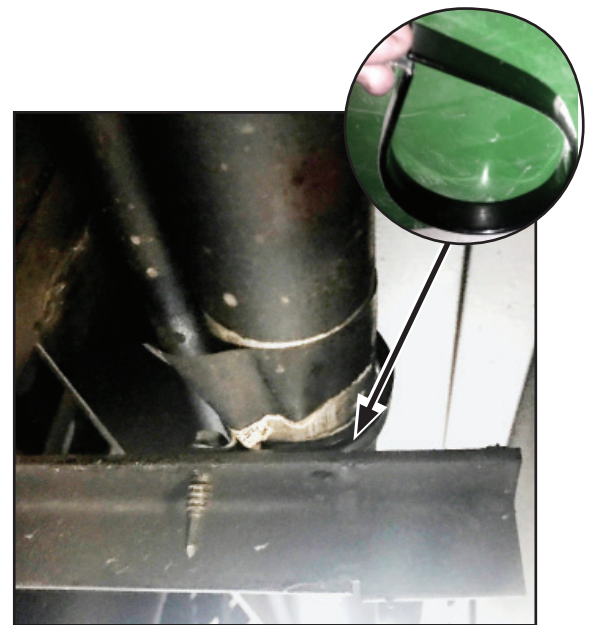
Figure 5

Insulated clamp secured with self-tapping screw

8. After proper clearance between the fuel fill and vent line and the spring shackle bolt has been achieved, secure the lines to the support bracket using an insulated clamp, REV Part # 10007781). Ensure the clamp goes around both tubes and is secured with a self-tapping screw to the support bracket. See Figure 5.
