**Campaign code.**  
L73X-R.01.17

**Campaign description.**  
Evap system upgrade

**Model.**  
Aventador Coupe and Roadster.

L73X-R.01.17	<b>To:</b> <b>Subject:</b> <b>Date:</b> <b>Pages</b>	<b>Official Lamborghini Service Network</b> <b>Update of fuel vapor circuit</b> <b>February 24, 2017</b> <b>58</b>

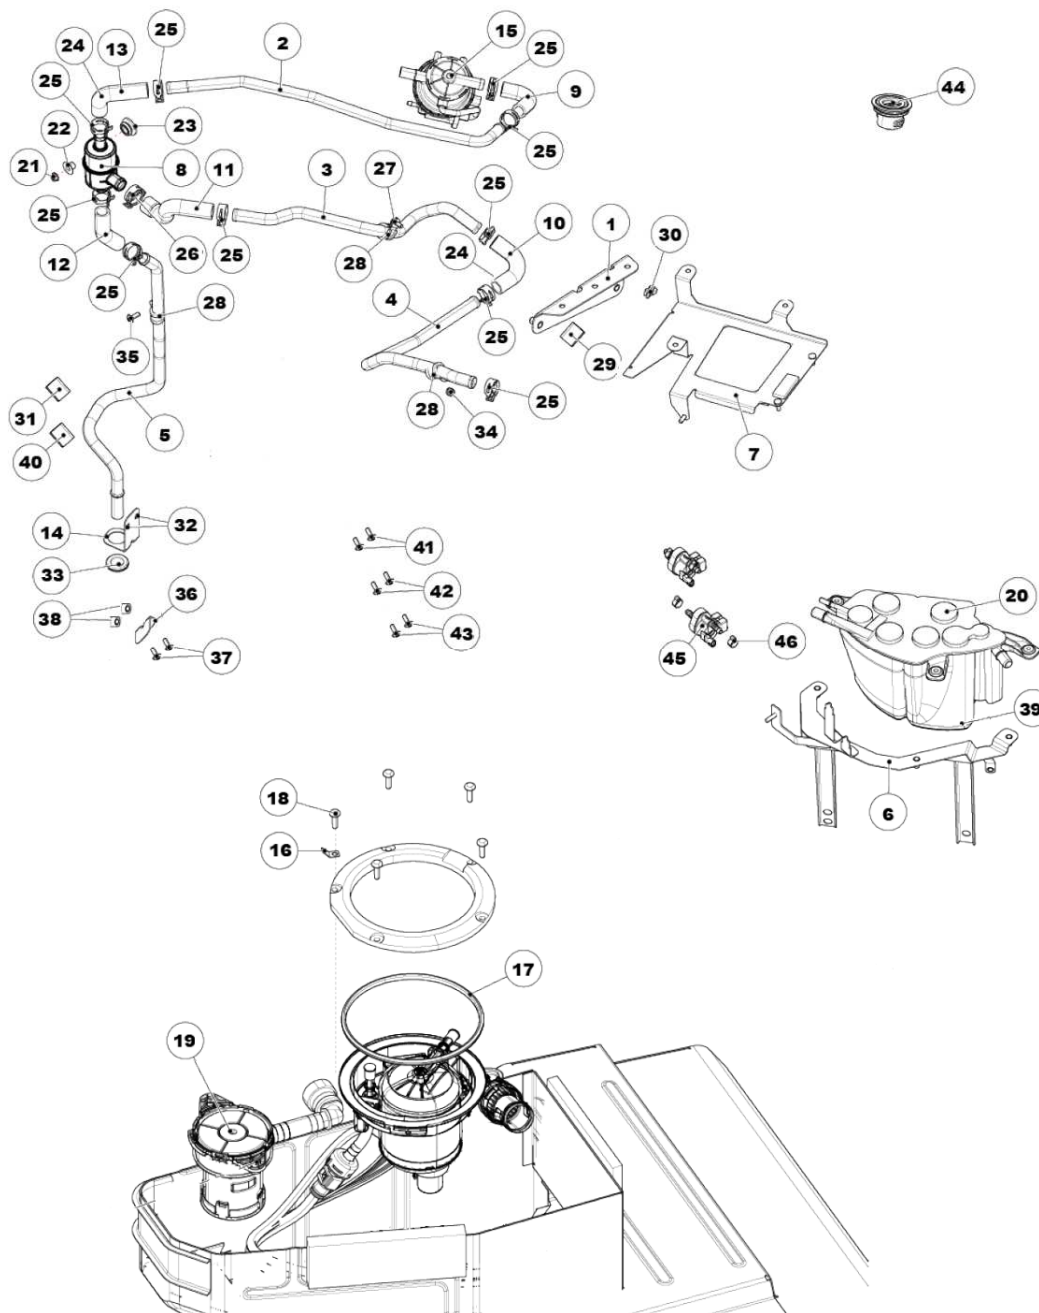
The Lamborghini Aventador fuel vapor collection circuit has been subjected to a few technical updates. A diagram of the updated components of the fuel system to be installed on the vehicle is provided below.

- A. Updating of the fuel vapor exhaust circuit, installation of the 3-way valve, replacement of the Activated Carbo Canister (ACC) filter and LDP diagnosis pump.
- B. FLVV valve update.
- C. Purge electro-valve update.
- D. Tank cap update.
