Campaign code.
L73X-R.01.17

Campaign description.
Evap system upgrade

Model.
Aventador Coupe and Roadster.

L73X-R.01.17	To: Official Lamborghini Service Network Subject: Update of fuel vapor circuit Date: February 24, 2017 Pages: 58	 
--------------	---	---

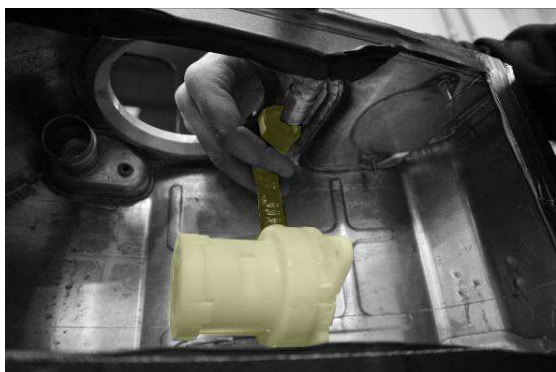
The picture below shows how to extract the old FLVV valve to be replaced.

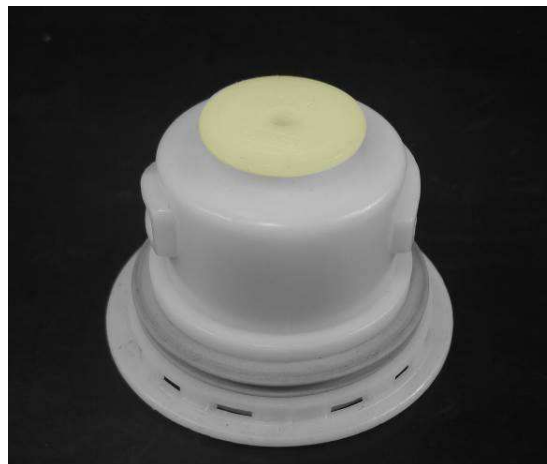
Avoid crushing or damaging the lower part of the component as it is highlighted in the pictures. In case of damages the parts need to be replaced.
