**REPAIR PROCEDURE
SAFETY RECALL 0917B**

A. VEHICLE INSPECTION PROCEDURE

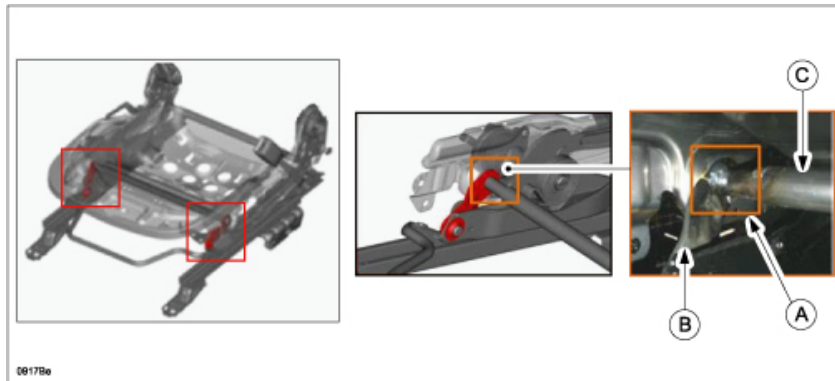
1. Check the bottom side of the seat and see if there is any damage to the welds (C) on the lifter link (A) or stabilizer (B).

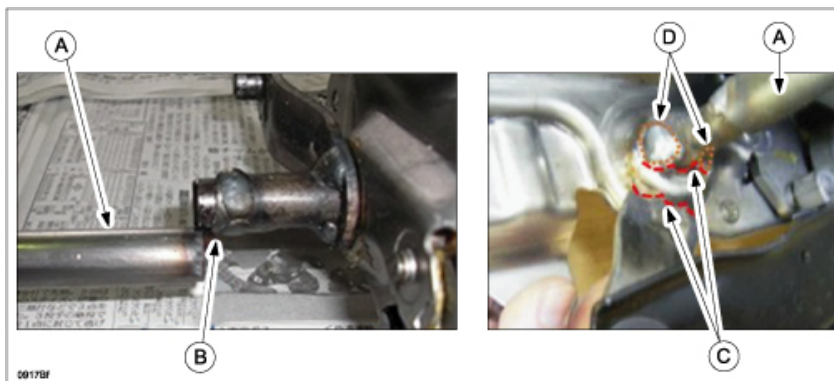
2. Check the lifter links on both front sides of the seat.
 - If the stabilizer or lifter link is damaged [stabilizer (A) is cracked or broken (B) / sub slider unit link or stabilizer is cracked or broken (C) at welding points (D)], replace the front seat slide adjuster unit (****88H50) with a modified one. Refer to the instructions on MGSS (FRONT SEAT SLIDE ADJUSTER REMOVAL/INSTALLATION).

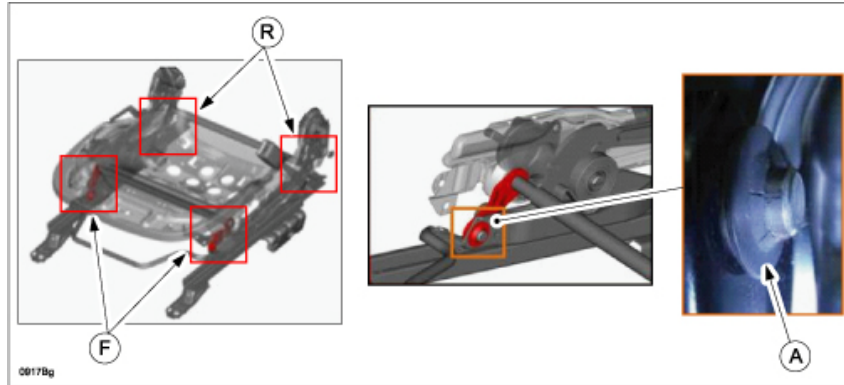
1. Check the bottom side of the seat and see if any push nuts (A) are loose or missing on the front side (F) or rear side (R).

NOTE: After completing this Inspection Procedure, it should be confirmed that 1 or 2 push nut(s) is/are installed on each front side and 2 push nuts are installed on each rear side.

Push nut is installed correctly	Push nut is loose (clearance not OK)	Push nut is missing

- a. Check the condition and number of push nuts on the front side (2 locations), then go to next step.
 - If a push nut is loose or missing, check the clearance and replace or add a push nut. Refer to the Repair Procedure A for checking clearance and removing/installing push nuts.

- b. Check the condition and number of the push nuts on the rear side (2 locations), then go to Repair Procedure B.
 - If a push nut is loose or missing, replace the push nut with new one. Refer to the Repair Procedure A for checking clearance and removing/installing push nuts.

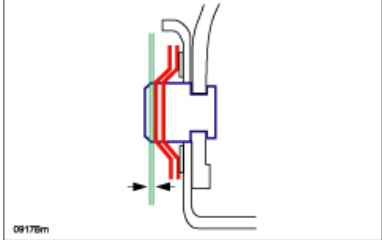
Measure clearance	1 Push nut (clearance not OK if 1.5 mm or less)	2 Push nuts (clearance not OK if 0.5 mm or less)

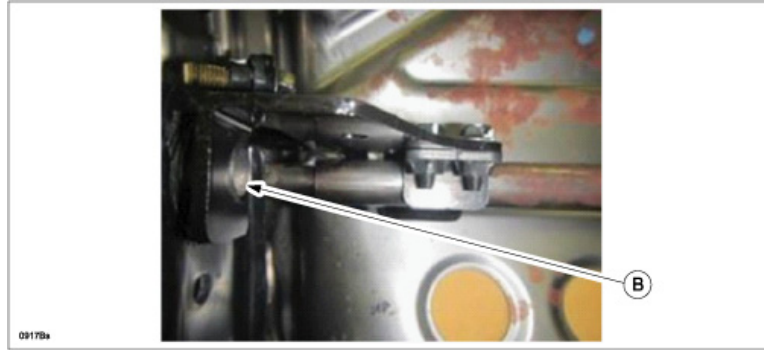
CORRECT: Side plate is attached to shaft.	INCORRECT: Side plate is NOT attached to shaft.

- b. At Point (B), attach the side plate to the shaft of the sub slider unit link.

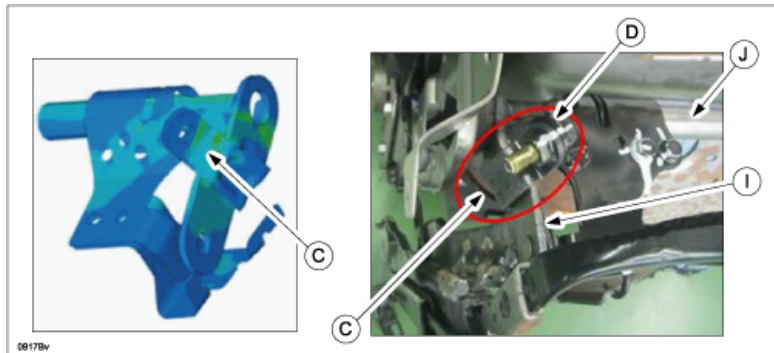
NOTE: The side plate (A) and the seat bracket (C) have (R) and (L) stamps for right and left sides. Make sure to install them on the correct side. If the right side and the left side are installed incorrectly, the bracket will interfere with the lifter and will not operate.

- c. Attach the seat bracket (C) to hold the sub slider unit link and tighten the lock bolt (D).

Tightening torque: 11.6 -16.6 ft.lbs. (15.7 - 22.6 Nm)
