UPDATE! **RECALL CAMPAIGN 17V-087: POWER DISTRIBUTION BOX POSITIVE SUPPLY CONNECTOR**

E84 (X1)

BMW AG is conducting a Voluntary Safety Recall on certain Model Year 2014 BMW X1 SAV models involving the power supply system.

REP-REP-RAE9061-6111X01 V.3 Installing the repair cable for the positive battery cable of the power distribution box, VIN: XXXXXXXX

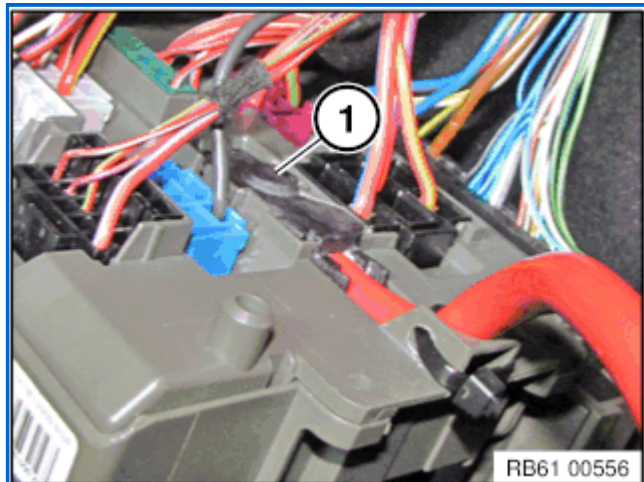
If cap (1) cannot be flush-mounted, the connector contact below it is not mounted correctly.

Mount the cap (1) flush.

In this case, release the connector contact as described in the previous operation and connect it again.
