RECALL CAMPAIGN 17V-088: CHECK TANK VENTILATION LINE AND REPLACE IT IF REQUIRED I01 REX

**Fuel Tank Vent Line
Safety Recall 17V-xxx
Model Year 2014 – 2017
BMW i3 REx
*Last Updated 02/09/2017***

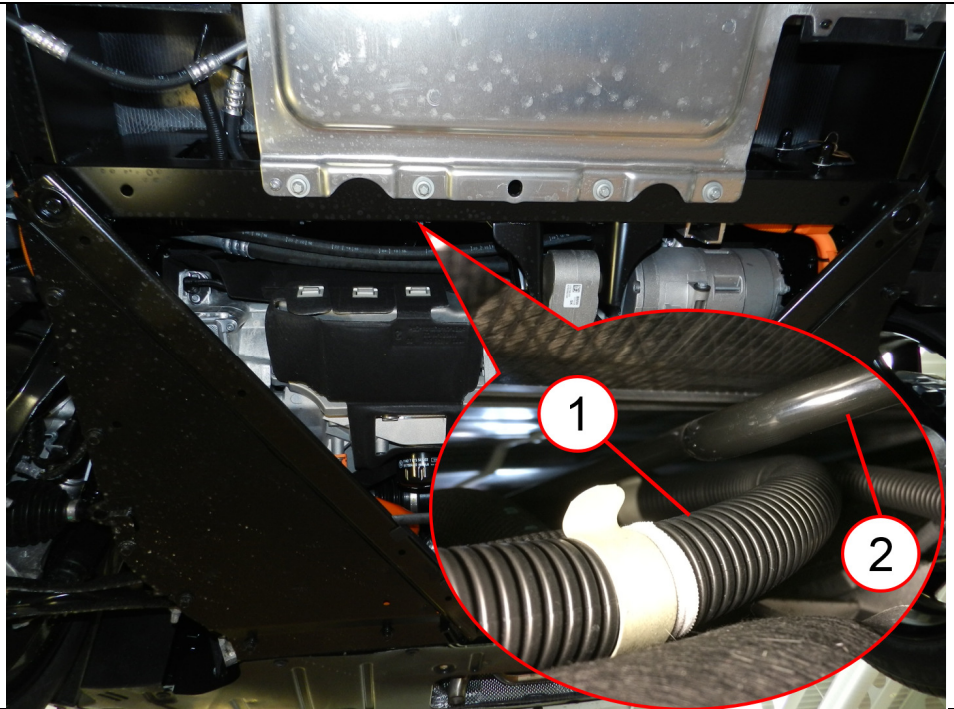
3. This example shows no damage. Proceed to step 6.

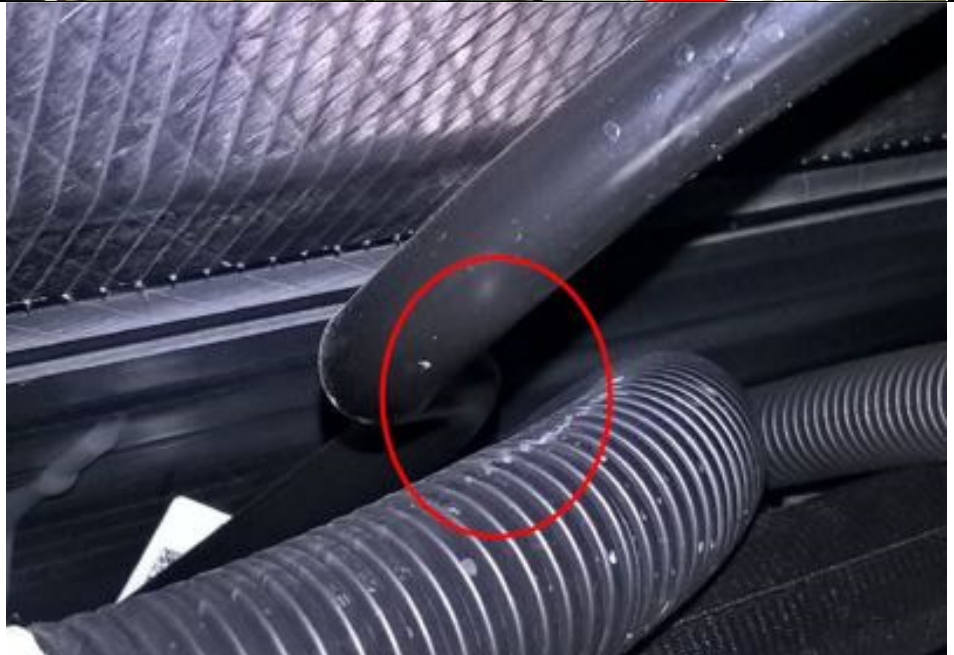
4. This example shows slight damage which is acceptable. Proceed to step 6.

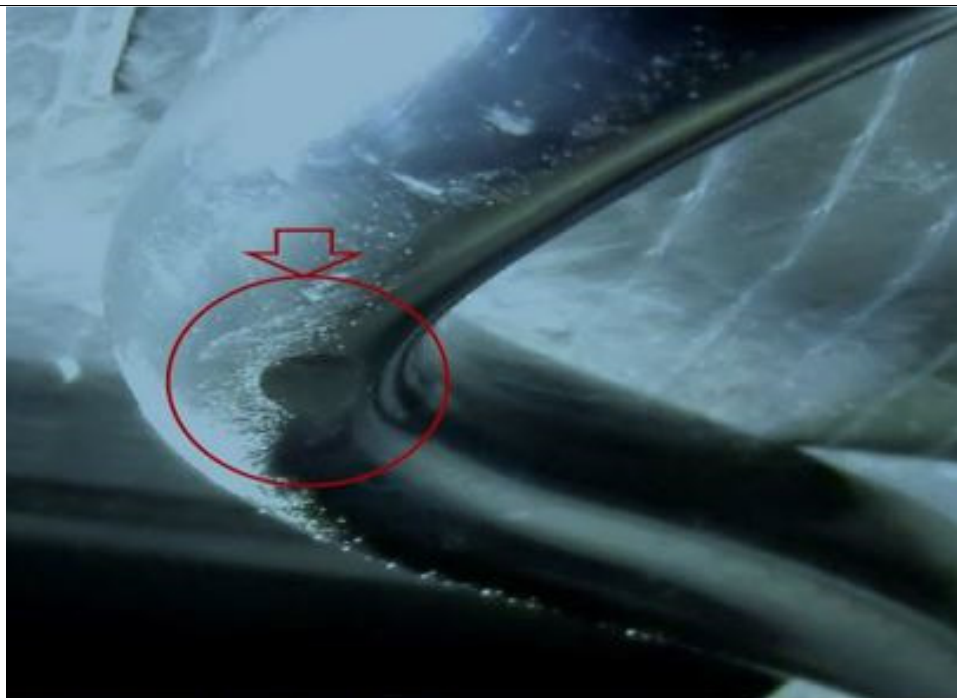
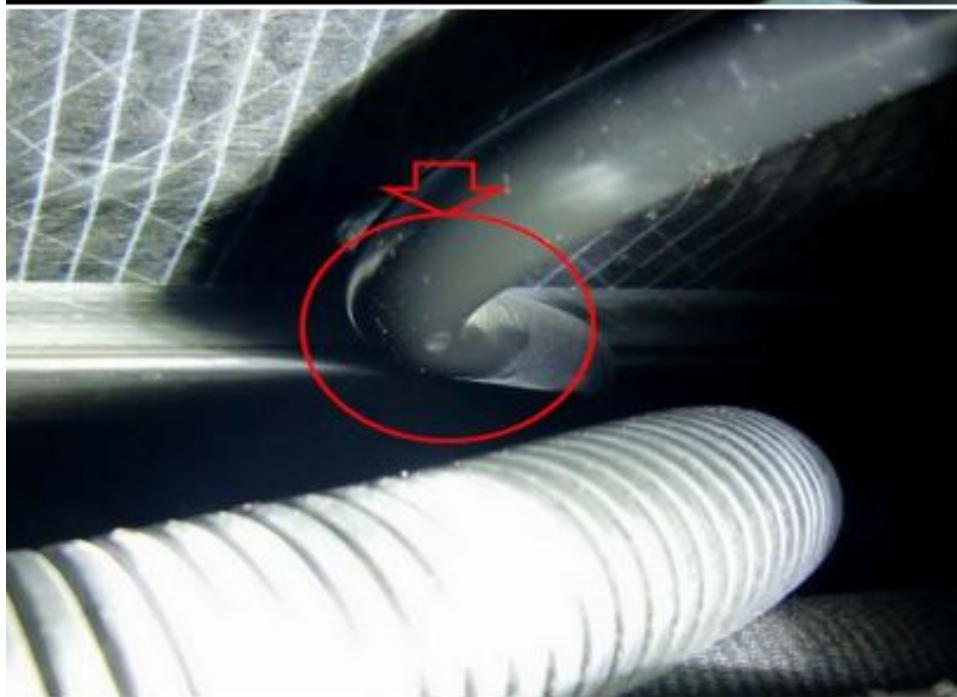
5. In this example the damage to the protective sleeve on the tank ventilation line is so severe that the white polyamide is already visible.

If the tank ventilation line has this much or more severe damage, replace the tank ventilation line per repair instructions “REP – 13 90 010 Replacing the tank ventilation line”.

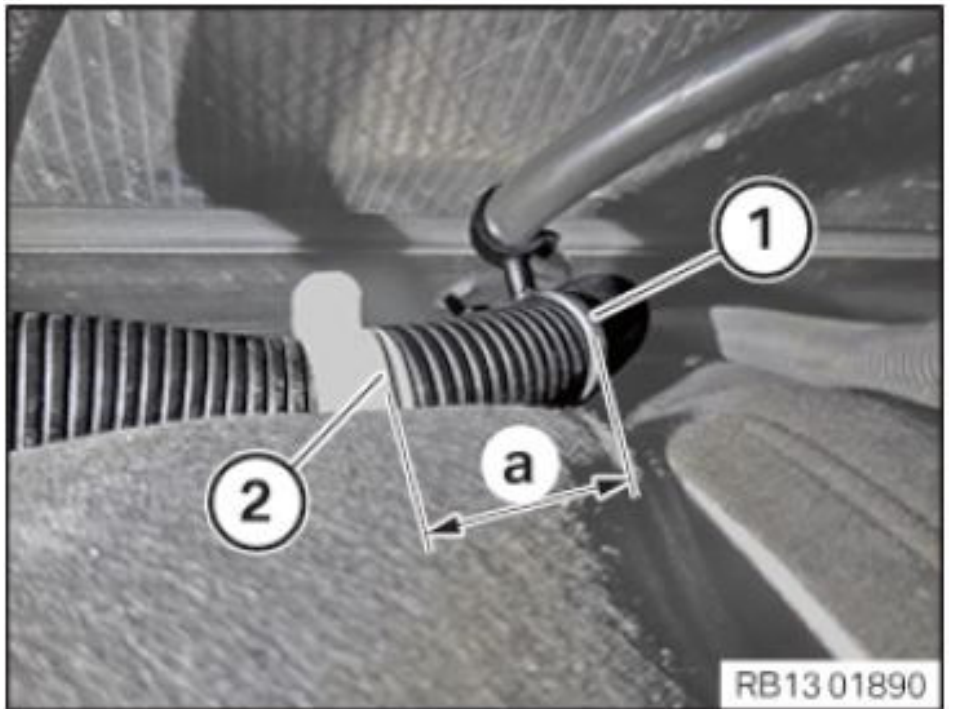
7. Verify that the abrasion protection (1) is installed on the tank ventilation line.

If the abrasion protection (1) is not installed, it must be retrofitted.
