Altec Industries, Inc.
Midwest Division
St. Joseph, Missouri

MAB 650

MANDATORY ACTION BULLETIN

Rotation Bearing Fastener Inspection

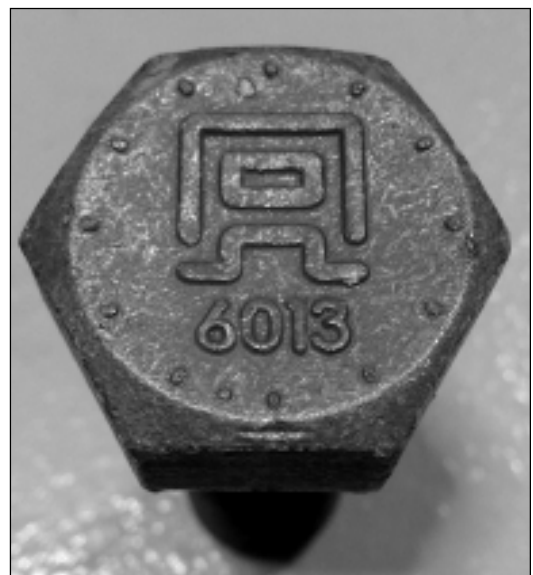
Figure 1 — Head Marking

Altec discovered a broken rotation bearing fastener while performing a check during the final assembly process. Further investigation found other fasteners broken due to stress corrosion cracking. All of the broken fasteners came from the same supplier. Failure of multiple fasteners on a single bearing race can cause uncontrolled movement of the turntable and boom. **Death or serious injury can result from uncontrolled movement.**

- Inspect the rotation bearing fasteners as soon as this MAB is received to see if the fastener head is marked with 6013 (refer to Figure 1) before the unit is operated again. If none of the fasteners are marked with 6013, no further action on the MAB is needed and the unit can be returned to service.
- If there are fasteners marked with 6013, perform a torque test on the fasteners in the race where the affected fastener was found using the Annual Torque Inspection Procedure in the Maintenance Manual.
- If any of the fasteners are broken or break during the torque inspection:
 - Remove the unit from service.
 - Replace all of the fasteners on the race where the affected fastener was located before the unit is returned to service. Rotation fasteners replacement kits are listed on Page 2 and can be ordered by calling 1-877-GO ALTEC (1-877-462-5832).

- If no broken fasteners are found in the inspection
 - Replace all the fasteners in the race where the affected fastener was found within the next 30 days.
 - Perform a daily visual inspection of the rotation bearing fasteners until the fasteners are replaced if none were broken.
- Complete the inspection form at the end of this MAB and return it to Altec.
