## INSTRUCTION TO SERVICE

<b>ITS: 6518</b>	
<b>SECTION:</b>	203 Front Suspension
<b>WRITTEN BY:</b>	Tyler Omichinski
<b>SUBJECT:</b>	Inspection of V8-65L Front Axle

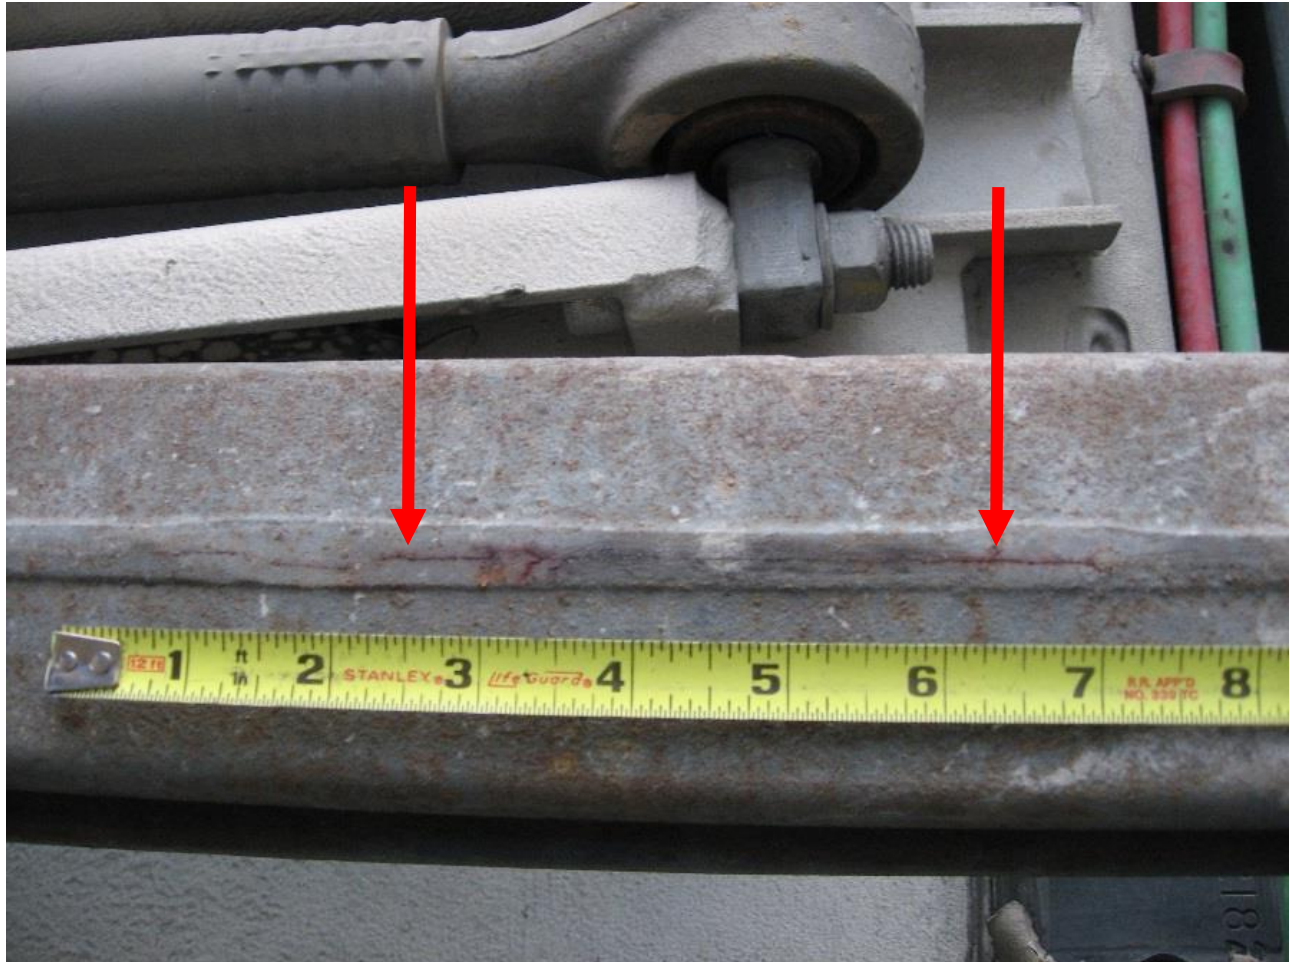
**Figure 2: Exemplar longitudinal crack down axle centerline**

5. Inspect the top and bottom faces of the front axle down the entire length of the I-beam. Look for longitudinal cracks running down the length of the beam at the forging trim line. Remove debris and corrosion using a clean rag or brush if required. An example of a beam crack is shown in Fig. 2.

**NOTE:** If no cracks are found, the axle beam may remain in service. An axle beam with cracks must be replaced. The vehicle with cracks in the axle beam may remain in service until replacement parts are available if:

- The longest crack is less than 12 inches (30 cm) long
- AND the combined length of all cracks on the top axle seam is less than 15 inches (38 cm) long
- AND the combined length of all cracks on the bottom axle seam is less than 15 inches (38 cm) long
- AND no cracks project outward from the forging trim line toward the edges of the beam
- AND no cracks exist on any part of the axle beam other than within the forging trim line on the top and bottom faces of the axle beam

All of the above conditions must be satisfied for the vehicle to remain in service. If any one of the above conditions is not satisfied, the vehicle must be removed from service until the axle beam can be replaced.

**NOTE:** If an axle beam is found to have cracks but meets the criteria for the axle beam to remain in service, it is required that the axle beam be inspected on a weekly basis until the axle beam is replaced. If the axle fails to meet any of the above criteria, the vehicle must be removed from service until the axle beam can be replaced.

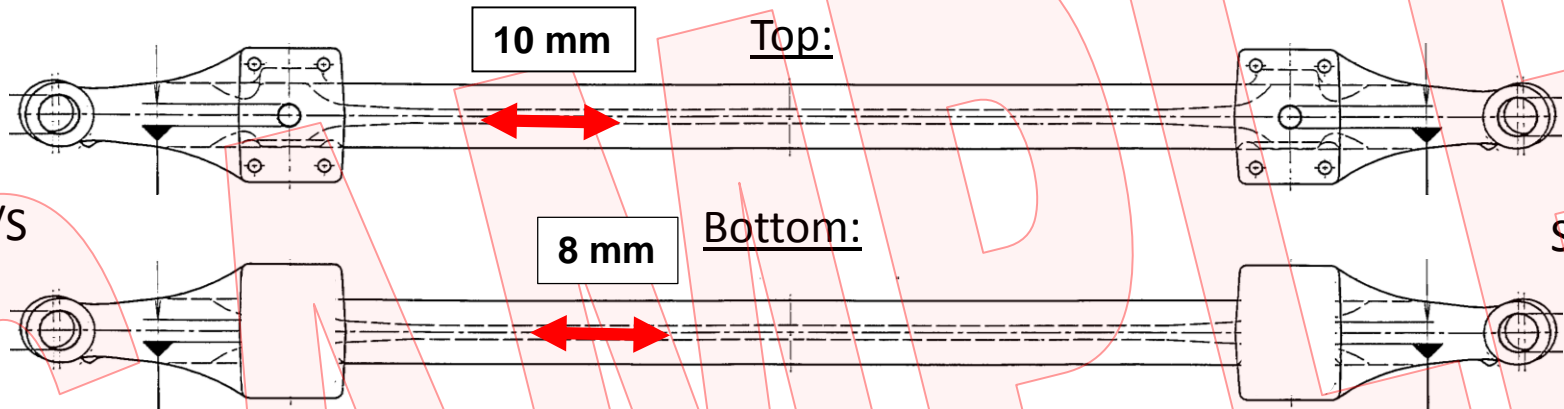
Comments: 10 mm crack on top of beam  
8 mm crack on bottom
