PRODUCT CAMPAIGN BULLETIN

APPLICABILITY: 2017MY Impreza

NUMBER: WTN-74R

SUBJECT: Reprogramming File Availability to Optimize Rear View Camera Operation on Harman Gen 3 Audio and Navigation Head Units

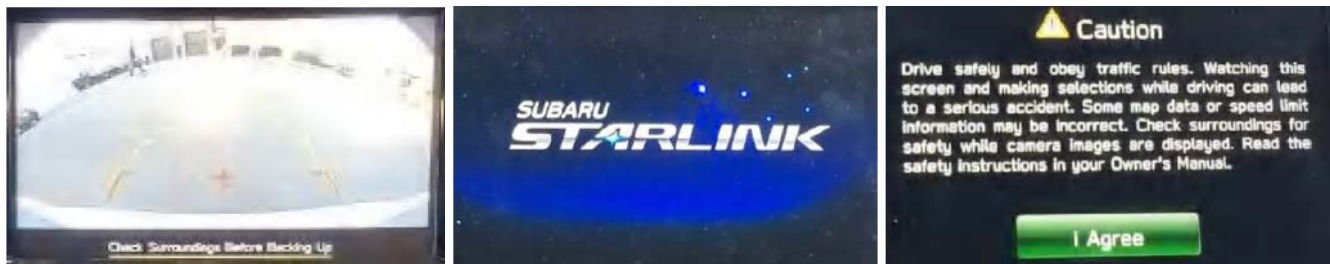
The main purpose of this campaign is to address display screen freeze-up during rear view camera display (when the shifter is in “R”). In addition, the screen may also freeze when either the Subaru STARLINK or Disclaimer Caution / I Agree is displayed.

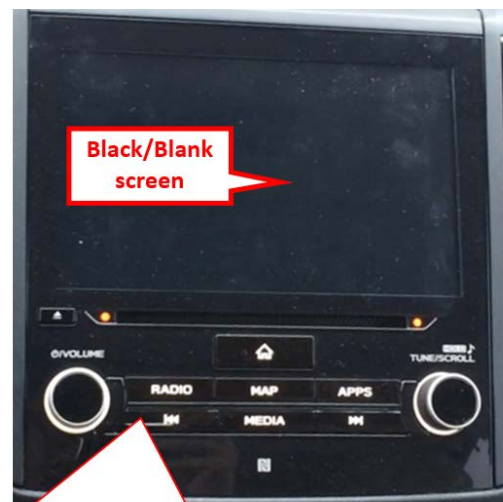
- 1) After switching the vehicle (ACC or IGN) on, the display screen goes black with no audio output and the hard key buttons are illuminated (on solid, or flashing / blinking).

Hard key (button) illuminated, on solid or flashing / blinking

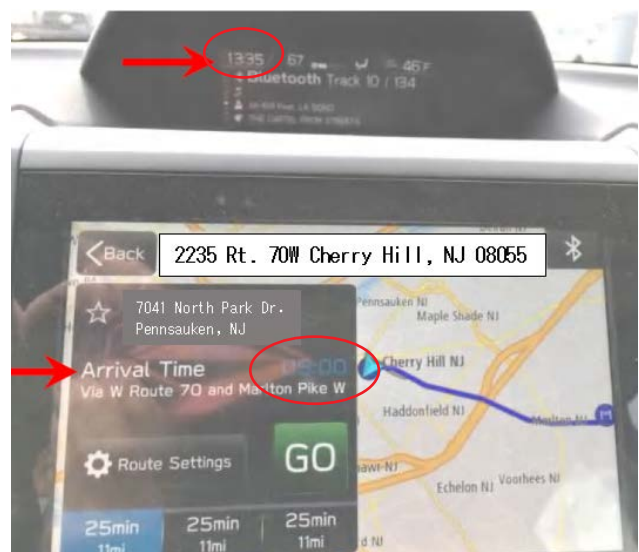
- 2) Time of day displayed in the MFD (Multi-Function Display) is incorrect and the arrival time displayed in Navigation units is also incorrect.

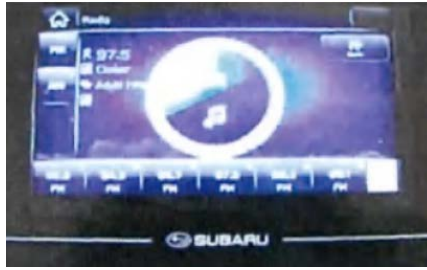
- 3) The time in the MFD automatically reverts back to a “default” setting, even after setting the time using “Manual” mode.
- 4) Audio volume goes to maximum automatically after one click of the volume up button on the steering wheel. In some cases, this condition may also occur without input from the operator. Maximum volume is also displayed on the screen.

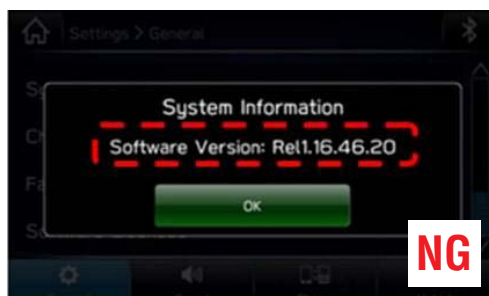
NG- Head Unit Must Be Updated, Proceed To Step 2.
