PRODUCT CAMPAIGN BULLETIN

APPLICABILITY: 2017MY Impreza

NUMBER: WTN-74R

SUBJECT: Reprogramming File Availability to Optimize Rear View Camera Operation on Harman Gen 3 Audio and Navigation Head Units

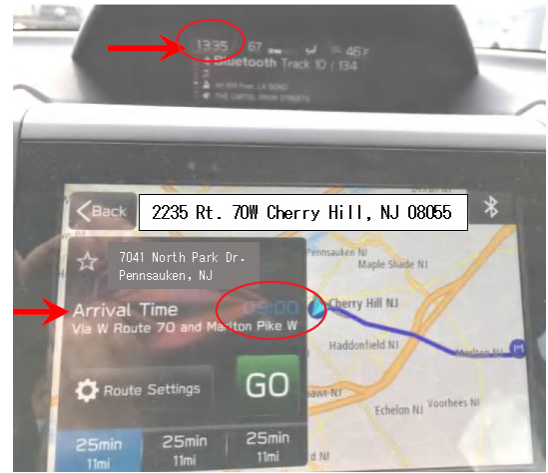
- 2) Time of day displayed in the MFD (Multi-Function Display) is incorrect and the arrival time displayed in Navigation units is also incorrect.

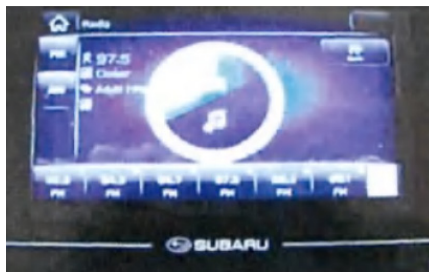
- 3) The time in the MFD automatically reverts back to a “default” setting, even after setting the time using “Manual” mode.
- 4) Audio volume goes to maximum automatically after one click of the volume up button on the steering wheel. In some cases, this condition may also occur without input from the operator. Maximum volume is also displayed on the screen.

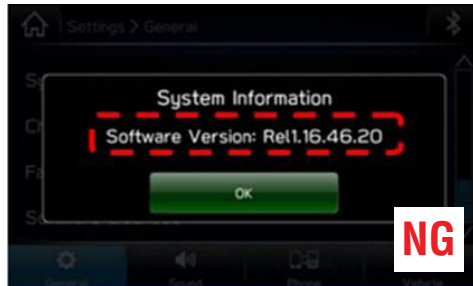
NG- Head Unit Must Be Updated, Proceed To Step 2.
