PRODUCT CAMPAIGN BULLETIN

APPLICABILITY: 2017MY Impreza

NUMBER: WTN-74R

SUBJECT: Reprogramming File Availability to Optimize Rear View Camera Operation on Harman Gen 3 Audio and Navigation Head Units

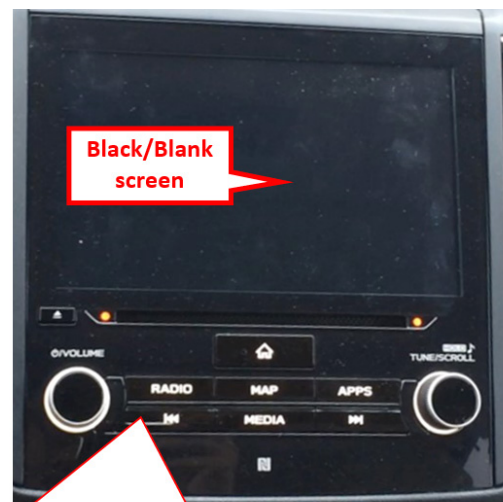
- 1) After switching the vehicle (ACC or IGN) on, the display screen goes black with no audio output and the hard key buttons are illuminated (on solid, or flashing / blinking).

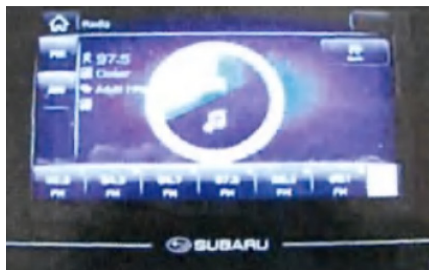
- 3) The time in the MFD automatically reverts back to a “default” setting, even after setting the time using “Manual” mode.
- 4) Audio volume goes to maximum automatically after one click of the volume up button on the steering wheel. In some cases, this condition may also occur without input from the operator. Maximum volume is also displayed on the screen.

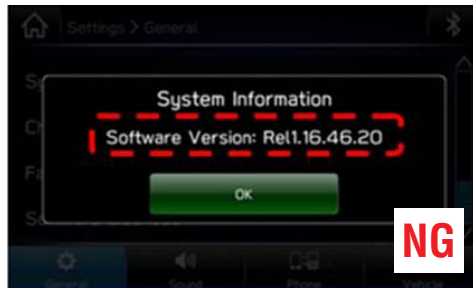
NG- Head Unit Must Be Updated, Proceed To Step 2.

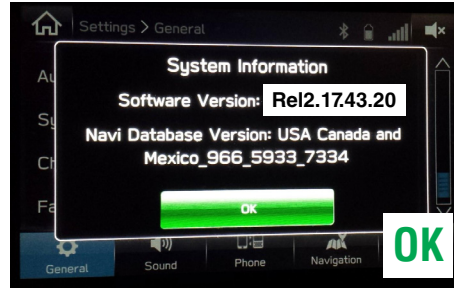
OK- Latest Version Installed, Proceed To Step 7.
