PRODUCT CAMPAIGN BULLETIN

NUMBER: WTN-74R

SUBJECT: Reprogramming File Availability to Optimize Rear View Camera Operation on Harman Gen 3 Audio and Navigation Head Units

DATE: 02/24/17

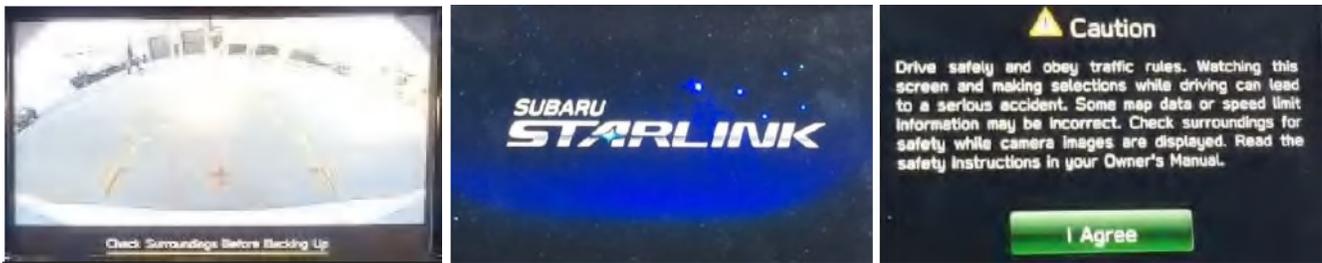
The main purpose of this campaign is to address display screen freeze-up during rear view camera display (when the shifter is in “R”). In addition, the screen may also freeze when either the Subaru STARLINK or Disclaimer Caution / I Agree is displayed.

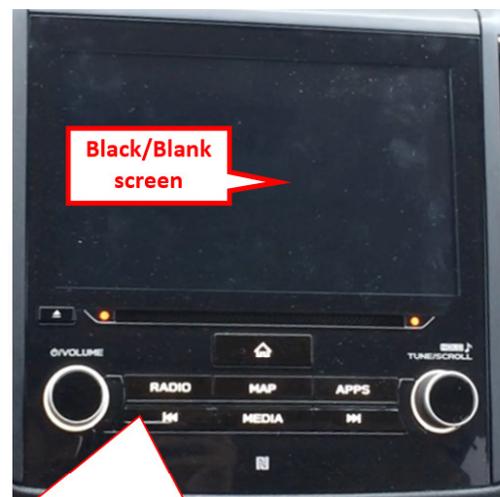
- 1) After switching the vehicle (ACC or IGN) on, the display screen goes black with no audio output and the hard key buttons are illuminated (on solid, or flashing / blinking).

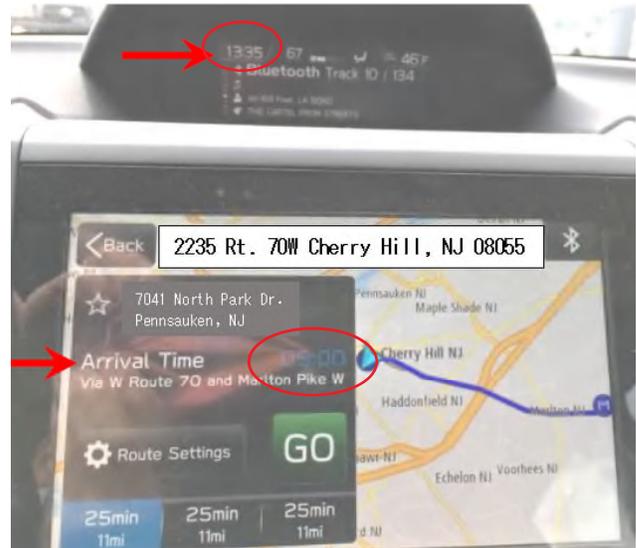
- 2) Time of day displayed in the MFD (Multi-Function Display) is incorrect and the arrival time displayed in Navigation units is also incorrect.

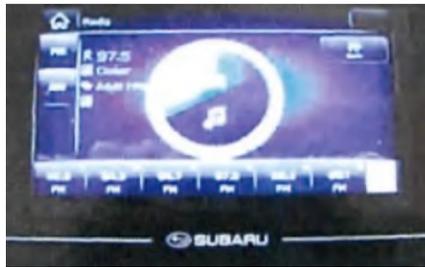
- 3) The time in the MFD automatically reverts back to a “default” setting, even after setting the time using “Manual” mode.
- 4) Audio volume goes to maximum automatically after one click of the volume up button on the steering wheel. In some cases, this condition may also occur without input from the operator. Maximum volume is also displayed on the screen.

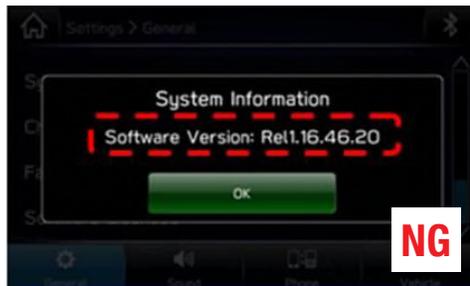
NG- Head Unit Must Be Updated, Proceed To Step 2.
