PRODUCT CAMPAIGN BULLETIN

APPLICABILITY: 2017MY Impreza

NUMBER: WTN-74R

SUBJECT: Reprogramming File Availability to Optimize Rear View Camera Operation on Harman Gen 3 Audio and Navigation Head Units

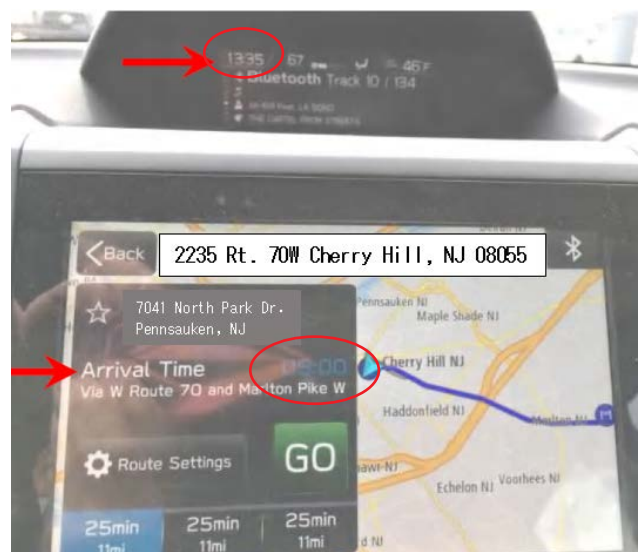
- 2) Time of day displayed in the MFD (Multi-Function Display) is incorrect and the arrival time displayed in Navigation units is also incorrect.

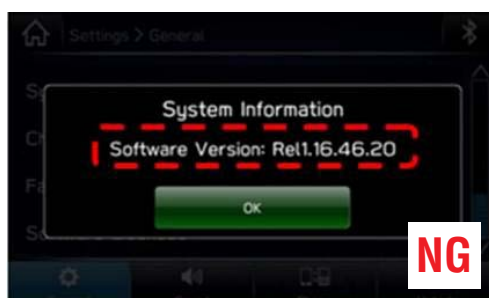
NG- Head Unit Must Be Updated, Proceed To Step 2.
