RECALL BULLETIN:
170228REV

YEAR(S) AFFECTED:
2015-2017

SUBJECT:
Securing the Stationary Interior Step Support Cleats and Solid Surface Step Treads

Issued April 2017
Revised May 2017

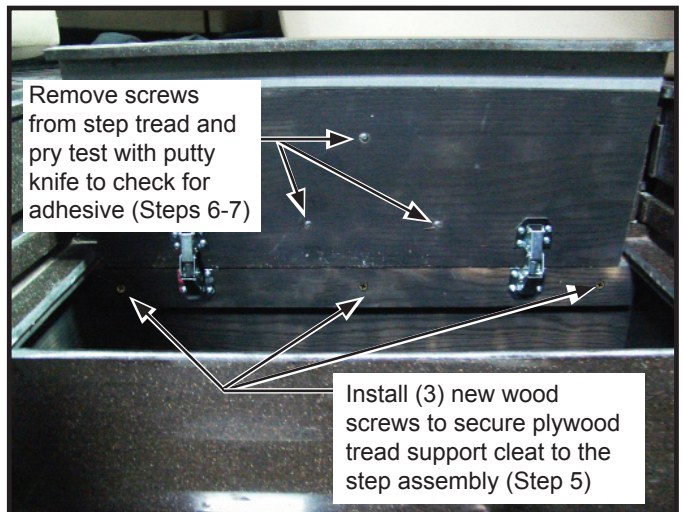
Figure 3

On motorhomes affected by this recall, the horizontally-mounted plywood cleats supporting the hinged solid-surface step tread of two stationary interior entry steps, may have been inadequately fastened to the plywood supporting structure and may detach as a result of step usage.

Additionally, the solid surface (“Corian”) step treads of the stationary interior entry steps may have been inadequately secured to the plywood substrate.

4. Open the entry door and open one of the two hinged interior entry steps. See Figures 1 and 2.
5. Install three new 1 5/8" wood screws, spaced equally across the plywood tread support cleat to secure it to the step assembly. See Figure 3. Repeat for the other tread support cleat.
6. Remove the screws from the underside of one of the hinged solid surface step treads. See Figure 3. Repeat for the other step. Save screws for reinstallation.
