Technical Service Bulletin

GROUP RECALL	NUMBER 17-01-025-1
DATE OCTOBER, 2017	MODEL(S) Sonata (YF) Sonata Hybrid (YF HEV)

SUBJECT: 2011-2014 SONATA (YF) AND 2011-2015 SONATA HYBRID (YF HEV)
ANCHOR PRETENSIONER INSPECTION & LABEL INSTALLATION
(RECALL CAMPAIGN 160)

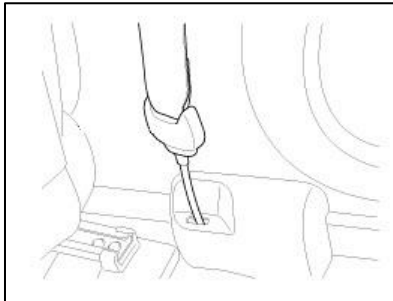
The front seat belt assembly incorporates a seat belt anchor pretensioner fastened to the vehicle's inner sill structure. During vehicle assembly, the anchor pretensioner is fastened to the sill prior to being connected to the seat belt linkage. If, during vehicle assembly, the connector did not fully latch when the linkage was pressed onto the connector, the seat belt can detach from the anchor pretensioner. If the seat belt linkage detaches from the anchor pretensioner in a collision, the risk of injury to the occupant is increased.

This bulletin describes the procedure to inspect the driver's and passenger's anchor pretensioner assemblies to confirm they are properly latched and install warning labels to prevent potential improper reattachment of the anchor pretensioners.

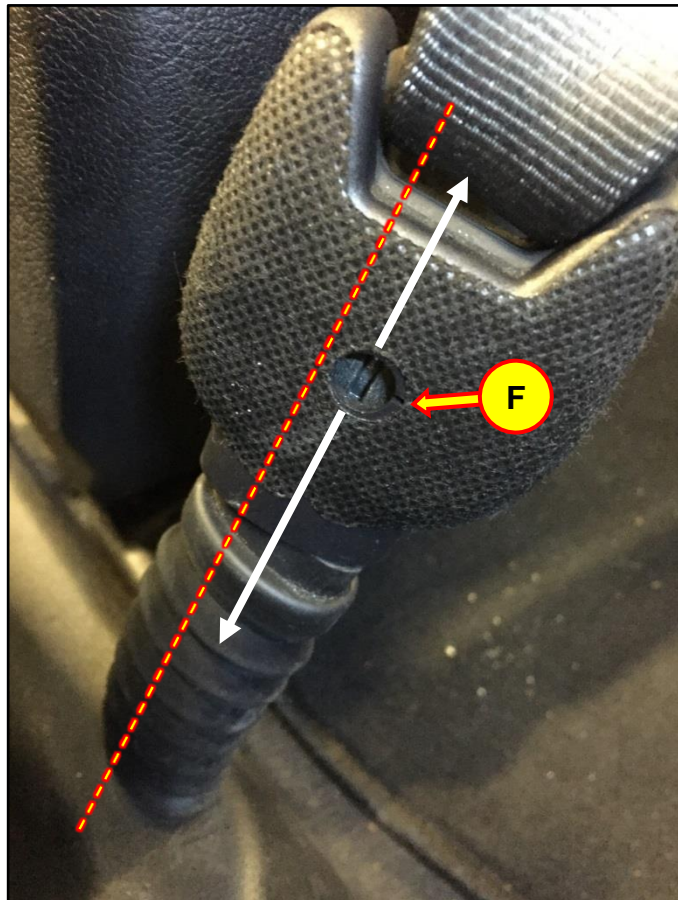
5. Visually inspect the center hole (F) on the outboard side of the linkage element to confirm that it is fully locked.
Note: When fully locked, the latch slot in the center hole is parallel to the anchor pretensioner cable.
