Service Bulletin No. 452B

<i>MODEL</i> J4500	<i>TYPE</i> Field Change Program	<i>SECTION/GROUP</i> 12-Suspension	<i>DATE</i> June 9, 2017
<i>SUBJECT</i> FRONT SWAY BAR			
<i>CONDITIONS</i>

Ref. MCI NHTSA Recall No.:17V-207

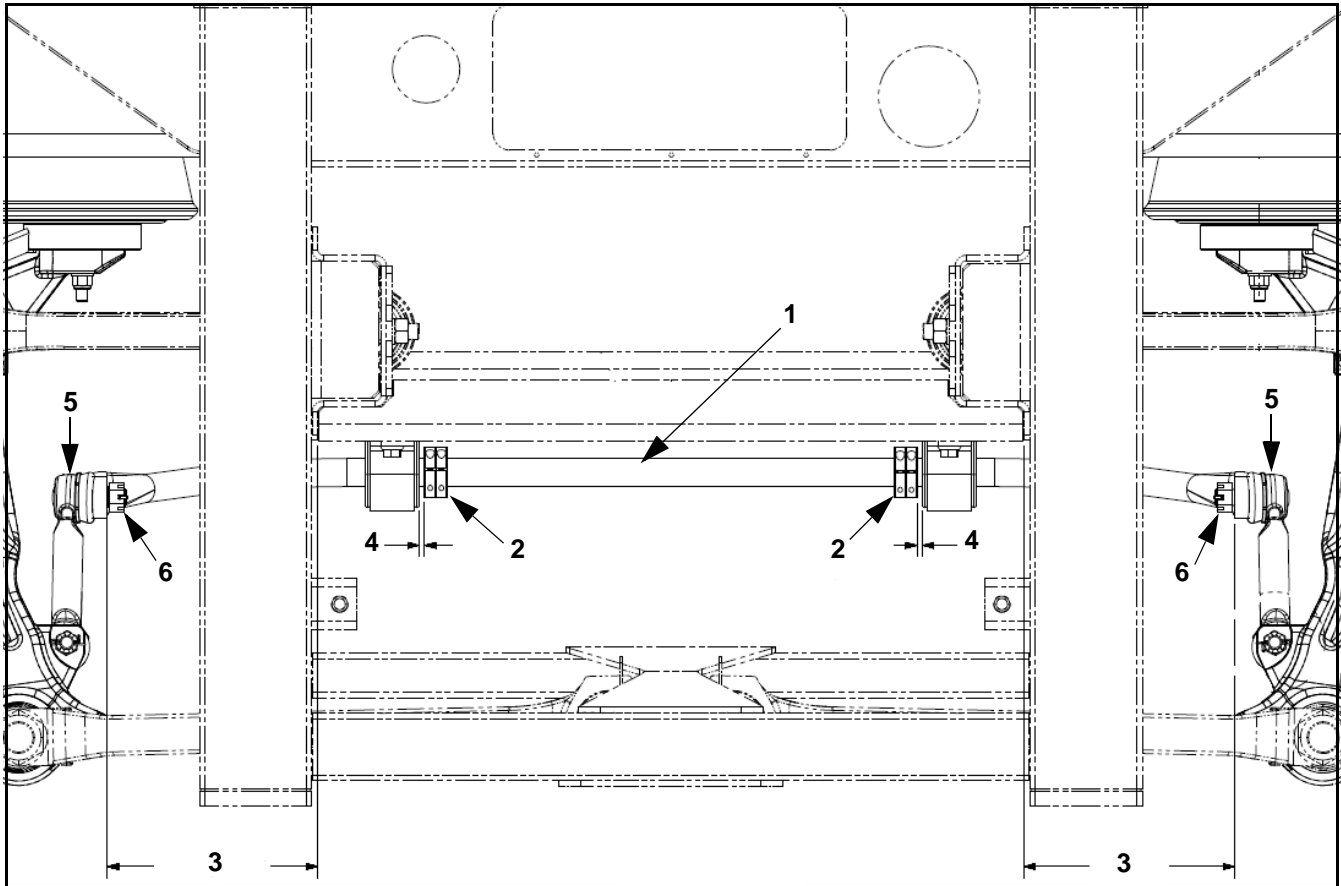
Figure 2. Sway bar installation.

DO NOT remove the existing sway bar links (refer to Figure 2 / Item 5).

Loosen only, DO NOT remove the existing castle nuts from the sway bar linkage (refer to Figure 2 / Item 6). Leave the two (2) castle nuts at least half way tight on the sway bar linkage stud.

Using a hammer, tap both ends of the sway bar to break the joint between the sway bar ends and the linkage (refer to Figure 2 / Items 1 and 5).

Once the joints between the sway bar and the linkage open up, remove and retain the castle nuts to be re-installed at a later step in this procedure (refer to Figure 2 / Item 6).

3. Remove and discard the existing front axle sway bar.
4. Install the new sway bar and service kit components as shown in Figures 2 and 3.

Item	Figure 2 Description
1	Sway bar
2	Collar. Torque collar allen bolts to 155-175 in-lbs.
3	Distance of 9.37 inches
4	Distance of 0.25 inch
5	Existing sway bars links. Ensure sway bars links are vertical and spaced equally from uprights.
6	Existing castle nut
