## Service Bulletin No. 452

| MODEL<br><b>J4500</b> | TYPE<br><b>Field Change Program</b> | SECTION/GROUP<br><b>12-Suspension</b> | DATE |
| SUBJECT<br><b>FRONT SWAY BAR</b> | | | |

Ref. MCI NHTSA Recall No.:17V-207

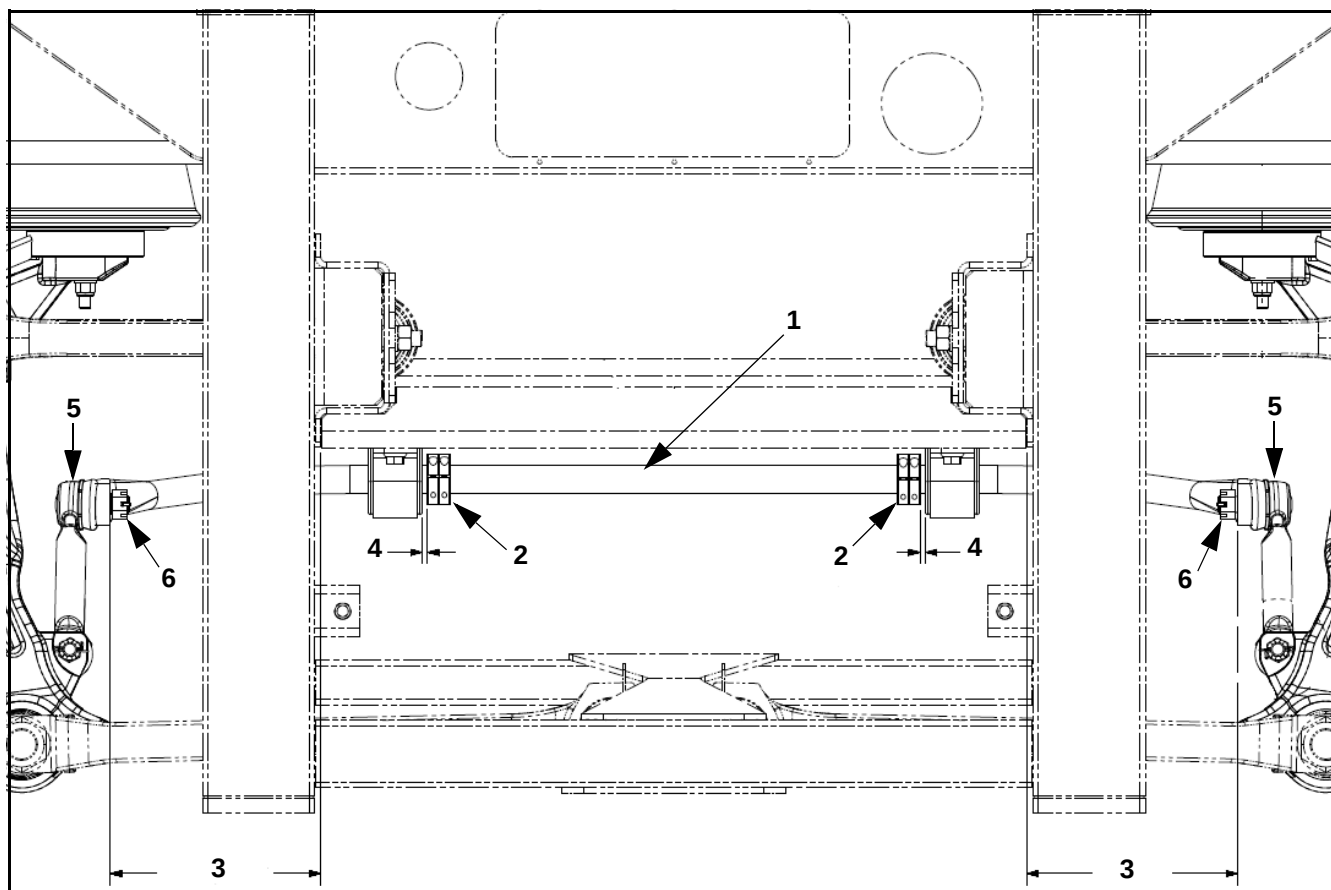
**Figure 2. Sway bar installation.**

Motor Coach Industries ("MCI") has become aware that a defect which relates to motor vehicle safety exists on the front sway bar used on certain front axles. The potential exists whereas the front sway bar may crack at the bushing / clamp locations.

Fatigue failure of the sway bar under certain conditions.

**DO NOT remove the existing sway bar links ( refer to Figure 2 / Item 5 ).**

**Loosen only, DO NOT remove the existing nut from the sway bar link assembly ( refer to Figure 2 / Item 6 ).**

3. Remove and discard the existing front axle sway bar.
4. Install the new sway bar and service kit components as shown in Figures 2 and 3.

| Item | Figure 2 Description |
|---|---|
| 2 | Collar. Torque collar allen bolts to 155-175 in-lbs. |
| 5 | Existing swaye bars links. Ensure sway bars links are vertical and spaced equally from uprights. |
