## Service Bulletin No. 452B

| MODEL<br><b>J4500</b> | TYPE<br><b>Field Change Program</b> | SECTION/GROUP<br><b>12-Suspension</b> | DATE |
| SUBJECT<br><b>FRONT SWAY BAR</b> | | | |

Ref. MCI NHTSA Recall No.:17V-207

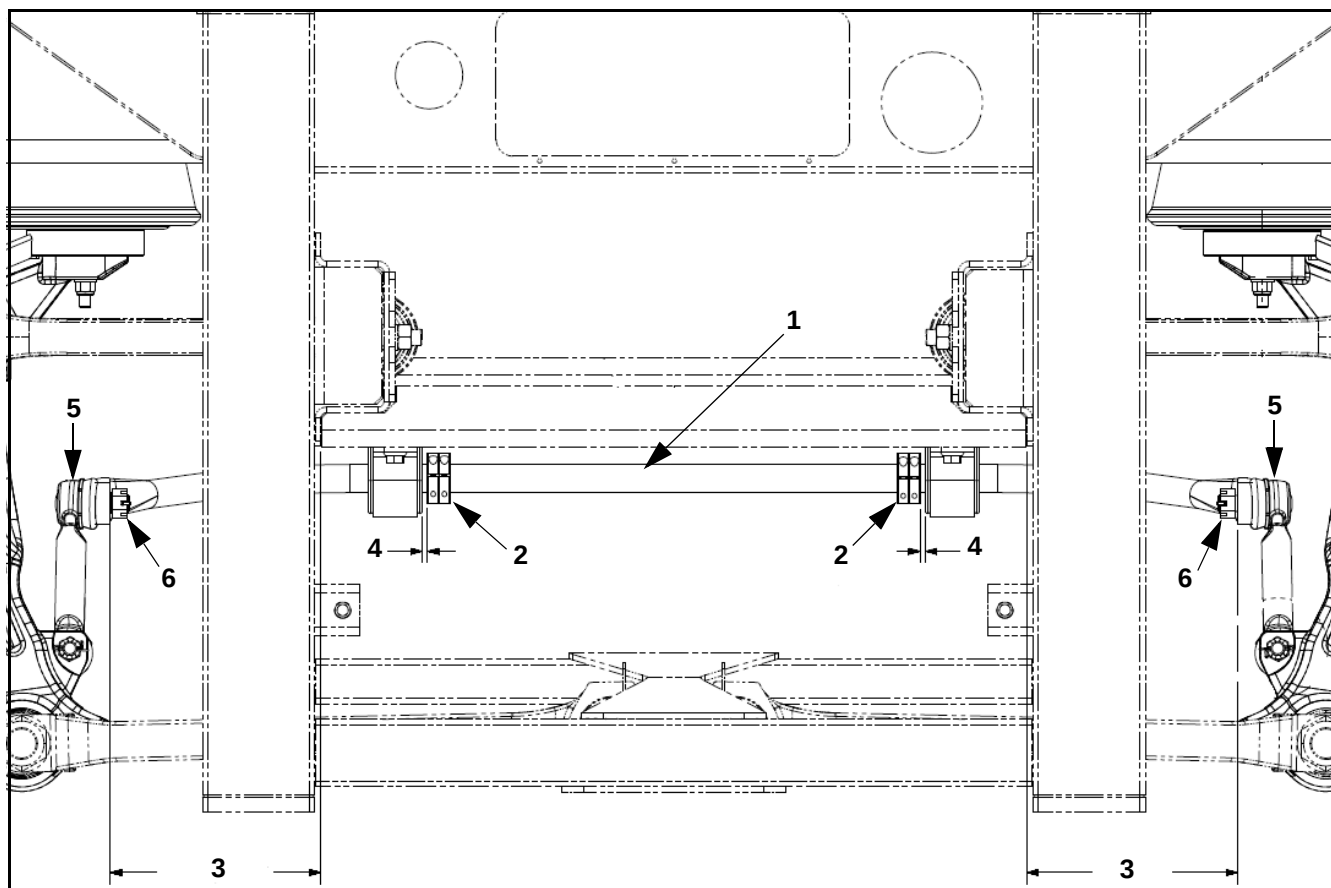
**Figure 2. Sway bar installation.**

Motor Coach Industries ("MCI") has become aware that a defect which relates to motor vehicle safety exists on the front sway bar used on certain front axles. The potential exists whereas the front sway bar may crack at the bushing / clamp locations.

Fatigue failure of the sway bar under certain conditions.

***Using a hammer, tap both ends of the sway bar to break the joint between the sway bar ends and the linkage ( refer to Figure 2 / Items 1 and 5 ).***

3. Remove and discard the existing front axle sway bar.
4. Install the new sway bar and service kit components as shown in Figures 2 and 3.

| Item | Figure 2 Description |
|---|---|
| 2 | Collar. Torque collar allen bolts to 155-175 in-lbs. |
| 5 | Existing sway bars links. Ensure sway bars links are vertical and spaced equally from uprights. |
